# A Critical Reanalysis of Uncontrollable Washboarding Phenomenon in Metal Band Sawing

**Abstract:** The article analyzes the cutting process of hard bars. Investigations conducted in industrial conditions demonstrated the presence of surface errors in the machined workpieces in the form of washboard patterns. The purpose of this study was to analyze the results of cutting on band sawing machines with different band saw blades. The cutting processes were conducted on three different horizontal band sawing machine types. Analyzed material was an alloy steel Ø40 mm rod with a hardened surface covered with a thin layer of chromium. The hardness of the outer layer was 547 HV with a core hardness of 180 HV. The surface topography measurements of the processed workpieces were carried out with the 3D Optical Profiler, which supplied information on the irregularities of the processed material texture. In each of the analyzed cases, a corrugated surface was obtained after sawing, which is the effect of the occurrence of the washboarding phenomenon, despite the fact that the teeth of each band saw had variable pitches. The washboarding phenomenon when cutting rods with hard surfaces is caus

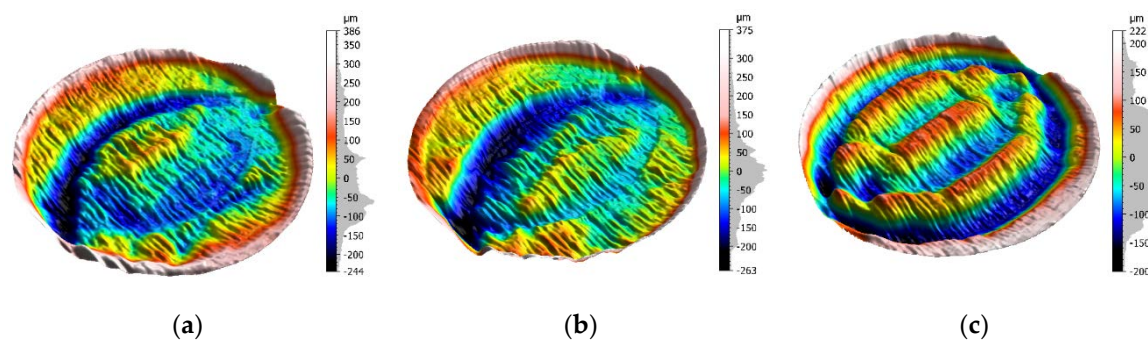
**Figure 5.** 3D waviness surface under investigation of the samples #1 (a), #2(b), and #3 (c).

The height parameters of the S-F surfaces (Table 1) point out that the maximum height between the edge of the sample and the maximum depth of the furrows is much larger for samples #1 and #2. In the case of sample #3, such value reaches 422  $\mu\text{m}$ , and it is 200  $\mu\text{m}$  smaller than for other samples.  $S_p$  and  $S_v$  parameters of the sample #3 indicate regular spacing of hills and valleys.

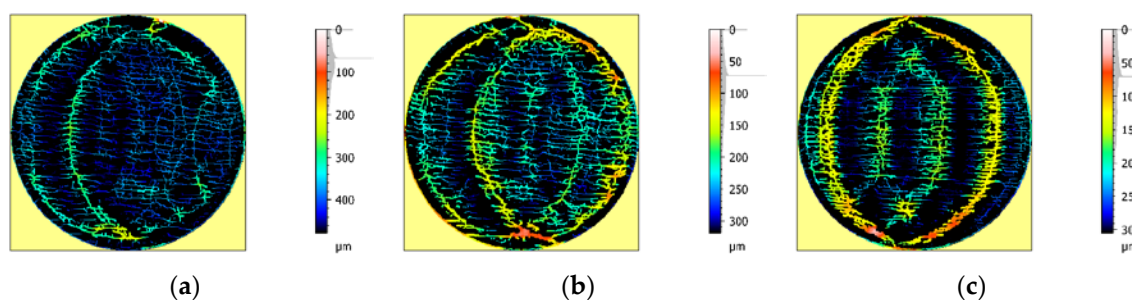
**Figure 6.** View of the furrows of the samples #1 (a), #2 (b), and #3 (c).

Data on furrow depth and density gathered from the examined surfaces are presented in Table 3. The obtained mean values oscillated around 100  $\mu\text{m}$ , the maximum depth of samples of furrows for sample #3 was about 200  $\mu\text{m}$  lower than for sample #1. In all cases, the density of the furrows, defined as a cumulative length per area unit (in 1/cm), were at the similar level.

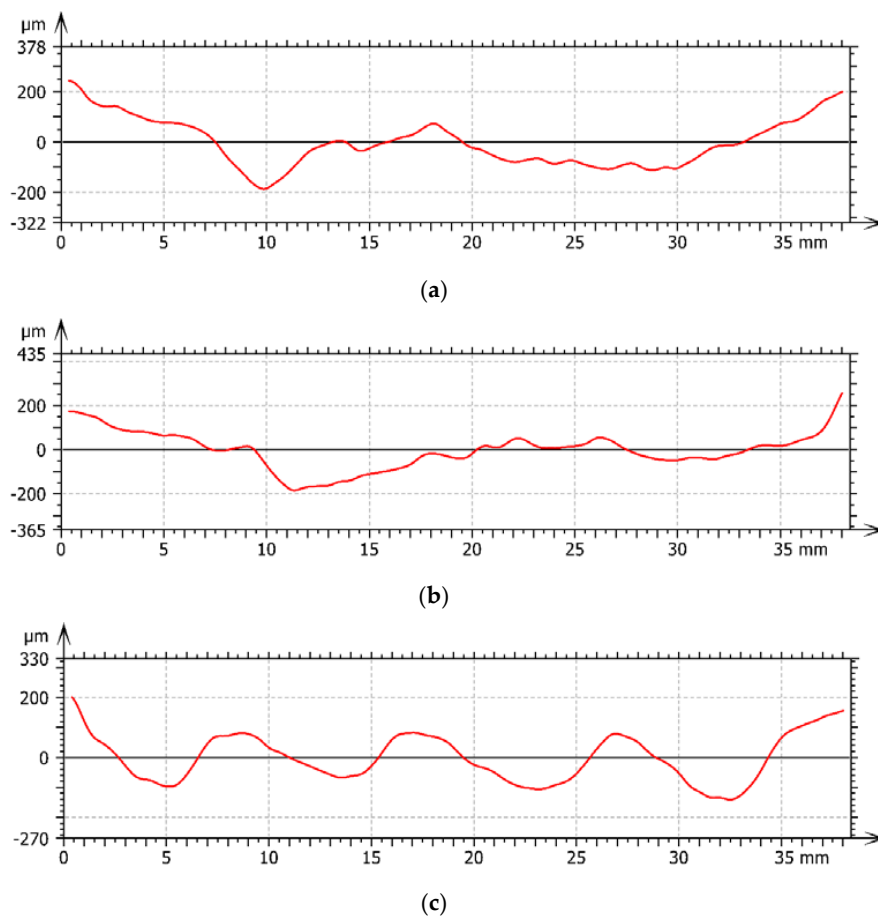
An exemplary W-profile at 50% position of the sample #3 is presented in Figure 7. According to the values of waviness parameters and profile information given in Table 3, the middle of the machined samples #1 and #2 was distinctly above the edge, 2–3  $\mu\text{m}$  wide, and with deep furrows. In sample #3, all of the furrows after machining process were well visible and their height was similar level to regular spacing of hills and valleys.

**Figure 7.** Exemplary W—profile at 50% position of the samples #1 (a), #2 (b), and #3 (c).

The phenomenon of the occurrence of the corrugated surfaces after sawing in this case could be due to the behavior of the saw blade with spring setting teeth caused by the high hardness of the outer layer of the sawn rod (547 HV). For spring setting teeth, the saw blade during entrance into cut material is twisted by the lateral forces (back forces). Under specific cutting conditions, while the washboard pattern is formed, every successive cutting edge regenerates a wave performed by the previous one. Nevertheless, this new wave is part of a distance velocity lag in the direction of primary motion. The result of this wave regeneration on the sawn surface is visible as a washboard pattern, which can be described by parameters of waviness. The wave regeneration in the examined cases is not a time function but a function of the saw blade position and simultaneous effect of forced excitations of the formed wave upon the saw blade lateral displacements. This phenomenon was described in detail by Orłowski and Wasielewski [15], who analyzed process of sawing beech and pine wood on the sash gang saw PRW15-M. In the sawing process, they used saw blades of poor quality of teeth cutting edges after grinding (minor cutting edges with feathers). It should be emphasized that waviness parameters for those species were almost equal.

Based on the study, the performed application of bandsaws with spring setting teeth is strongly discouraged for cutting-off hard-to-machine materials. If this type of bandsaw is used, in the next step another technological operation, e.g., turning, is needed. On the other hand, with such a difficult technological task, cutting-off wire electro discharging machining (WEDM) could be recommended.
