**J. Łabanowski<sup>1</sup>, S. Topolska<sup>2</sup>, J. Ćwiek<sup>3</sup>,**

## **ASSESSMENT OF EVAPORATOR TUBES CORROSION IN LOW-EMISSION STEAM BOILERS**

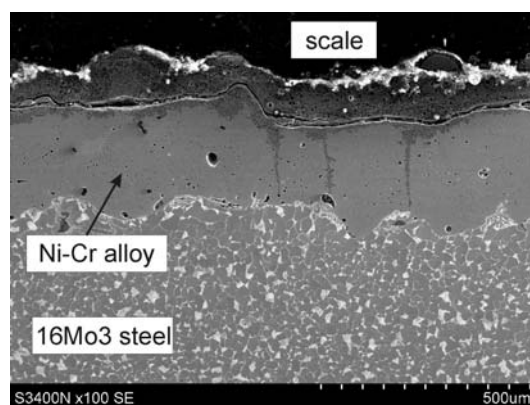
The tube surface with arc sprayed single layer of 70% Ni and 30% Cr alloy after one year operation is shown in fig 4 and 5. The thickness of this layer varied from 300 to 450  $\mu\text{m}$ . Bonding with base material was rather weak because of evidence of many voids and porous structure at material-coating interface.

**Fig. 4.** Cross section of  $\varnothing 57 \times 5.0$  mm evaporator tube with thermal sprayed Ni-30Cr layer after one year exploitation

were severely cracked (Fig.5b) - probably during exploitation, and this allow the corrosive species to attack the base material through the cracks. Cracks penetrated all the way through the coating. The ways of corrosive attack through the Ni-30Cr coating are visible in Fig. 4 and 5a. Sulphur presence was confirmed along the cracks and on the interface coating-base material.
