J. Hucińska, G. Gajowiec

Gdansk University of Technology, Mechanical Engineering Faculty, Gdansk, Poland

ASSESSMENT OF FITNESS FOR SERVICE OF Cr-Mo STEEL TUBES IN CATALYTIC REFORMING CHARGE HEATERS

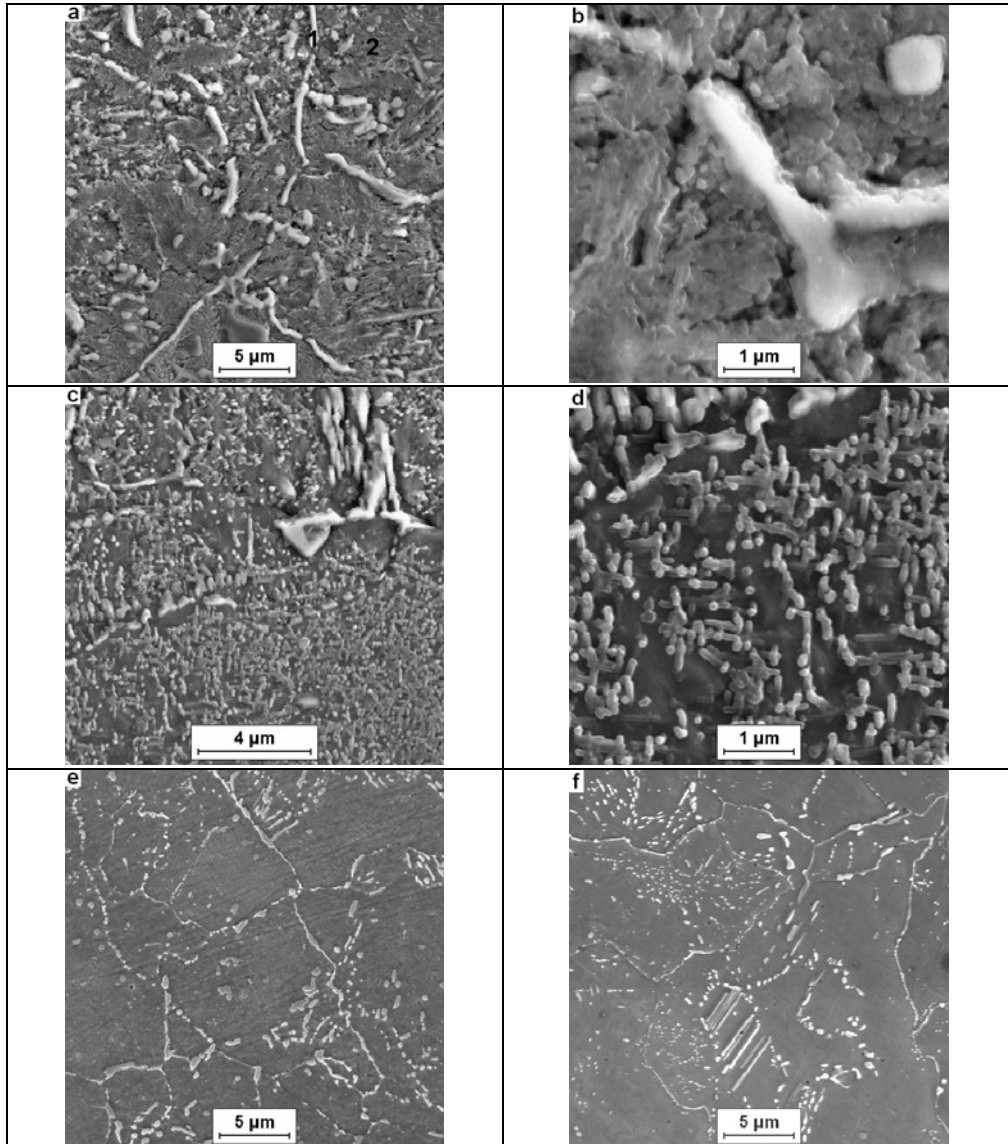
The microstructure features across 9Cr-1Mo steel tube wall are presented in Figs. 6(a) through (f). Like the zone situated close to the IS, which is shown in Fig. 4, the material situated at about 50 μm from the surface is composed of big degraded primary carbides surrounded by a 'matrix' comprising carbide precipitates instead of alloy ferrite. The microstructure of this zone is shown in Fig. 6(a), (b). According to a micrograph in Fig. 6(c), (d), some areas of the ferrite matrix with a dense network of fine carbides may be seen at about 200 μm from the surface. At a depth of 700 μm , the ferrite grains and fine carbides mainly occurring at grain boundaries are illustrated in Fig. 6(e). The microstructure in this area is the same as the microstructure of the middle-wall material situated at a depth of 3 mm, Fig. 6(f).

Fig. 6 (a)-(f). Micrographs of the cross-section of 9Cr-1Mo steel tube wall. Distances from the IS: (a),(b) 50 μm , (c),(d) 200 μm , (e) 700 μm , (f) 3 mm
