Assessment of Wooden Beams from Historical Buildings Using Ultrasonic Transmission Tomography

The main goal of this study was non-destructive evaluation of wooden elements using ultrasonic waves. The inspection was carried out on wooden beams from a historical object. Elastic wave signals were processed by ultrasonic transmission tomography to obtain imaging of the internal structure of tested elements without disturbing their state and integrity. The focus was on the influence of wood anisotropy on the propagation of ultrasonic waves. A novel method of determining the position of the cross-section pith was proposed. The study presented that the proposed imaging approach was capable to assess the technical condition of historic wooden beams by determining the degree of wood damage and the location of discontinuities, scratches or fibrosis in the tested cross-section.

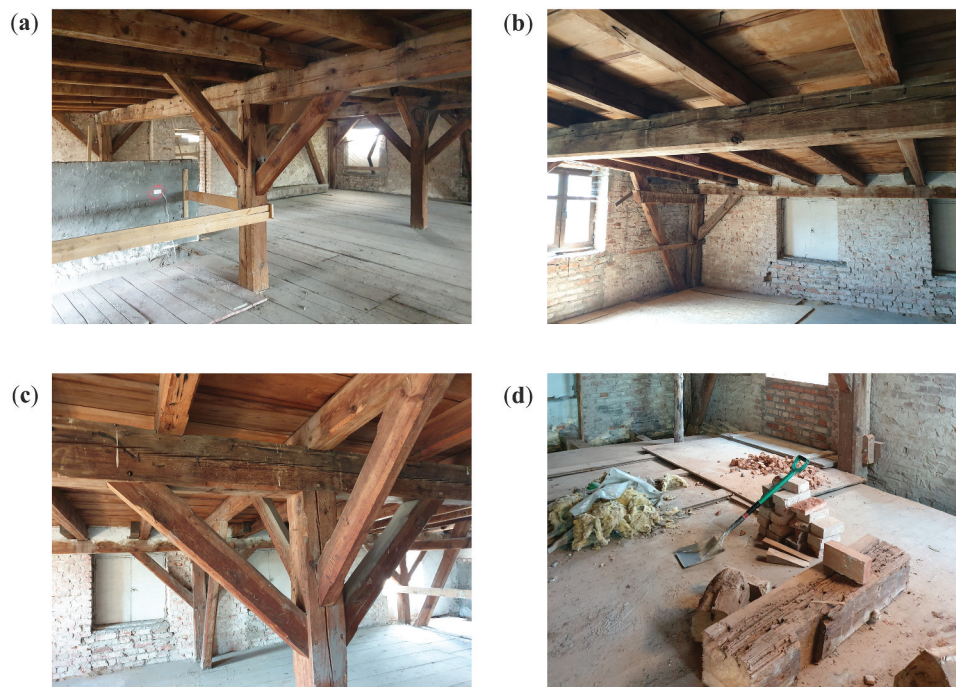
Figure 4. Photographs of the roof framework from the monastery of congregation of the sisters of St. Catherine in Orneta (Poland) before starting construction work (a-c) and when the works are carried out (d).

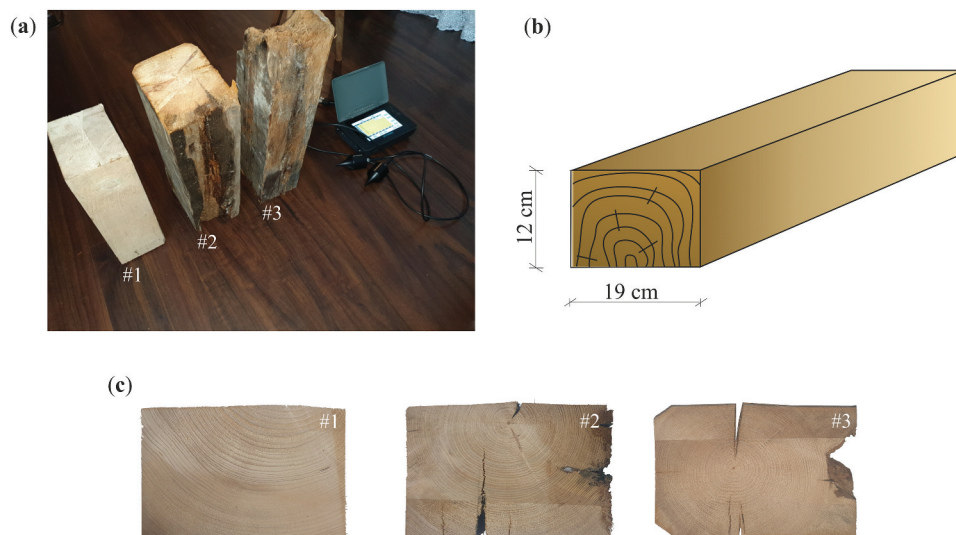
beams were significantly damaged. There were defects in the material on one edge. In addition, cracks run along the wood fibres. They were replaced due to their bad technical condition by new wooden beams. After the tests, all tested samples #1–#3 were cut at the height of the reconstruction image. As a result, it was possible to identify the course of the fibres and the damage exactly at the plane of measurement (Figure 5c).

Figure 5. Laboratory models of wooden beams: (a) view of the beams, (b) dimensions of the beam, (c) cross-section of the tested beams #1–#3.

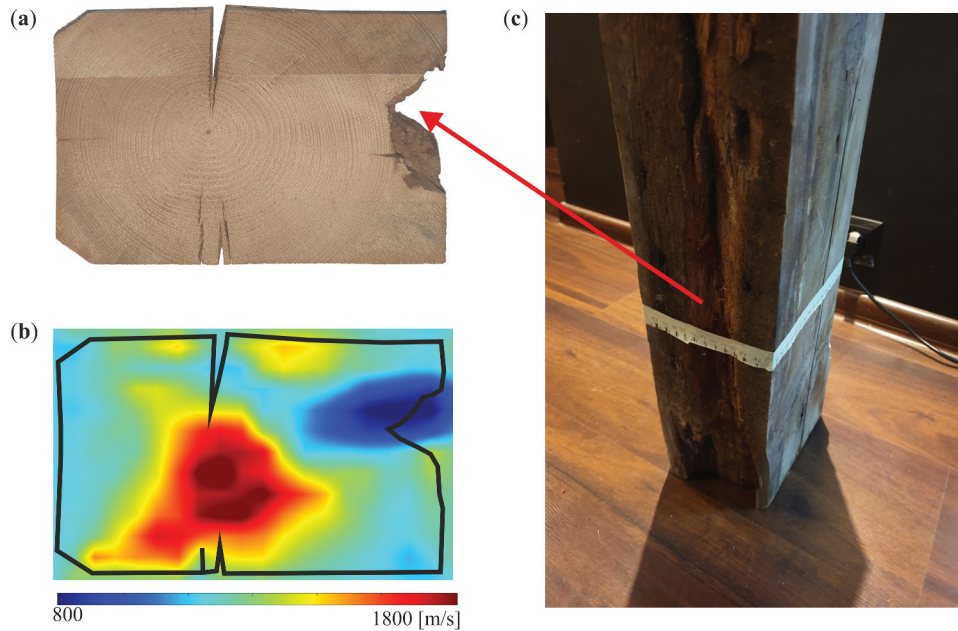
Beam #3 had the highest level of degradation. One of the sides included a significant cavity caused by insects (**Figure 10a**). This place is marked in blue on the ultrasonic tomography map (**Figure 10b**). The remaining sides included cracks. The biggest crack is marked on the tomographic image. Similarly to beams #1 and #2 the greatest concentration of the wave propagation velocity determined the location of the pith. The

propagation velocity of ultrasonic waves was between 478.6 m/s and 2262.3 m/s. The difference between the minimum and maximum velocity was the largest compared to the other two beams. It was twice as high as in the reference beam. The average velocity was 1462.3 m/s. The standard deviation (SD) was 293.4 m/s, while the coefficient of variation (CV) is 20.1%. Such a high value indicates significant damage to the beam.

Figure 10. Results obtained for beam #3: (a) top view of the beam, (a) ultrasonic tomography image, (c) side view of the beam.
