Case study of masts damage of the sail training vessel POGORIA.

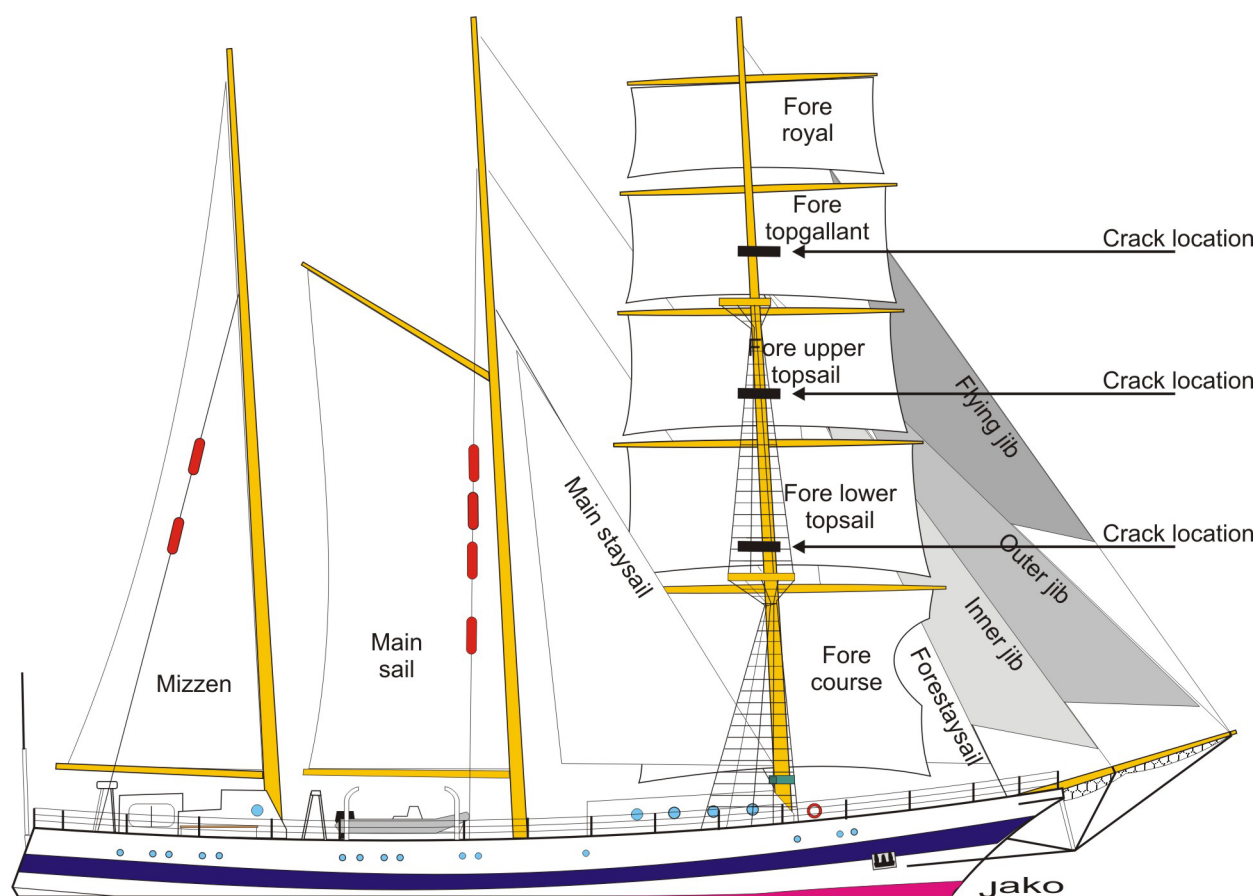
Fig.2. Pogoria sails set and foremast crack location in the moment of the accident

In our opinion, cooperation of two main factors was the direct cause of the fracture of foremast in its upper part:

- substantial weakness of the mast skin material in the determined cross-section,
- periodical action of dynamic strength triggered off by upper foremast sails called flying and outer jibs respectively.

Phenomenon explanation of the first factor will be presented in the further part of this paper. The second factor is connected with a way of sailing according to the close hauled course what means that Pogoria had the sails trimmed for sailing as close to the wind as possible. In the case of not very careful steering, this course can cause the sudden ‘down casting’ and ‘filling out’ upper triangular sails so-called stays. Several times repetition of such a maneuver triggered off the periodic dynamic forces which caused destruction of a skin material coherence of the foremast in its weakening place.
