# Causes of damage and methods of repairing floor made on polystyrene concrete

**Abstract.** The paper describes damages, tests and repair of the floor made on existing ceiling and expanded polystyrene concrete underlay. The floor was built on a reinforced concrete ceiling with an area of about 1050 m<sup>2</sup>. Significant damage in the form of cracks, detachments and unevenness was found in the floor. In order to determine the causes of damage, in situ tests and laboratory tests were carried out. It was found that the damage was caused by numerous performance errors. A test repair of the damage (4.7x6.0 m) was carried out, and then the repair method was applied on the entire floor surface.

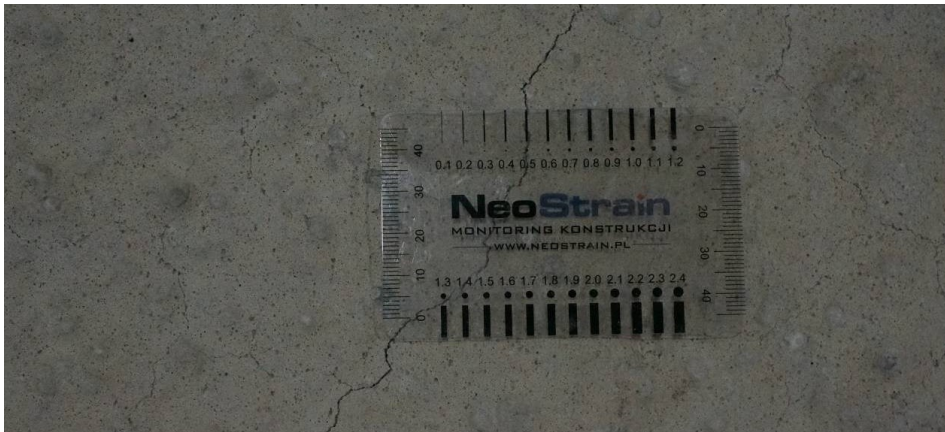
The visual evaluation of the samples was being conducted for over 2 months. The observations lasted over 2,5 times longer than the time in which the cracks occurred in analyzed floor. After 49 days first three samples did not exhibit any signs of cracking. The last sample exhibited small shrinkage cracks. Local width of the crack reached between  $0.1 \div 0.5$  mm. The cracks on the surface of the EPSC occurred after two weeks due to lack of curing. The cracks are shown in Fig. 10.

**Fig. 10.** Measurement of the cracks in sample no. 4.

Comparative tests have shown that it is possible to make a self-levelling screed for the designed floor. Lack of curing resulted in the occurrence of cracks in the EPS concrete.

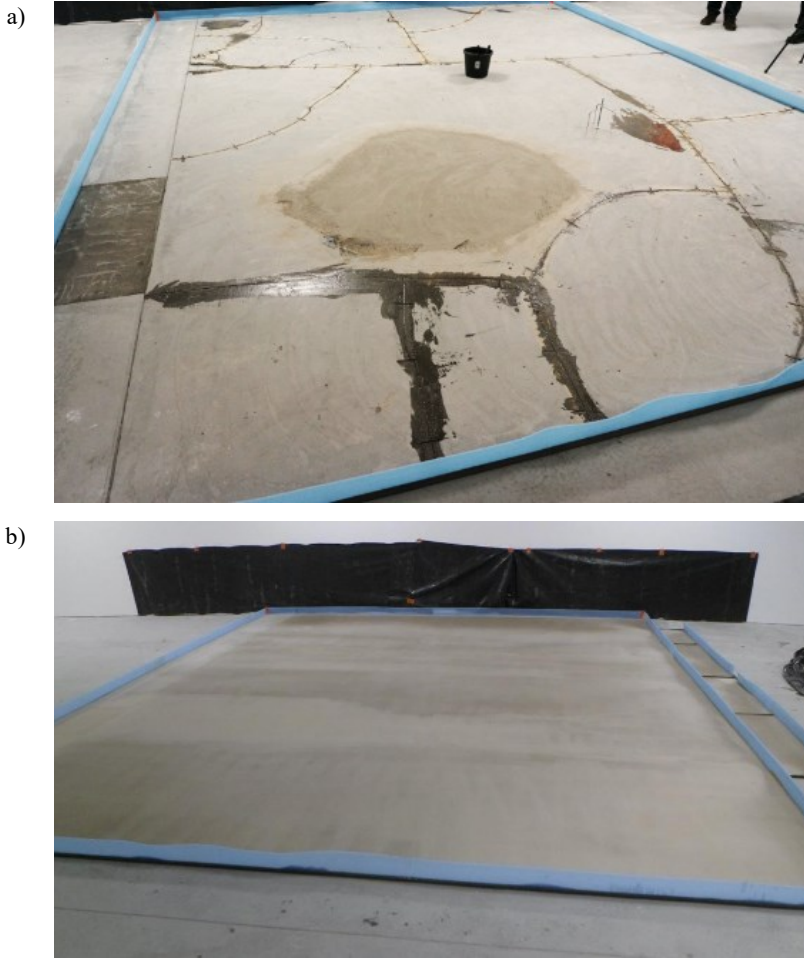
**Fig. 13.** Repair method: a) view after stitching and injection of the cracks, b) finished top layer.

An attempt was made to repair damaged floor in a selected field of 4.7 x 6.0 m. It was decided to perform repair by stitching cracks with a thin copper stainless steel wire, perpendicular to their course, filling possible empty spaces with cement-based mortar. Stitching reinforcement was placed in incisions every 20÷25 cm. The places of stitching and cracks were filled with an injection resin (Fig. 13). This method allowed for a tight connection of floor fragments separated by cracks. It also allowed to obtain a smooth surface under the planned top floor, which was the base for the final finishing of carpet floors. Since the sample repair has proved correct, the whole floor was repaired with this method.
