COMPREHENSIVE MONITORING OF CHANGES IN THE GEOMETRIC STRUCTURE OF A HISTORIC BUILDING THE "SALA BHP" IN GDAŃSK

Jacek SZTUBECKI¹, Maciej NIEDOSTATKIEWICZ², Maria MRÓWCZYŃSKA³,
Tomasz MAJEWSKI⁴

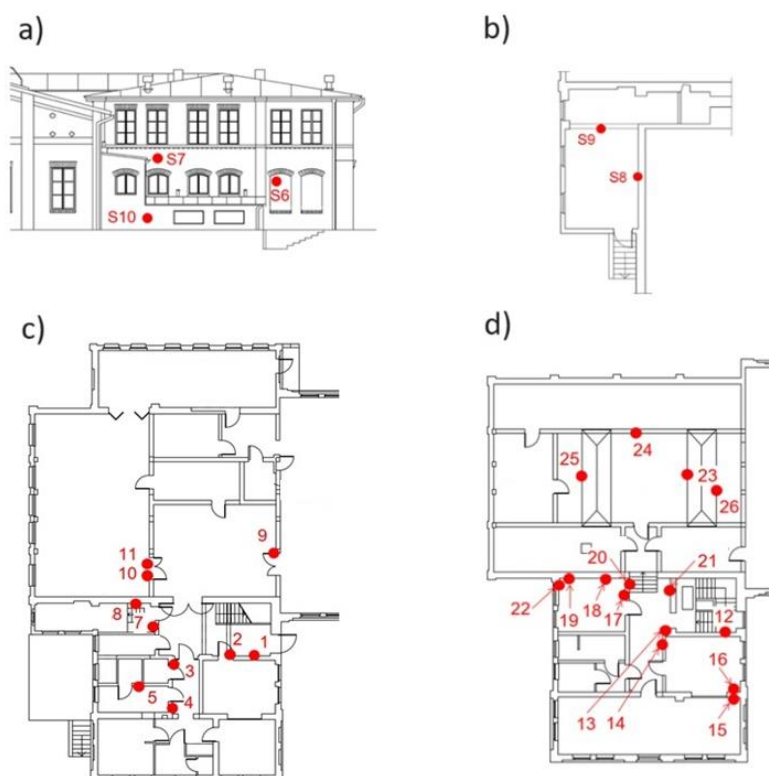
Fig. 11. Location of crackmeters: a) eastern elevation, b) boiler room, c) ground floor, d) first floor

Crackmeters were installed on the building's structural and finishing elements, where scratches were observed (Fig. 11).

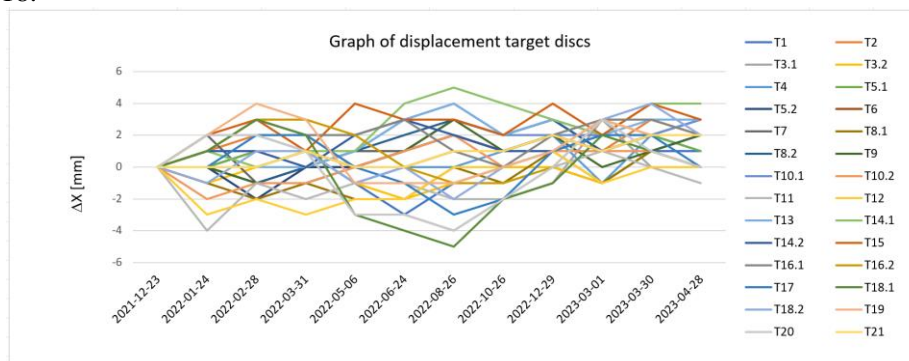
Fig. 17. Horizontal displacements of the discs in the X direction

The maximum horizontal displacement was recorded for the T15 disc in the Y direction and amounted to -8 mm. In the alignment process, errors in the position of the points of the controlled network in relation to the reference points were determined. The values of these errors were a maximum of 1.5 mm. According to the currently applicable standard [9], the values of horizontal displacements are permissible in the case of brick buildings, which are considered up to 20 mm on each floor and up to 50 mm along the entire height of the wall.

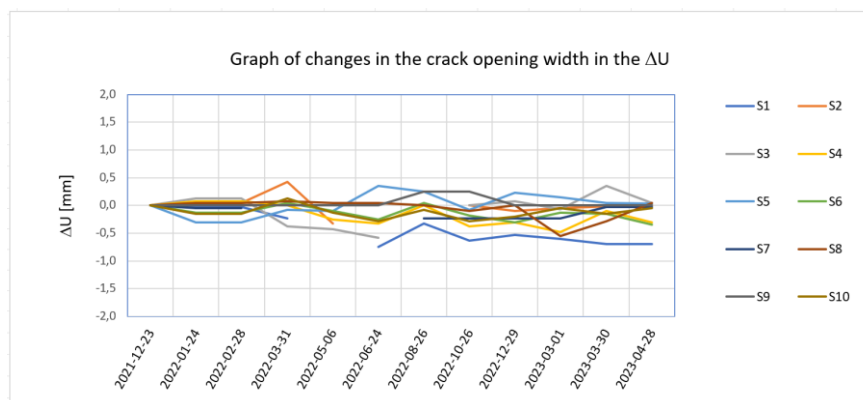
Fig. 19. Changes in the crack opening width in the ΔU direction for crackmeters S1-S10

min $\Delta U = -1.00$ mm - crackmeter no. 24,

max $\Delta U = +1.25$ mm – crackmeter no. 25,

It was found that changes in the width of monitored cracks located on the walls of the building's facade are caused by changes in atmospheric conditions: ambient temperature, humidity, and sunlight. Significant changes in the readings of the S10 crack gauge means that the crack above the lintel is active, and therefore it is recommended to check the lintel's stress and propose ways to strengthen it.

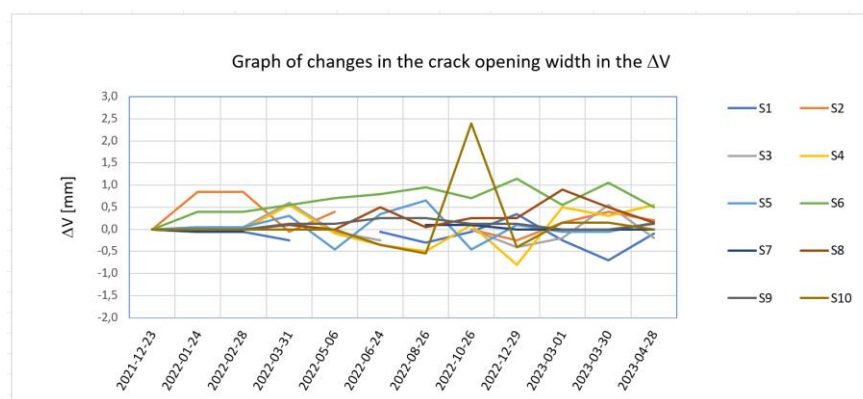
Fig. 20. Changes in the crack opening width in the ΔV for crackmeters S1-S10

min $\Delta V = -1.63$ mm – crackmeter no. 25,

max $\Delta V = +2.40$ mm – crackmeter no. S10.
