COMPREHENSIVE MONITORING OF CHANGES IN THE GEOMETRIC STRUCTURE OF A HISTORIC BUILDING THE "SALA BHP" IN GDAŃSK

Abstract

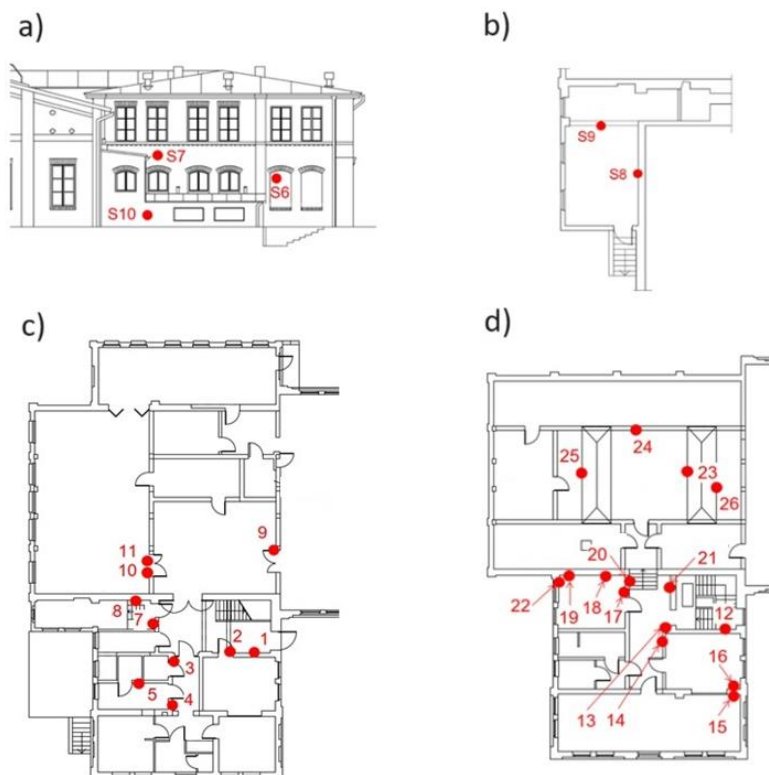
Fig. 11. Location of crackmeters: a) eastern elevation, b) boiler room, c) ground floor, d) first floor

Crackmeters were installed on the building's structural and finishing elements, where scratches were observed (Fig. 11).
