Corrosion of evaporator tubes in low emission steam boilers

S. Topolska ^{a,*}, J. Łabanowski ^b

S. Topolska, J. Łabanowski, Corrosion of evaporator tubes in low emission steam boilers, Archives of Materials Science and Engineering 42/2 (2010) 85-92.

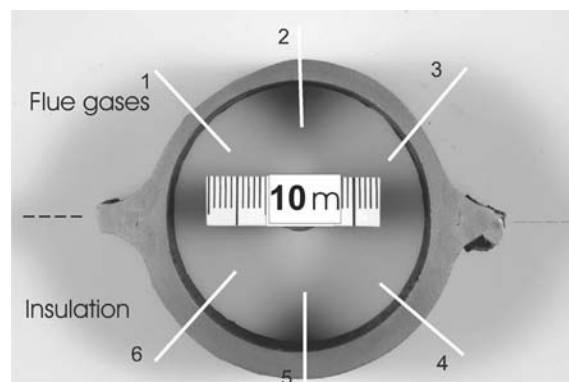
Tubes wall thicknesses were measured on the cross sections at the places indicated in Fig. 1. The results are collected in Table 1. The reduction in wall thickness was not uniform on tube's perimeter. The front side of the tube facing the combustion radiant heat suffered the worst metal wastage and reaches 58% of its nominal value. Reductions in wall thickness from insulation side of tubes were not observed. The highest reduction in wall thickness was detected at points 1 and 3 from the fire side of the tube. Thickness reduction was considerable on the segments taken from the level of 10 m, when at level 18 m this reduction was small.

Fig. 1. Cross section of $\varnothing 57 \times 5.0$ mm evaporator tube (level of 10 m)

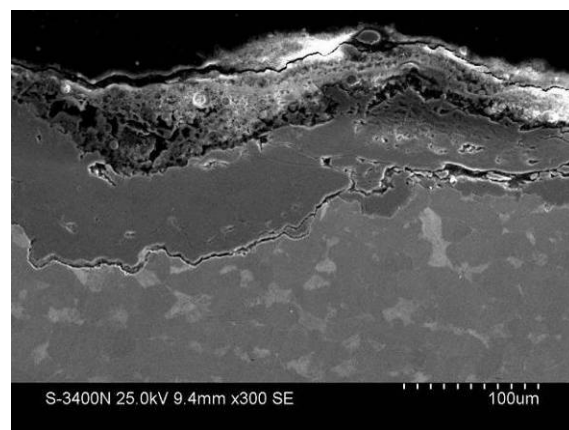
The view of cross section of the tube surface is shown in Fig.2. The deposits on the tube's surfaces differ in the thickness from 100 to 300 μm . Scale consists of two layers, external, which is porous and weakly connected with the tube surface, and internal, which is dense and adherent to the base metal.

Fig. 2. Cross section of $\varnothing 57 \times 5.0$ mm evaporator tube after two years exploitation. Deposits on the fireside of the tube

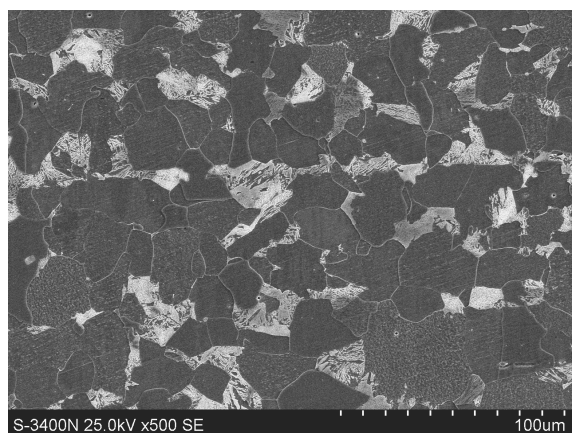
Microstructure of tube wall material (16M steel) is shown at Fig. 3 and 4. Microstructure of both tube segments taken from the level 10 and 18 m from the bottom of combustion chamber show non degraded structure consisted of ferrite and bainite grains. The grain growth due to the high temperature operation was not detected.

Fig. 3. Microstructure of 16M steel. Tube segment taken from the level of 10 m at combustion chamber, SEM image

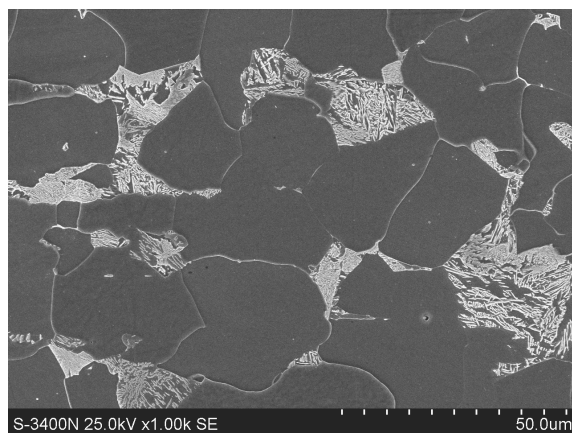
Fig. 4. Microstructure of 16M steel. Tube segment taken from the level of 18 m at combustion chamber, SEM image

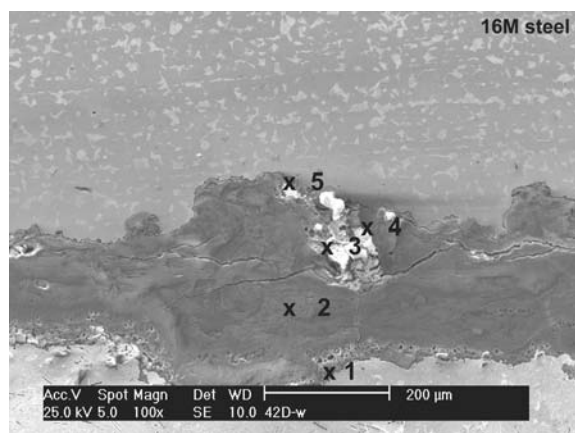
Scales consist mainly of iron oxides with considerable amount of sulfides. Detected elements were not uniformly spaced at the scale. The bands rich in sulfur were detected as well as zones enriched in chlorine. More alkaline metals were observed at scales covered samples taken from the level of 18m. Maximum sulfur contents were 32% and chlorine about 6%.

Fig. 5. Cross section of the fire side face of water wall tube. Sample 42D taken from the level of 10 m, "X" indicate points of spot analysis

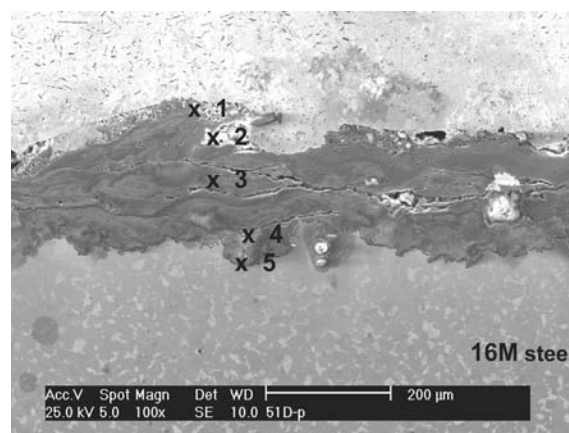
Fig. 7. Cross section of the fire side face of water wall tube. Sample 51D taken from the level of 10 m, "X" indicate points of spot analysis

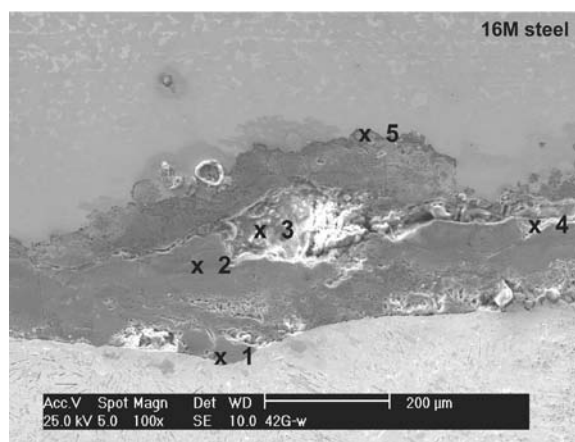
Fig. 6. Cross section of the fire side face of water wall tube. Sample 42G taken from the level of 18 m, "X" indicate points of spot analysis

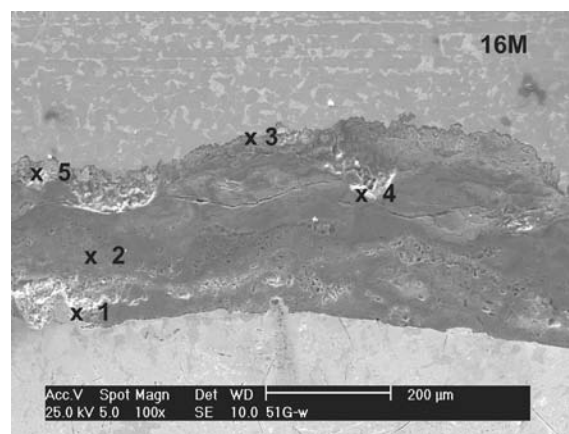
Fig. 8. Cross section of the fire side face of water wall tube. Sample 51G taken from the level of 18 m, "X" indicate points of spot analysis

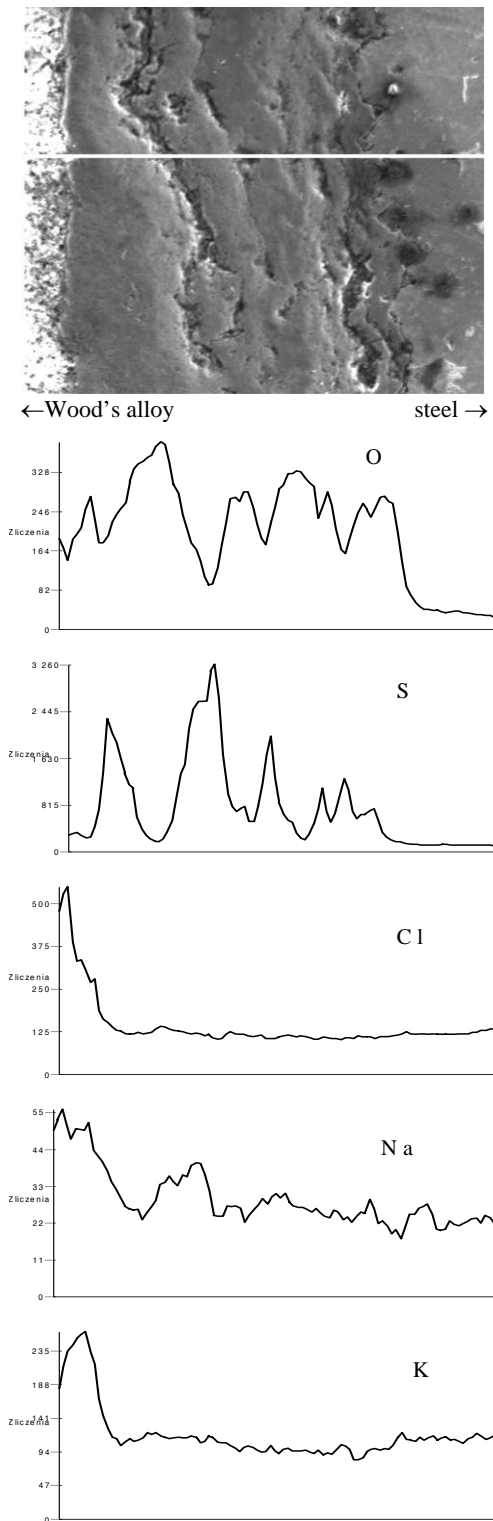
Linear distribution of elements (Figs. 9 and 10) has shown the increased concentration of chlorine and alkaline metals in the areas adjacent to the interface of base material and scale. Such shape of element distribution is dominant for samples taken from the level of 18 m.

Fig. 9. Linear distribution of elements on cross section of deposit layer on $\varnothing 57 \times 5.0$ mm evaporator tube, level of 10 m

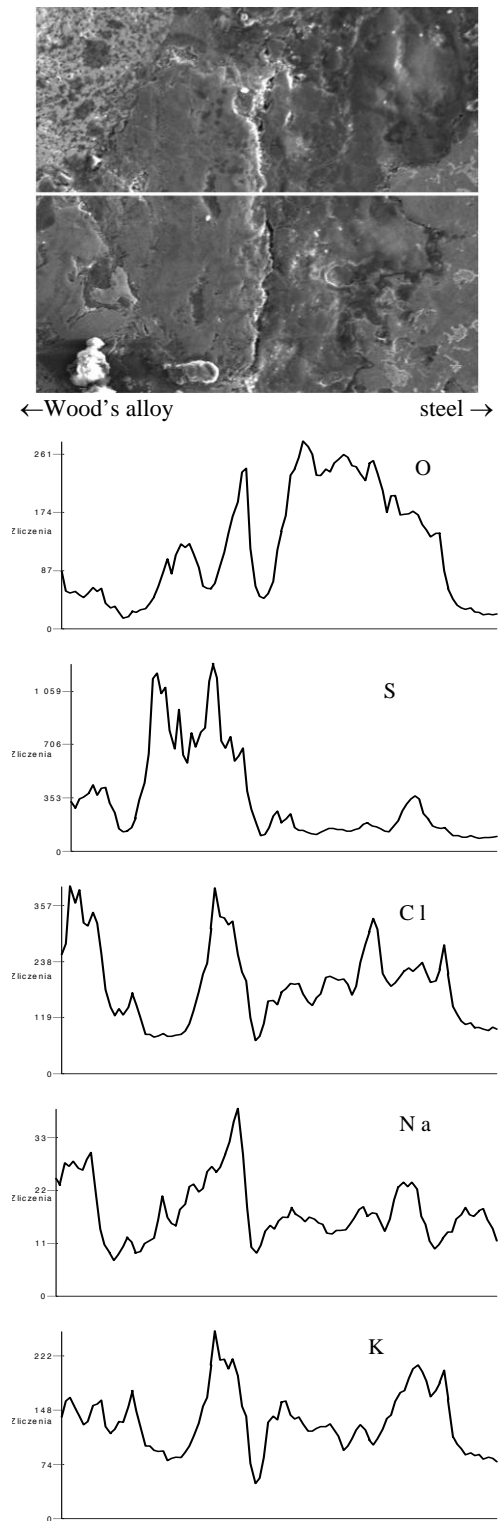
Fig. 10. Linear distribution of elements on cross section of deposit layer on $\varnothing 57 \times 5.0$ mm evaporator tube, level of 18 m

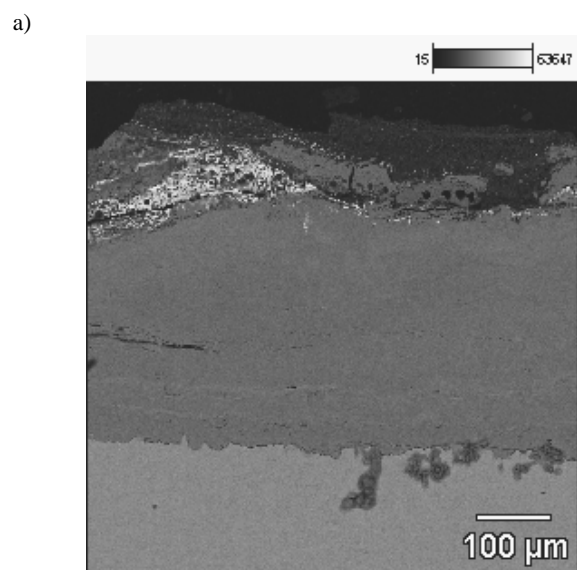
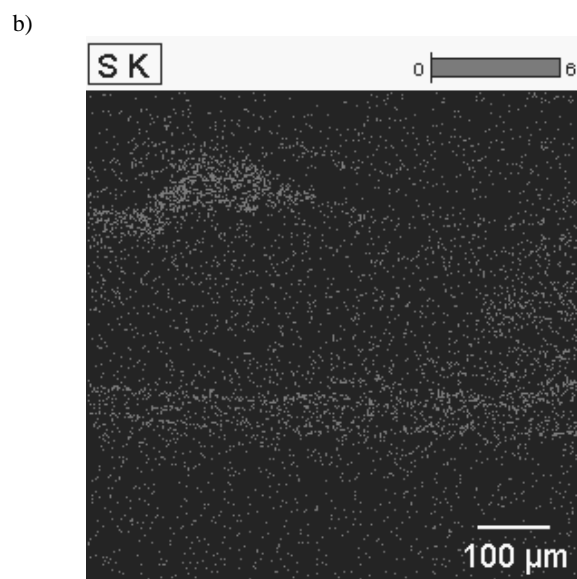
Fig. 11. Cross section of fire-side face of water wall tube subjected to reducing combustion conditions a) optical micrograph b) x-ray elemental dot map for sulphur

Dot maps confirmed observation on inhomogeneous of scale composition. Fig. 11 shows bands enriched in sulfur situated at external layer of the scale and second band close to the interface of base material and scale.

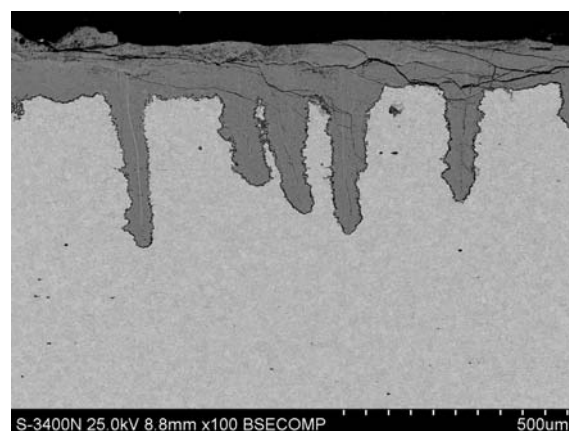
Detailed observations revealed pits and deep penetrations into the tube wall on the samples taken from the level of 18 m (Fig. 12). Such deep pits can form as a result of low melting ash constituent action. Local microanalyses of chemical composition (Figs. 13 and 14) indicated enriched concentrations of sulfur, chlorine and potassium close to the borderline of base material and scale.

Fig. 12. Cross section of fire-side face of water wall tube, level - 18m. Dip penetrations into the tube wall

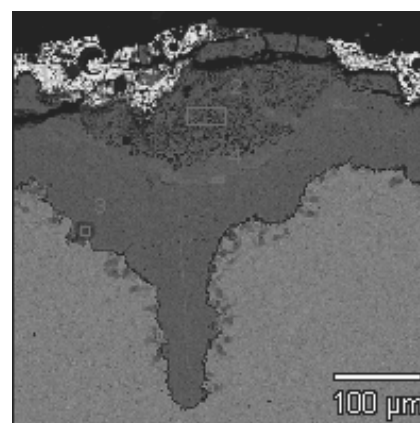
Fig. 13. Chemical analysis of the scale at the corrosion pit (wt.%). Level - 18m, measure points indicated in micrograph

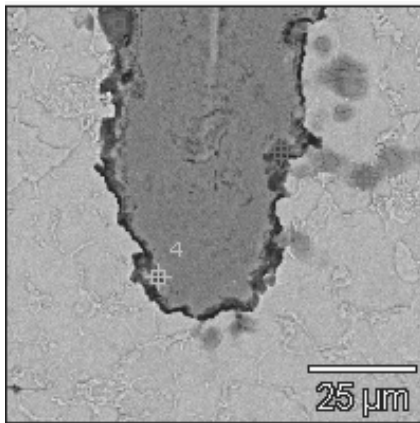
Fig. 14. Chemical analysis of the scale at the tip of corrosion pit (wt. %). Level - 18m, measure points indicated in micrograph
