Diagnosics and protection methods a residential building in connection with the reconstruction of a road located in its immediate neighborhood - case study

Maciej NIEDOSTATKIEWICZ ^{1*}

¹ *Department of Engineering Structures, Faculty of Civil and Environmental Engineering,
Gdansk University of Technology, Gdansk, Poland*

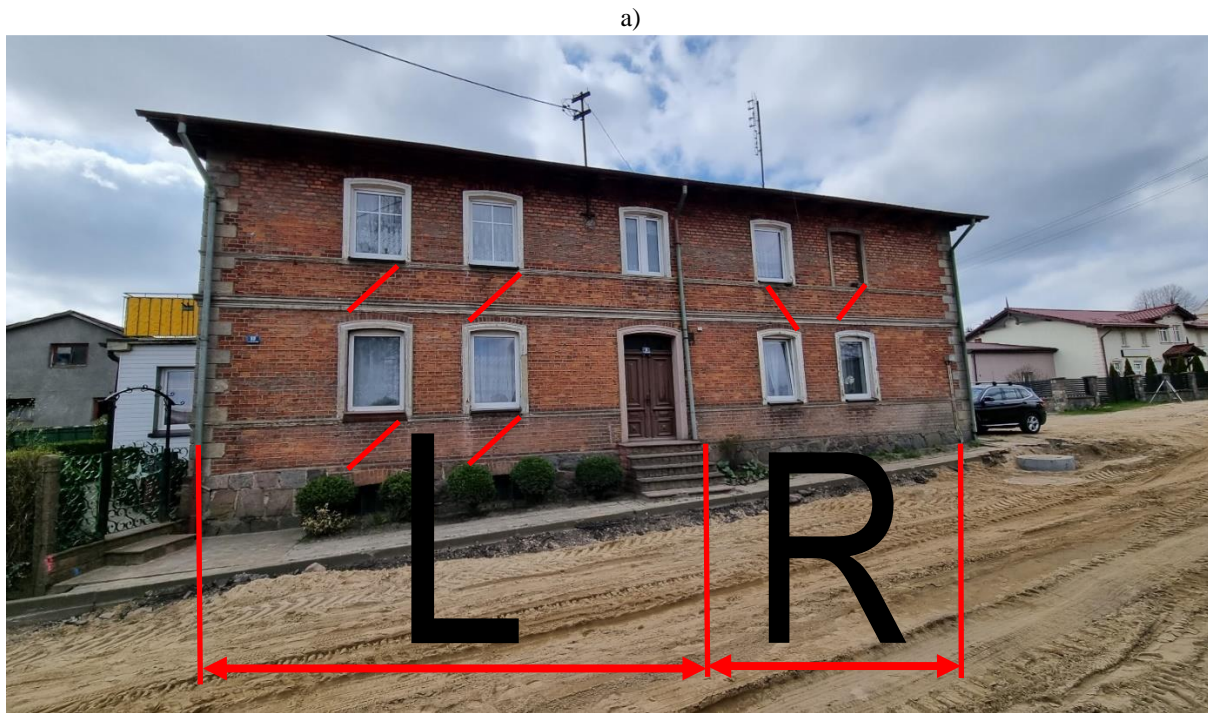
Fig. 4: Distribution of damages to the front wall (northern elevation) in the residential building: a) general view of the front elevation, b) left side (L) (basement part), c) right side (R) (non-basement part)

On the front, longitudinal wall (northern façade), damage to the brick wall of the longitudinal wall was visible: scratches to the strips under the windows occurred both on the ground floor and on the first floor, in the basement part (L) and in the non-basement part (R). The scope of damage in the basement part was greater: scratches and cracks in the brick strips under the windows were larger. The brick wall of the front wall was not plastered.

Scratches and cracks were visible on the front (northern) elevation (Fig. 4). Scratches were also visible on the garden (southern) elevation. The morphology of the above damage, especially that visible on the unplastered brick wall, i.e. on the front elevation, indicated that they were the result of uneven settlement of the building as a consequence of its partial basement. A similar picture of damage can be found in the literature on the subject (Fig. 5): in the case of the building in question, the analogy to the examples from the literature is that, similarly to Fig. 5, damage to the wall is visible, i.e. its cracks above the window arches that are tilted to the right, in the basement part (L) and to the left in the part without a basement (R). The inclination of the cracks is consistent in terms of direction

with the place of change in stiffness caused by the partial basement. The foundation of the part without a basement (R) in the ground freezing zone additionally contributed to the formation of damage to the wall - this method of foundation results in damage to the front elevation tilted to the right: in the winter, the corner of the building was uplifted upwards, and in the summer it settled excessively, which resulted in the formation of diagonal cracks tilted to the right. Unquestionably, the lack of tie beams between floors and the probable lack of frontal and side anchoring of the ceiling beams contributed to the extension of the damage to the wall. In practice, it was impossible to estimate quantitatively to what extent the previous traffic on the street contributed to the damage to the building's walls. Certainly, vibrations from moving vehicles had a negative effect, especially since the analyzed building had no foundations, which made it even more sensitive to vibrations from road traffic, propagating through the ground and affecting its structures - however, it was impossible to assess quantitatively the impact of traffic on the technical condition of the walls in practice.

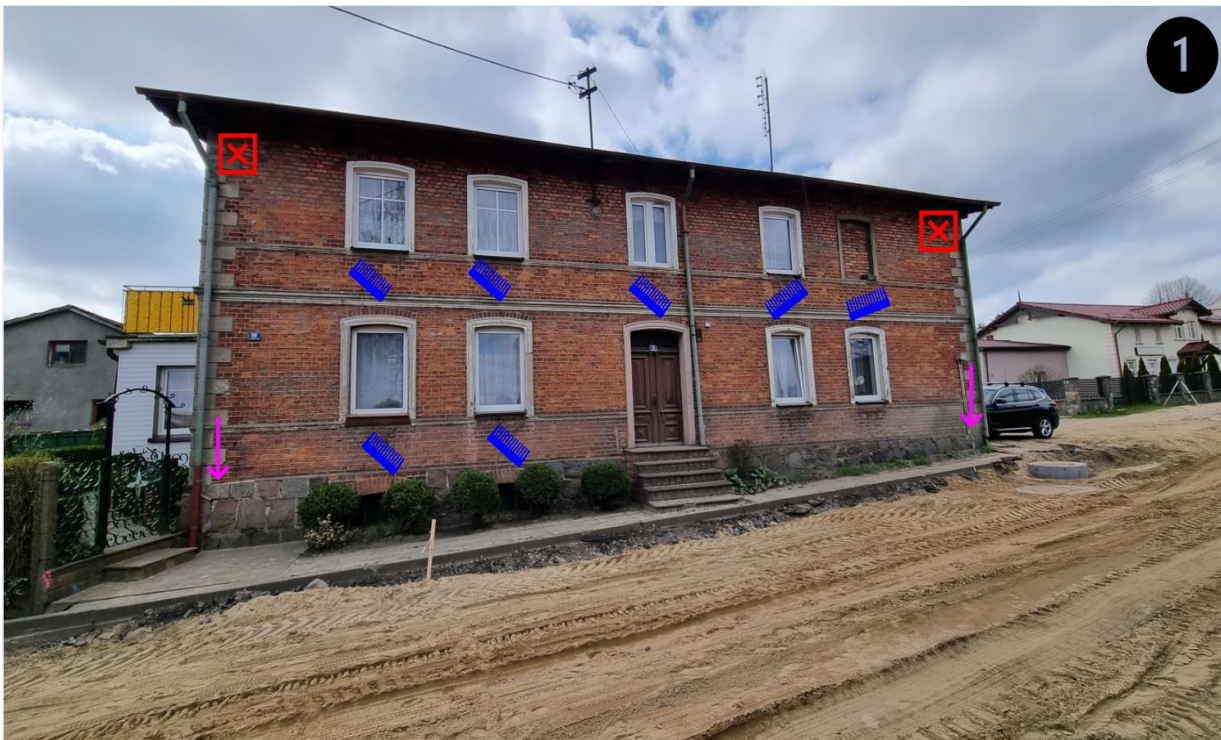
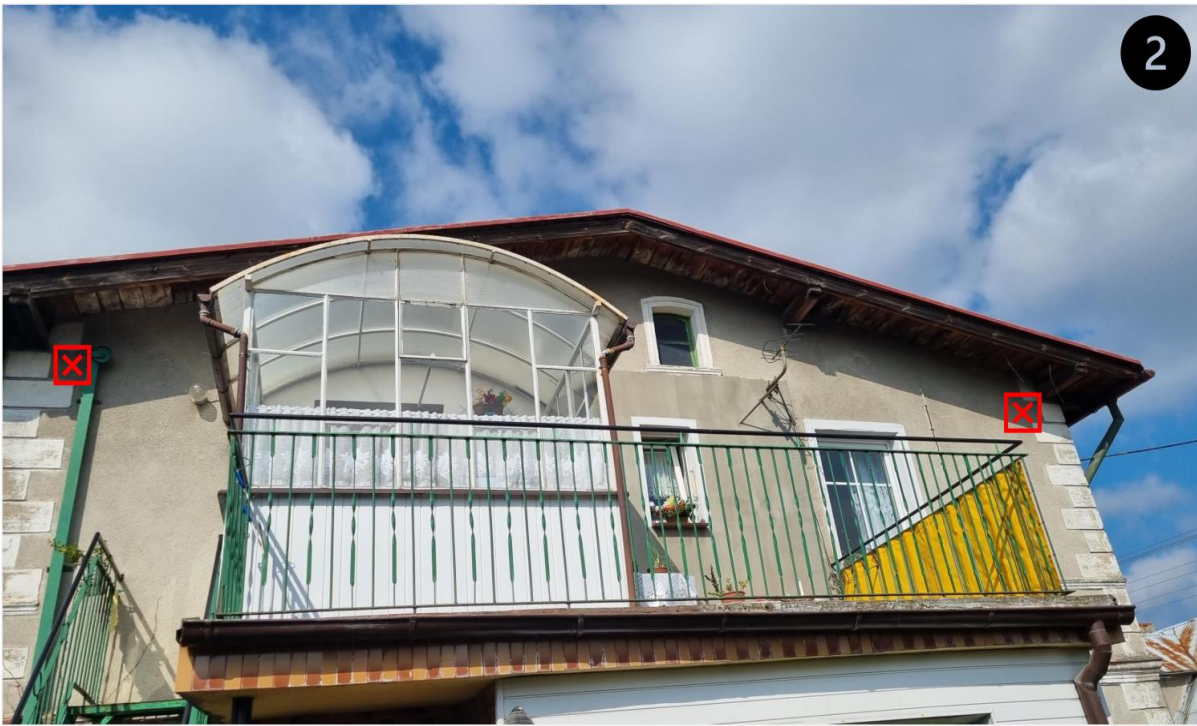
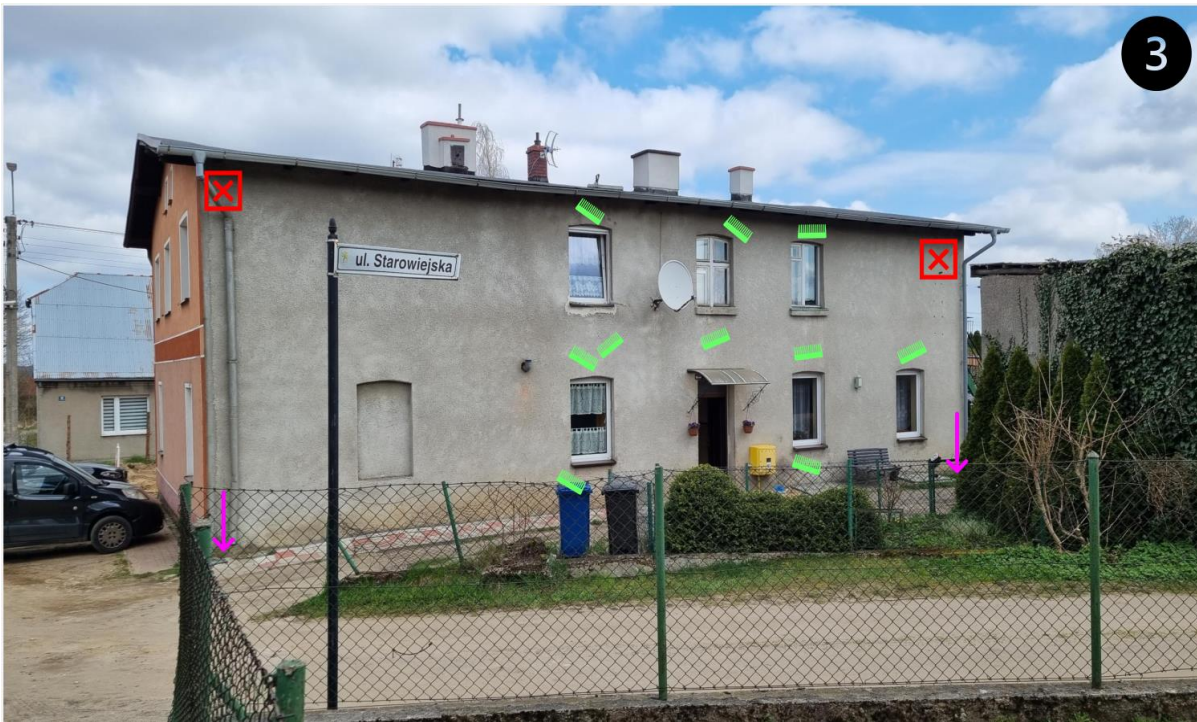
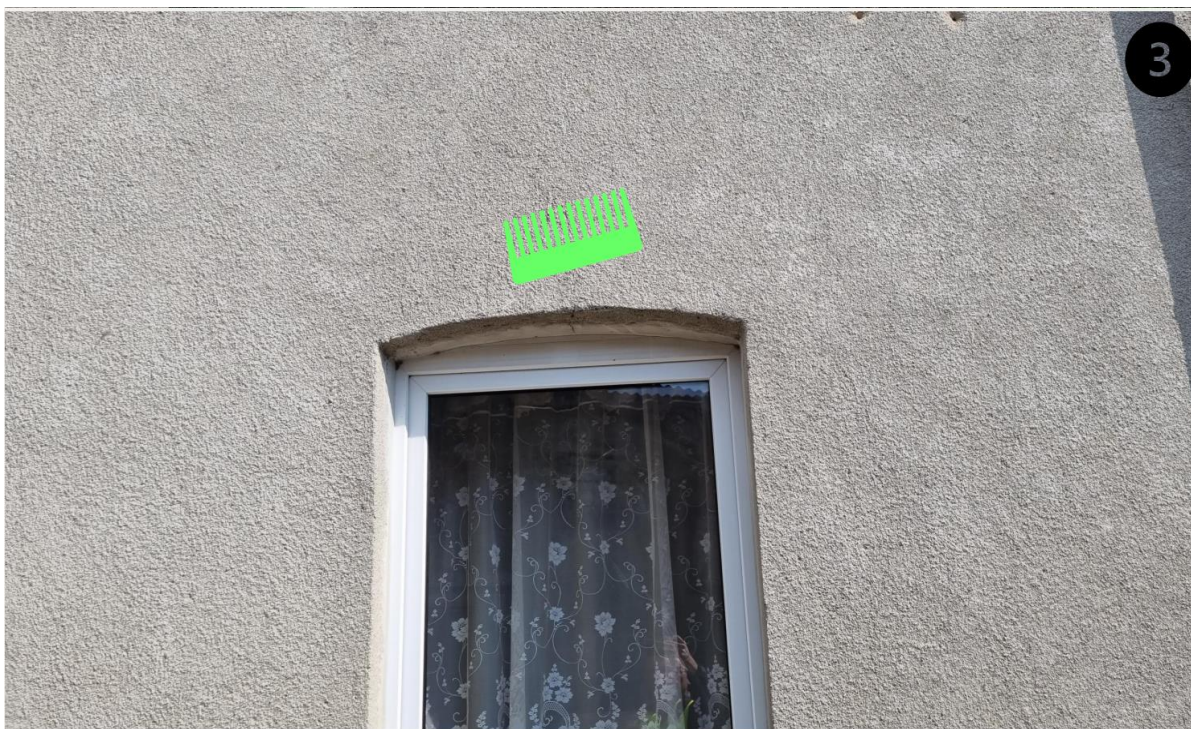
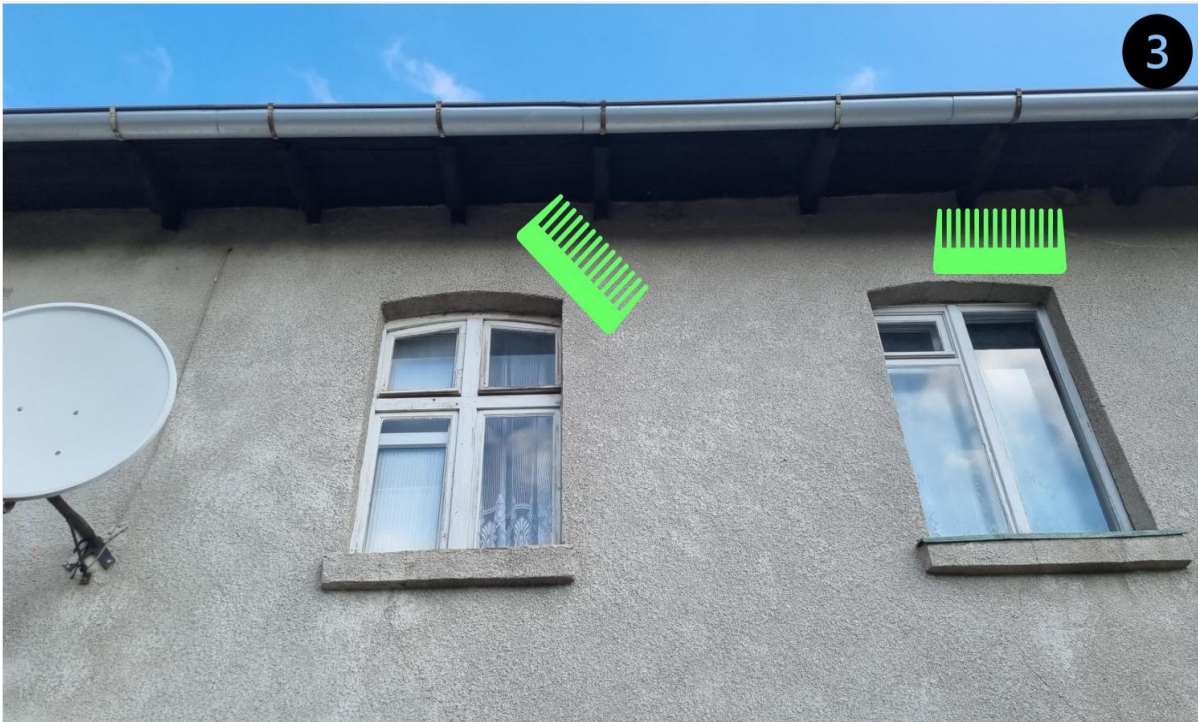
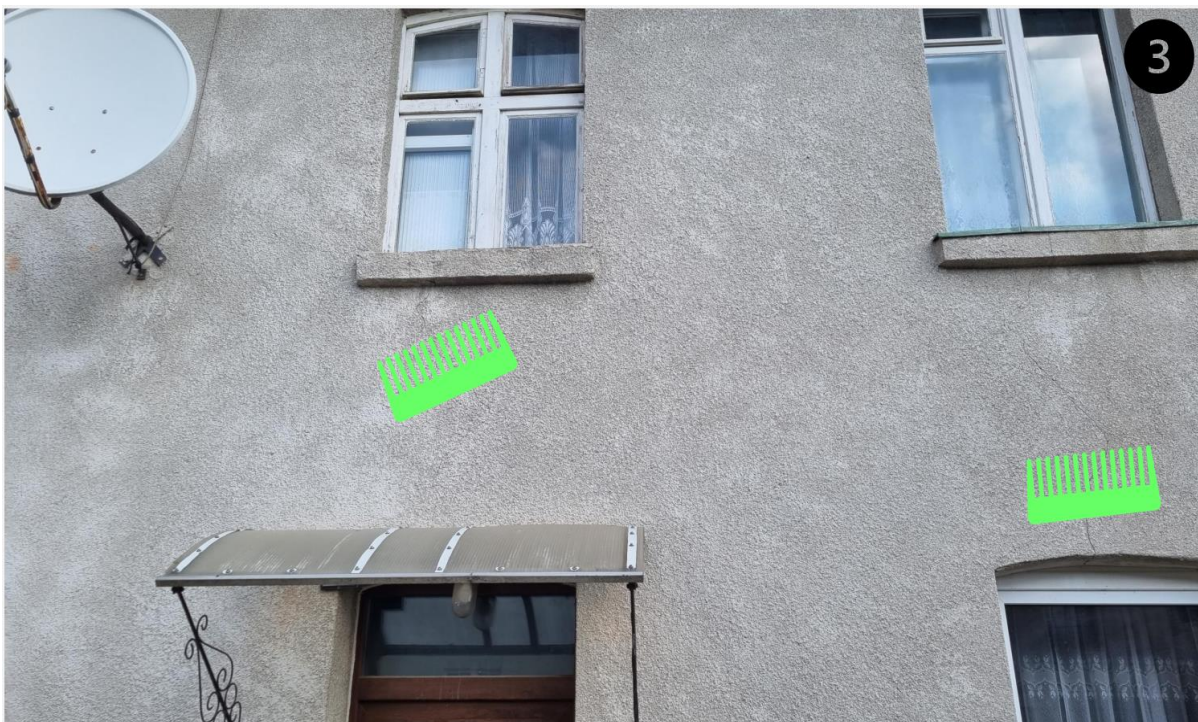
Fig. 6: Proposed location of target plates, benchmarks and feeler gauges on the external walls of a residential building: 1) front elevation (north), 2) side elevation (east), 3) garden elevation (south), 4) side elevation (west)

- ❖ when the works related to the reconstruction of the road are completely completed: every month for 6 months,
- after the completion of **STAGE 2** works, the feeler gauges may be destroyed. In such case, geodetic measurements should be limited to measurements of benchmarks and target plates, which are recommended to be carried out for a year at monthly intervals.

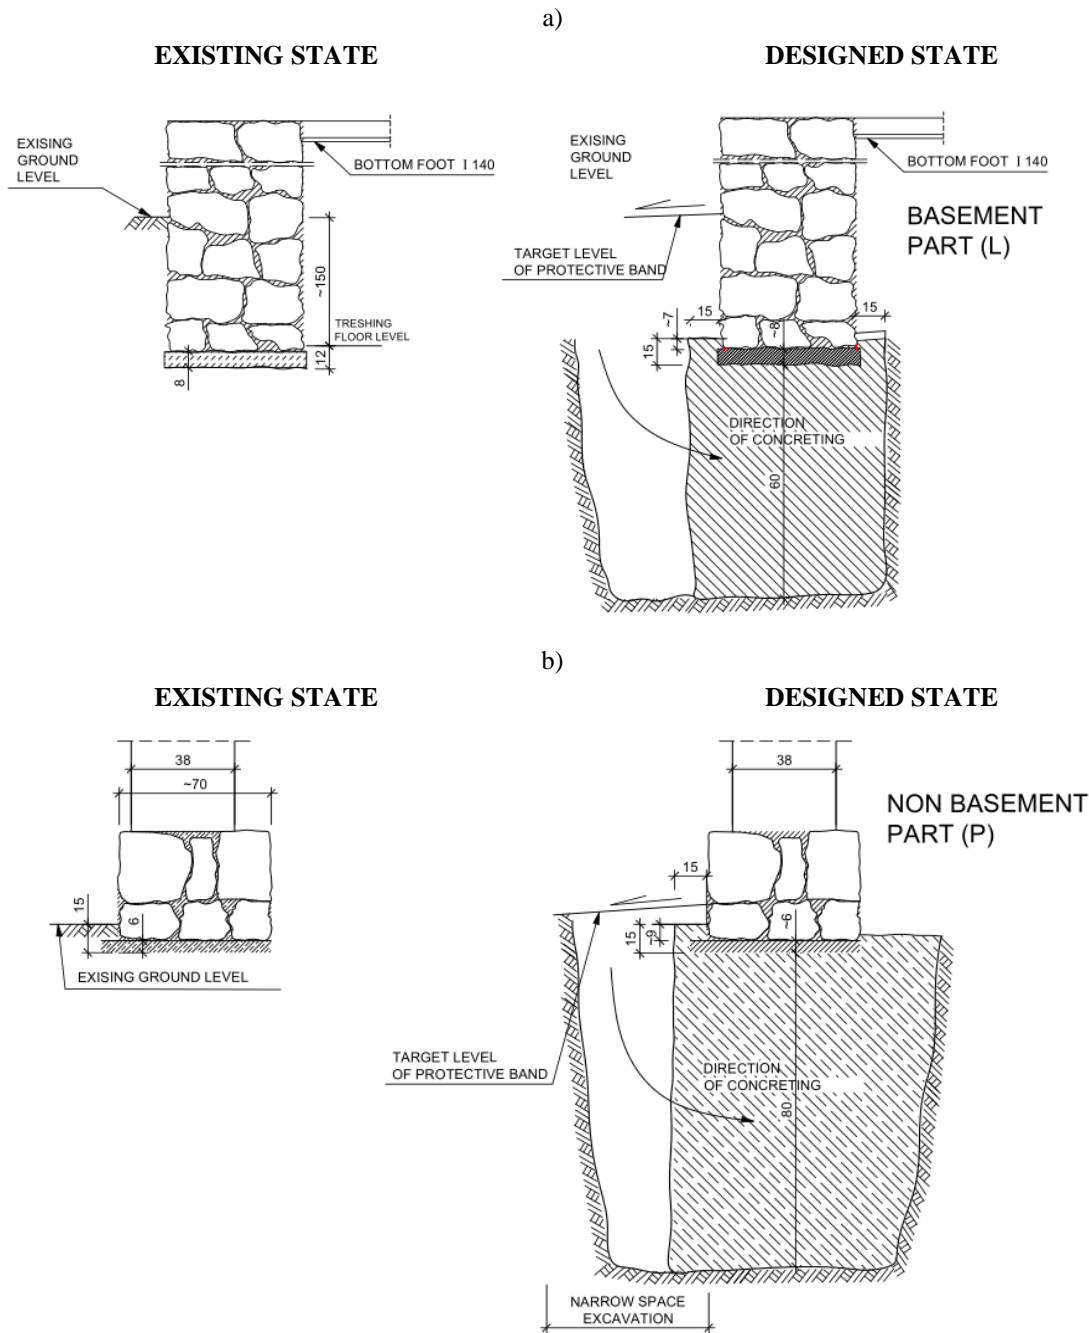
Fig. 8: Details of reinforcement of the front, longitudinal wall (northern elevation) in a residential building: a) left side (L) (basement part), c) right side (R) (non-basement part)

- dismantle the entrance stairs to the building from the street side,
- perform sub-concreting of the front, longitudinal wall (northern elevation) according to the concept of solutions presented in Fig. 7 and Fig. 8,
- sub-concreting of the left side (L) (basement part) should be performed from the outside of the building with a control excavation of the wall foundation from the basement side in order to check whether the concrete introduced under the stone wall tightly fills the space under the wall across its entire width,
- sub-concreting of the right side (R) (non-basement part) should be performed from the outside of the building, paying particular attention to ensuring that the concrete is distributed across the entire width,
