## DYNAMIC STATE ASSESSMENT OF THE WATER TURBINE WITH THE POWER OF 600 kW

Grzegorz ŻYWICA, Paweł BAGIŃSKI, Łukasz BREŃKACZ

Institute of Fluid-Flow Machinery, Polish Academy of Sciences  
80-231 Gdansk, Fiszerka 14 str., [gzywica@imp.gda.pl](mailto:gzywica@imp.gda.pl)

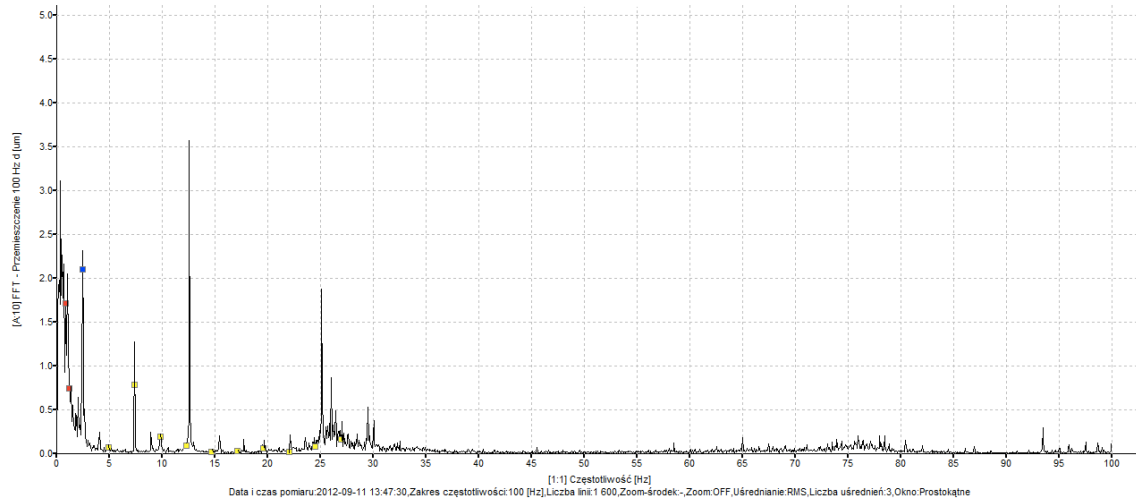
Analyzing the vibration spectrum shown in Figure 4 we can see the dominance of the following components of vibration. At very low frequencies (up to 2 Hz), components were associated with the resonance frequency of the system, which results in the vibration of the whole machine and the foundation. At a frequency of 2.5 Hz the rotational speed component was observed (for the water turbine shaft). At 7.5 Hz we can distinguish the component associated with the shaft misalignment or bend, but its amplitude was lower than the synchronous component. At a frequency of 12.5 Hz synchronous component of generator shaft appeared, and at 25 Hz the increased amplitude of vibration testified about a misalignment or deflection of the shaft. Other components of vibrations in Figure 4 was characterized by a much smaller amplitude. Since in the case of measuring the amplitude  $A_{p-p}$  vibration limits for new machines are not exceeded even once, it can be concluded that the observed symptoms of various defects were at an acceptable level. Synchronous vibrations of both shafts were relatively low, and the successive harmonics were reduced almost twice, which meant a slight bend or misalignment.

Fig. 4. Frequency spectrum of the vibration amplitudes measured at node III in the direction Y with the selected synchronous frequency of water turbine's shaft at 2.5 Hz (blue dot) and its harmonics (red and yellow dots)

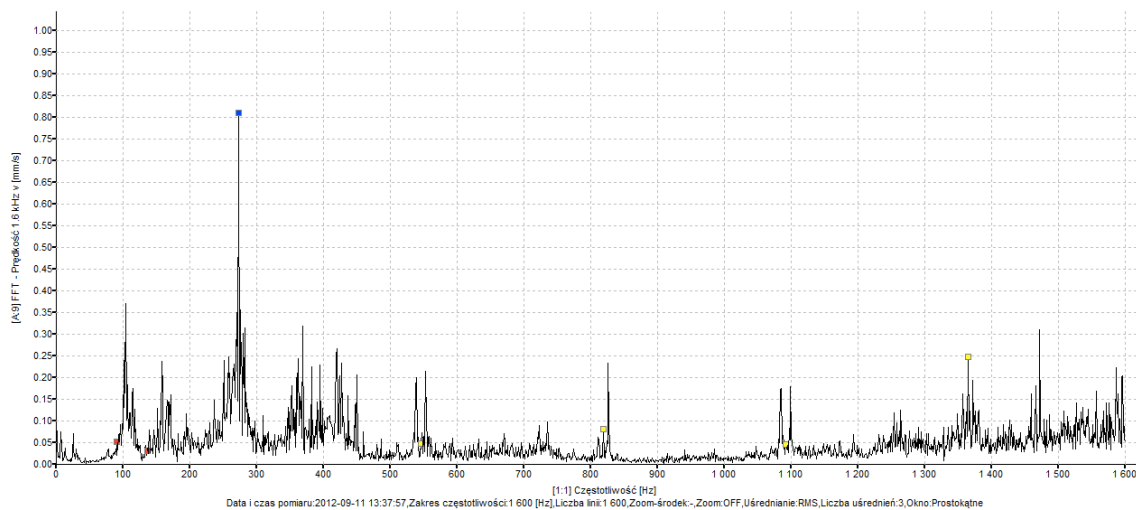
At higher frequencies, for all the measuring nodes similar vibration spectra were recorded. Characteristics shown in Figure 5 was determined for the measured signal at node II in the direction of the Y axis (on the flange connecting the generator with the transmission gear). The recorded vibration signal allowed to draw the following conclusions. The dominant component (272 Hz frequency) of the resulting characteristics relates to the toothed ring's meshing frequency (it was marked by a blue point and its harmonics by yellow and red points). The origin of the vibrations of toothed gear also testified clear sidebands. Elevated levels of vibration can also be observed in successive harmonic frequencies of toothed ring's meshing: 544, 816, 1088, 1360 Hz. At the frequency of 103 Hz a component occurred resulting from the frequency of meshing the satellite wheels with the toothed ring. Under the frequencies within the range of 170 Hz appeared increased vibration levels that could be associated with the co-operation of the satellite wheels with the central wheel of the planetary gear. Other areas of high vibration levels were difficult to clearly interpret.

Fig. 5. Frequency spectrum of the vibration velocity measured at measuring node II in the Y direction with the marked frequency of toothed ring meshing with the planetary cage at 272 Hz (blue dot) and its harmonics (red and yellow dots)

The study clearly showed that the cause of elevated levels of rms values of vibration velocity was the operation of planetary gear, and more specifically the lack of smooth cooperation of gears. Since the vibration of the machine was measured on the housing, the registered signal was dominated by vibrations coming from the toothed ring cooperation with the planetary gear. This ring was permanently connected to the gear's body, resulting in the direct transfer of vibrations to the housing.

The analysis conducted of vibrations therefore clearly indicated the source of high level of vibrations, which impacted directly on the acceptable level of vibration (for new objects which are ready for use). The cause of the elevated vibration level was due to the planetary toothed gear. Since this was a new gear, it was unlikely that such quick wearing or damage could have occurred, so this evidenced by low accuracy performance of toothed wheels.

- In the test machine at each of the five tested states the level of RMS value of vibration velocity was exceeded (according to the standard ISO10816-5:2000 for newly commissioned machines),
- The results of measurements allowed to qualify the turbine set for zone B, which according to [3] is the possibility of long-term operation without restrictions,
- The frequency analysis showed that the cause of high levels of vibration was due to the toothed gear operation, and other incompatibilities (e.g. rotors unbalance, bend or misalignment) were at an acceptable level,
- Because studies have shown that the vibration levels were exceeded for the new objects placed in operation, the next inspection of the machine is recommended in the future to detect possible rapid wearing of components (mainly the parts of toothed gear).

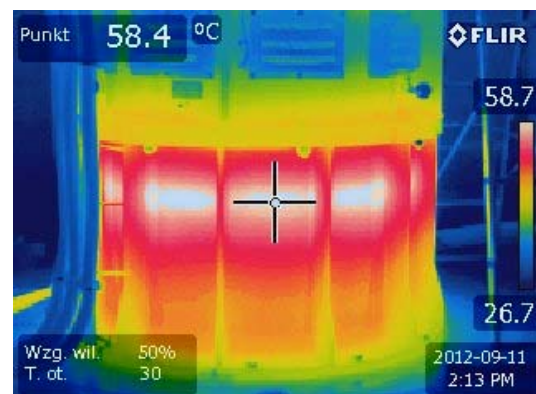
Fig. 6. The temperature distribution on the external surface of the gear housing.

In case of the examined water turbine no excessive temperature levels were observed for any of the controlled parts. The highest temperature in the housing of toothed gear was 59.7 °C and it was in the area of connection of toothed ring with the housing (Fig. 6). The temperature on the outer surface of the generator was up to 46.4 °C in the vents, where hot air was removed. Housings design prevented temperature measurement directly on the bearing housing, but the steel elements connected to these retainers had a low temperature. It can be concluded that the control of the temperature distribution showed no symptoms of excessive wearing or damage.
