ENDOSCOPIC IMAGE PROCESSING AND ANALYSIS OF PISTONS' SERVICE FAILURES OF MARINE DIESEL ENGINES

Zbigniew Korczewski

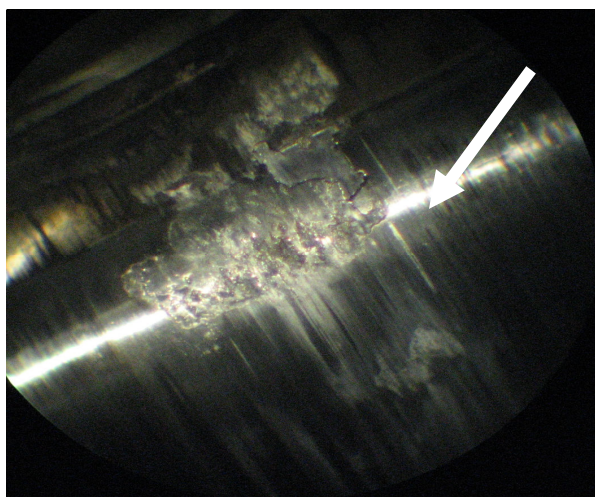
c) cylinder bearing surface – smearing traces of the piston material's layer (aluminum alloy)

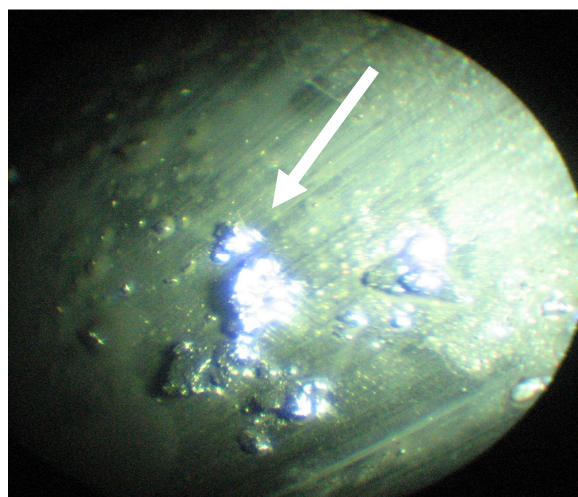
the piston head's temperature when the lubricating conditions get better. Unfortunately, it usually produces undesirable results - an intensive growth of the aluminum particles quantity in the engine's lube oil system - Fig. 2d.

d) cylinder bearing surface – metal fillings (aluminum alloy)
