## Failure of austenitic stainless steel tubes during steam generator operation

S. Topolska <sup>a,\*</sup>, J. Łabanowski <sup>b</sup>, M. Głowacka <sup>b</sup>

Received 16.10.2012; published in revised form 01.12.2012

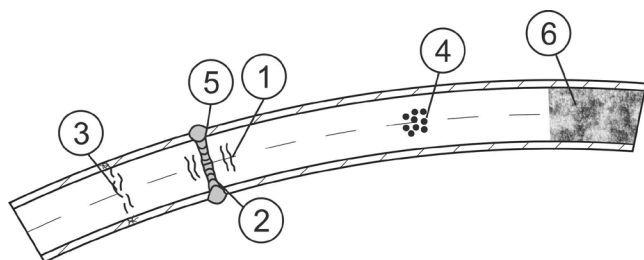
Inspection and macroscopic observations of the internal and external surfaces of the coil pipe segments revealed circumferential cracks, clusters of small pits, a single topical water spills and significant corrosion damage in the areas of welded joints. Discolored outer surface of the pipe was detected in the form of rusty and very dark coatings. The inner surfaces of tubes were covered with a fairly thick layer of deposits with different color and morphology. The color of deposits was significantly different, from light rust to a very dark, almost black. Figure 1 shows schematically the defect types at observed steam coil pipe.

Fig. 1. The observed damages of the steam coil pipe: 1 - circumferential cracks in the HAZ, 2 - depressions, cracks and voids in the root of the weld, 3 - cracks in the areas of stress concentration, 4 - clusters of pits, 5 - corrosion on welding joints defects, 6 - a thick layer of deposits

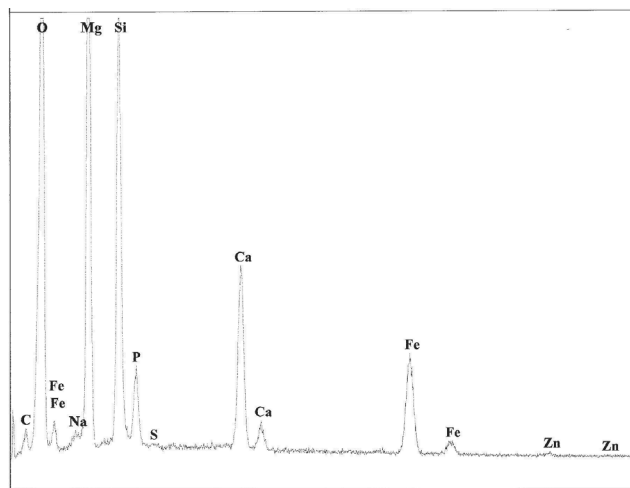
Fig. 2. The results of microanalysis of deposit

The high concentration of Mg and Ca ions in the deposits indicates that water quality monitoring and its treatment was insufficient. Sparingly soluble carbonates and sulphates of calcium and magnesium formed a hard and porous layer called boiler scale. Excessive deposition of minerals, due to disorders of the boiler water composition has a significant influence on the temperature of the pipe wall, which can be overheated (up to 500-600°C) and can deform, which accelerates the initiation of cracks and corrosion processes [2,19]. Corrosion processes are accelerated by water penetrating into the sediment and producing superheated steam. In such conditions all salts can evolve out of the water, even these very soluble, then react with the metal ground and form corrosion products [11,12]. Examples of deposit corrosion as deep pits in the tube wall are shown in Fig. 3.

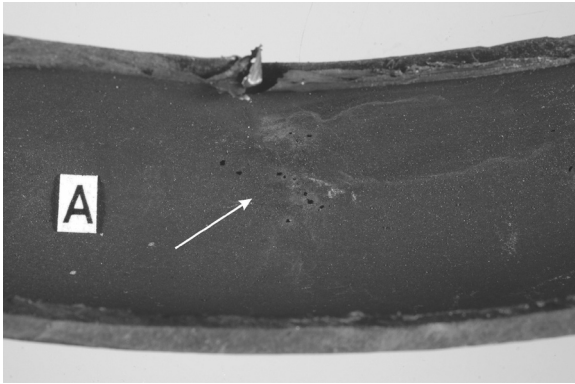
The cause of corrosion attack in the crevices (in place of welding defects), or under adjacent to the pipe surface sediment is reduced oxygen access, and thus insufficient surface passivity.

Fig. 3. Pitting corrosion on the inner surface of the tube

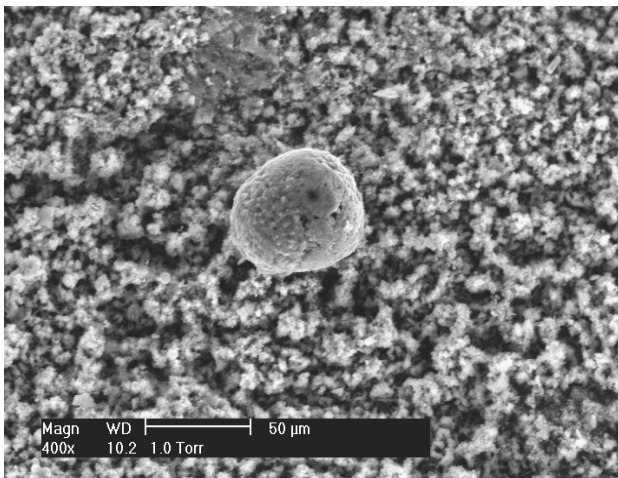
A very dangerous phenomenon occurring in porous deposits of boiler scale is development of condensate containing dissolved oxygen and chloride ions and sulfate. There may be a strong reduction of the pH solution under sediments up to a value of 1.0 and in the presence of chloride ions formation of hydrochloric acid, which rapidly accelerates the progress of pitting corrosion. Studies with the use of scanning electron microscope revealed the existence of local spherical particles of different morphology that is more compact than the surrounding sediments, Fig. 4. Microanalysis of the chemical composition of sediments revealed the presence of aggressive ions O, Na, Ca, Mg, K, while the

spherical particles also contain Cl ions, Fig. 5, which shows selective adsorption of this element and the local increase in concentration.

Fig. 4. View of the inner surface of the pipe. The spherical particle of different morphology than the rest of the surface sediment

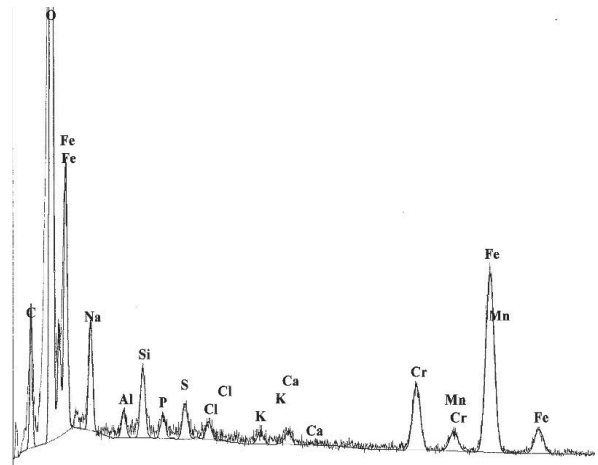
Aggressive effect of sediments against austenitic stainless steel surface increases particularly strongly with increasing alkali metals chlorides content, which presence in high concentrations were detected. Under such conditions, the rapid progress of local corrosion leads to perforation of the pipe walls and destruction of structural elements what was proven by attempts to repair of perforated pipe walls by welding which ended in failure Fig. 6 a. Application of padding welds on the outer tube side (without whole penetration), caused warm-up to the inner tube's surface and its oxidation. These oxide layers are rich in chromium, which is taken from the steel matrix adjacent to the oxide layer. This process depletes the chromium in metal surface and consequently reduces the corrosion resistance [16].

Fig. 5. The results of microanalysis of sediments in the form of spherical particles with a higher concentration of chlorine, as shown in Fig. 4

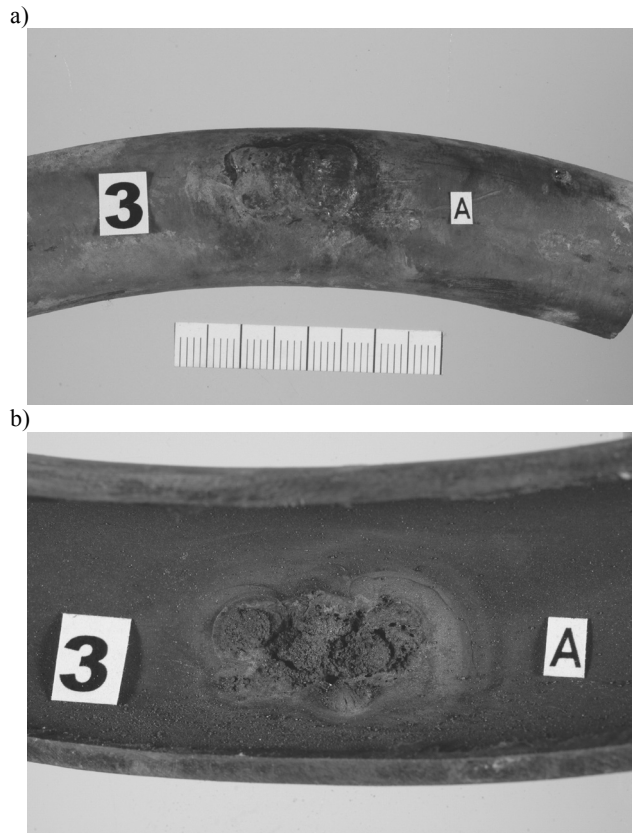
The rapid progress of corrosion on the inner tube surface under padding welds was detected, Fig. 6 b. Probably padding welds were performed without the simultaneous protection of internal surfaces of tubes with an inert gas.

Fig. 6. a) The padding weld on the outer tube surface; b) the view from the inside - the progress of corrosion processes

- Strictly use the backing inert gases for welding. The use of welding in the test case without forming gases resulted in oxidation of the inner surface of pipes and abnormal

formation of the weld root, and in consequence, the porosity cracks and potential sites for corrosion development.

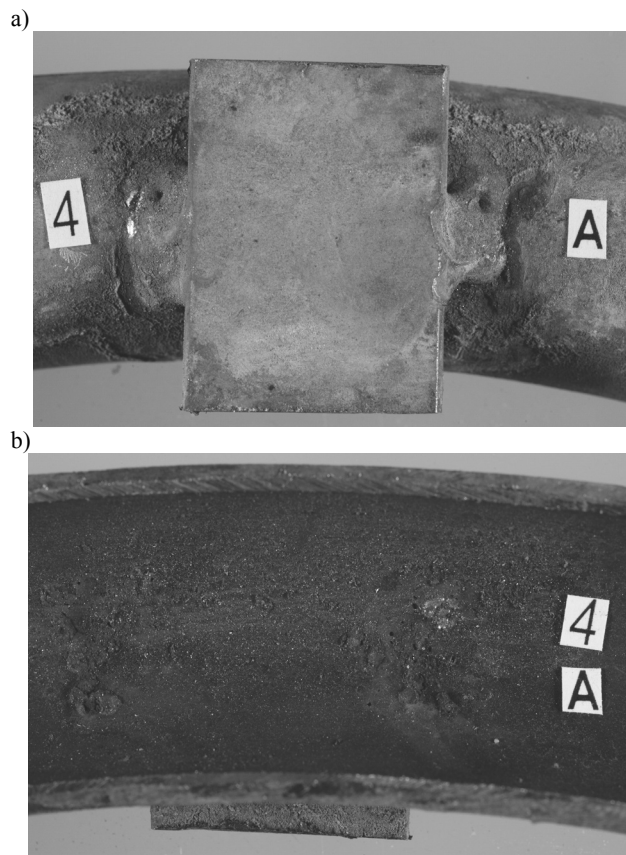
Intense pitting corrosion was also found on the inner surface of pipes under welds connecting coil stiffeners. Figure 7 b clearly shows two pitted areas under the welded joints where the inner surface of the pipe is heated to high temperatures.

Fig. 7. Stiffener welded to the pipe coil, a) outer surface, b) the inner surface attacked by pitting corrosion

- Avoid excessive stiffening of the tubes. Welding of the coils stiffeners should be performed with minimal heat input.
- It is advised to apply stress relief annealing after cold bending of the tubes to remove internal stresses.
- Cleaning the inner surfaces of the coil tube surface passivation of the surface should be performed after welding.
- Water quality monitoring. Keep the feed water pollution at the appropriate level.
- Flooding of the evaporator tubes with water or completely remove water and drain installation at each stopping installation.
- Procedures for the periodic removal of scale in the coils should be supplemented by passivation of the pipe.

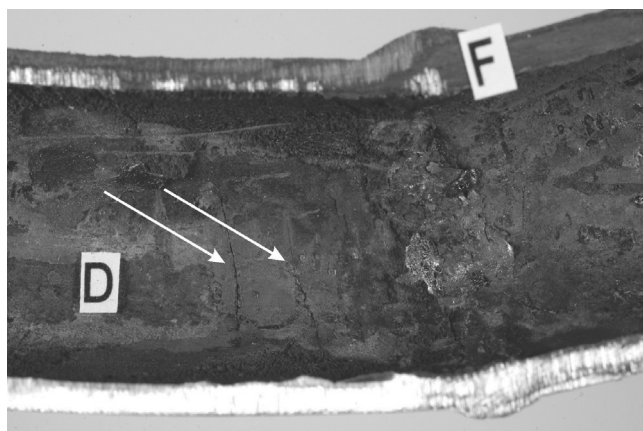
Many cracks were observed in the welded joints area. These cracks propagated parallel to the joints at heat affected zone Fig. 8.

Fig. 8. Cracks in the HAZ of the circumferential weld

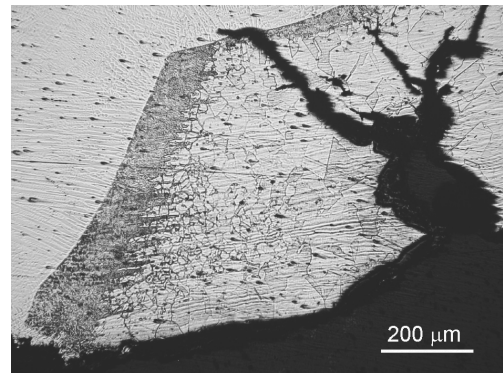
Initiation of cracks come from the inside of the pipe. Metallographic examination of pipe wall sections showed that crack initiated in the HAZ propagate in different directions and the development of cracks in some cases has been blocked and changed direction at the fusion line. Figure 9 shows crack of considerable thickness, it is associated with subsequent reactions inside the crevices and electrochemical dissolution of cracks walls.

Fig. 9. The propagation of cracks initiated by intergranular corrosion

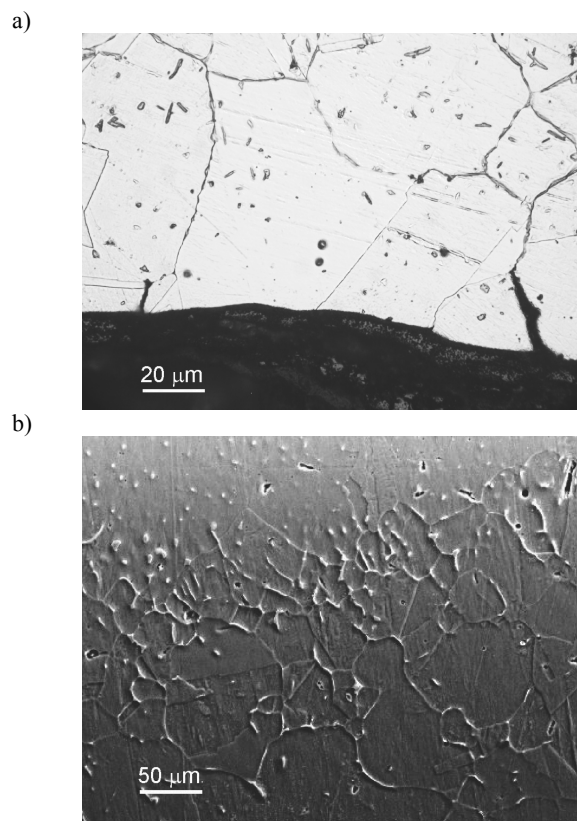
Fig. 10. The structure of sensitized zone of austenitic stainless steel, a) light microscope image, b) SEM image - visible carbides net at grain boundaries of austenite

A detailed analysis of cracks showed their intergranular propagation along the austenite grain boundaries which were decorated by chromium carbide precipitates. Figure 10 shows the microstructure of sensitized HAZ zone, with clearly visible coagulated carbides located mainly at the austenite grain boundaries, forming an almost continuous net. Such a distribution of carbides in the HAZ was also observed by scanning electron microscope, Fig.10 b. This was confirmed by EDX field qualitative analysis of the chromium distribution and is direct evidence of steel sensitization in the HAZ area where the temperature reached 500 to 800°C.

- In order to avoid intergranular corrosion austenitic steels with a carbon content below 0.02% should be selected instead of steel stabilized with Ti or Nb, which does not fully protect against such corrosion.

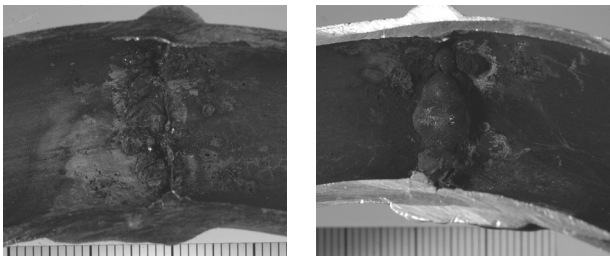
Numerous corrosion damages were observed in the root of welded circumferential joints of the coil. The predominant type of corrosion was pitting and crevice. There are several reasons for the progress of corrosion in the analyzed area. Slots, root reinforcements, and porosity were observed at incorrectly formed welds, Fig. 11. Welds were performed with the use of TIG method probably without backing gas protection. Root of the welds and heat affected zone areas were subject to intense oxidation, which after a short operation time resulted in a degradation of the passive layer and initiate corrosion.

Fig. 11. Improper shape of the root of the pipe welds

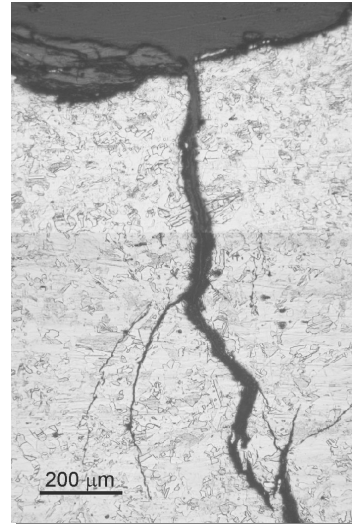
Many cracks were revealed in the parent material of the coil. The cracks were located perpendicular to the tube axis passing through the entire thickness of the pipe wall and causing leaks. The places of crack initiation were pits on the inner surface covered with a dense sludge of corrosion products. Cracks have characteristic branching shape and transgranular propagation typical for stress corrosion. Figure 12 shows the fissure of stress corrosion cracking filled with corrosion products. The results of microanalysis of corrosion products and deposits are shown in Table 2 and as EDS spectra as Fig. 13.

Stress corrosion cracking is preceded by a certain incubation period for crack initiation, during which the rupture of the passive film occurs and which is typically much longer than the subsequent propagation of cracks [1]. So, sufficiently high

concentration of chloride ions in certain areas of the environment, high temperature, the presence of oxygen ions in the feedwater, high level of tensile stresses received from welding, cold bending and stresses generated during the operation, create conditions for the development of stress corrosion cracking.

Fig. 12. Transgranular propagation of stress corrosion crack through the pipe wall with characteristic branching

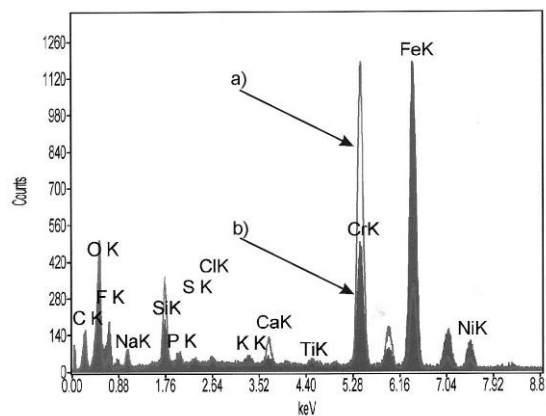
High concentrations of Cr and the presence of Ti were detected in the pit, which is the result of the destruction of the passive film. The composition of corrosion products in the pit, show a much lower content of Cr and Ti, (Table 2).

Fig. 13. The results of microanalysis of corrosion products and deposits, a) in the pit from which was initiated stress cracking (unfilled), b) in the main gap of crack
