INFLUENCE OF GEOTECHNICAL CONDITIONS ON DAMAGE STATES OF GDANSK BAY COAST CLIFF FORMATIONS

ABSTRACT

A geotechnical aspect of destruction processes of seashores was identified based on the case of erosion of Gdansk Bay Coast cliff formations. Causative factors of landslide were described in the context of natural phenomena, land development and its anthropogenic transformations. Possible directions of theoretical analysis of changes in ground-water relations were indicated.

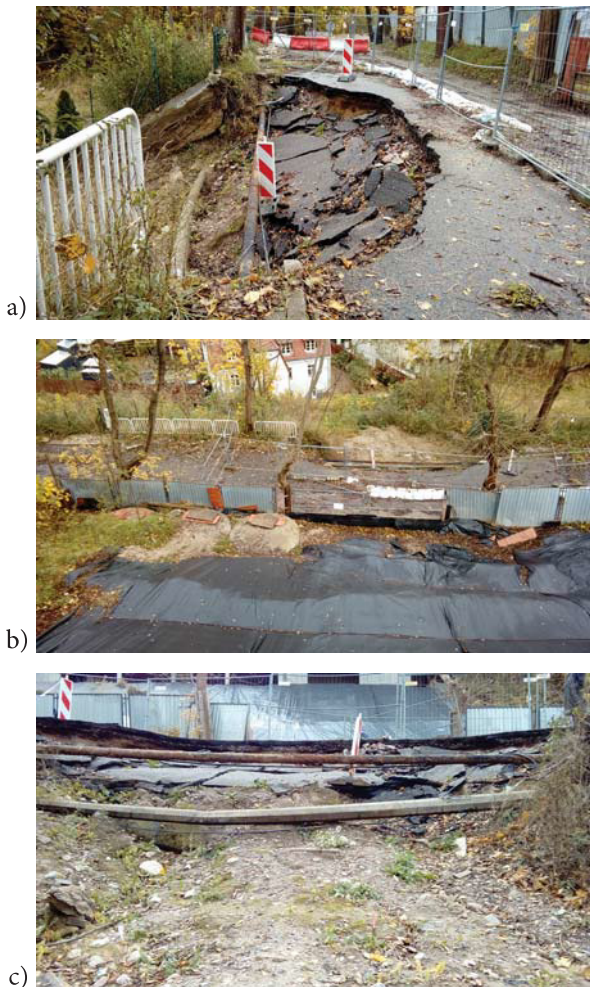
In the night from 23rd to 24th February 2017, in Gdynia, below Sienkiewicz Street, a sudden landslide and run-off of ground-water mass occurred from the escarpment. The slid-down and watered ground mass displaced forming a precipice. Simultaneously, the active tongue of the landslide locally deformed the lie of the land, rising the terrain level by 1,5 m in some places.

A 7 m fragment of the street pavement and roadway was damaged. A geotechnical consequence of the occurred situation is a new state of force equilibrium spontaneously settled in the ground. The geotechnical investigations of the terrain in question show [10] that this state is not stable and may be changed after subsequent intensive watering the ground. A week after the reported event some water flow sources and symptoms of the significant ground watering were found in the site of the landslide.

Fig. 5. State of the landslide 8 months after the damage
