# Integrated Application of GPR and Ultrasonic Testing in the Diagnostics of a Historical Floor

**Abstract:** The paper presents the results of integrated ground penetrating radar (GPR) and ultrasonic testing (UT) measurements conducted on a historical floor in St. Nicholas' Church, Gdańsk, Poland. The described inspection was the first stage of the technical state assessment of the building. The aim of the study was the detection of underfloor air gaps, which were observed in a few trial pits. The condition of the ground under the floor was determined by localizing other inclusions such as rubble, human remains, brick walls and pipes. To identify the phenomenon of electromagnetic and ultrasonic wave propagation within the air gap, laboratory tests were conducted on physical models consisting of two concrete slabs stacked on top of each other and gradually moved apart to simulate a slot of varying thickness. The conducted research was supported by the numerical models of electromagnetic wave propagation. The obtained results showed that the integration of the GPR and UT methods provided an effective imaging of the floor and the area under it. Ultrasonic testing was proved to be a

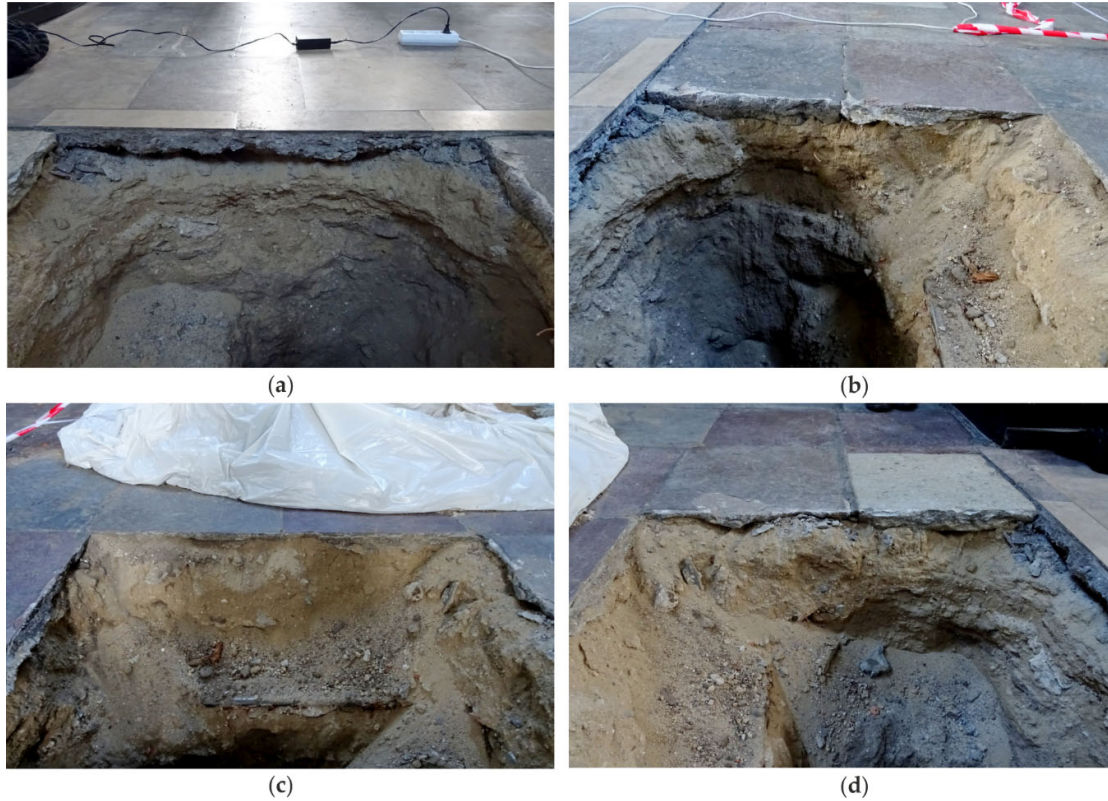
The conducted floor inspection reported in this paper was the first stage of investigations directed to assess the technical state of the church. NDT tests were performed on the floor of two aisles, south and north, as shown in Figure 1. In both aisles, the top floor layer was made of stone tiles measuring approximately 43 cm × 43 cm. In the central part of each aisle, tombstones were laid. The cross-section layers of the floor were identified in a few trial pits. One of the pits located in the north aisle is shown in Figure 2. Based on a visual inspection of the cross-section visible in the trial pit, particular layers in the floor were identified (Figure 3). It was found that the stone tiles laid on the cement mortar layer had a thickness of approximately 2–6 cm. Below was a layer of sand and ground backfill. It was also identified that at some edges, an air gap with a thickness of approximately 1–2 cm was visible below the cement mortar.

**Figure 2.** Photographs of the trial pit in the floor: (a) edge 1; (b) edge 2; (c) edge 3; (d) edge 4.

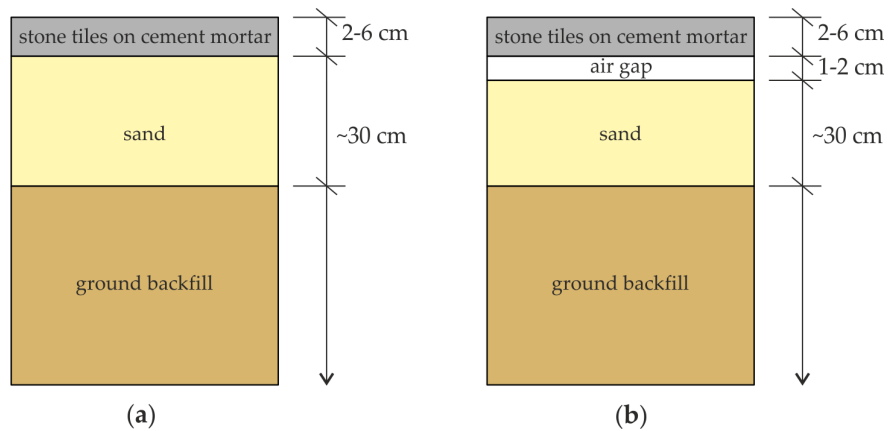
**Figure 3.** Schematic sketch of floor layers in the trial pit: (a) appropriate cross-section (without air gap); (b) cross-section with damage (air gap).

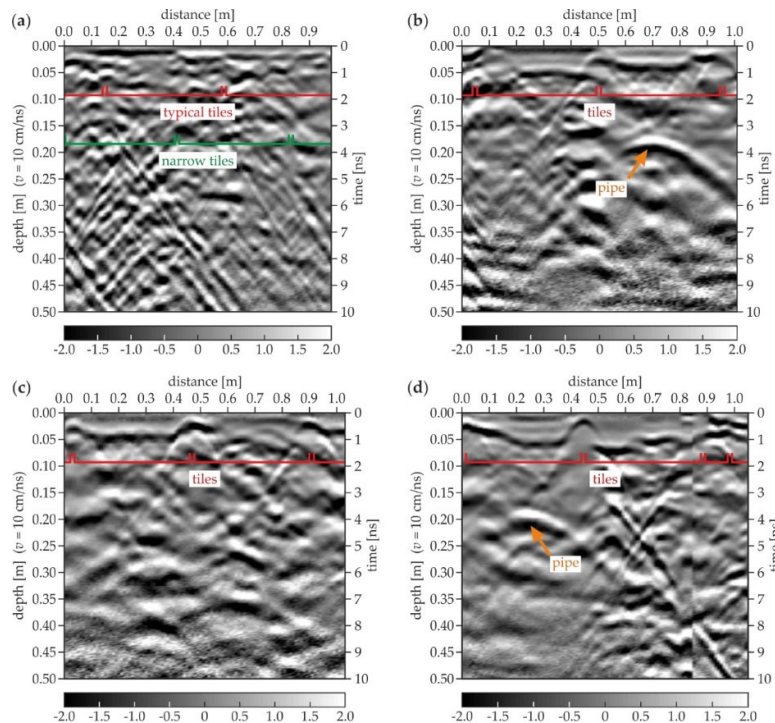
Figure 15 presents the GPR B-scans collected around the trial pit. As can be seen in Figure 7a, several rectangular tiles formed a joint at one of the pit's sides. Therefore, during the acquisition of the C-1 scan (Figure 15a), the GPR antenna was moved along the joint, thus the bottom faces of the tiles were not clearly imaged. However, the analysis of the upper part of the scan allowed identifying two different rows of tiles; the typical tile (43 cm × 43 cm) row was replaced at the edge of the trial pit with a narrower one (43 cm × 10 cm) laid with the overlap (cf. Figure 2a). The overlap length was about 0.16 m and it could be seen the clearest at the distance of 0.42–0.58 m. The ground under the C-1 scan had many inclusions, resulting in numerous irregularly distributed reflections (cf. the concentrated inclusions in Figure 14c,d). The C-2 scan (Figure 15b) clearly presents the line patterns being the reflections from the joints. The bottom faces of the tiles were identified at dissimilar levels, therefore the tiles (or the mortar layers below them) had different thicknesses. The hyperbola located at the distance of 0.7 m and the depth of 0.18 m denoted the presence of a metallic (steel or aluminum) pipe (cf. Figure 2). The ground on the right side of the scan (around the pipe, at the distance of 0.5–1.0 m) seemed less heterogeneous than the remaining part. This might be caused by the fact that the original ground was removed and replaced with another, more homogeneous one during placing the pipe under the floor. The C-3 scan (Figure 15c) shows the clear image of two tiles, one with the regular bottom face and the second with an unbalanced shape. The ground seemed to be original because it is highly heterogeneous, such as in the C-1 scan. The C-4 scan (Figure 15d) also clearly shows two typical tiles together with the narrow one (located at the distance of 0.88–0.98 m). The shape of the bottom face of all tiles was irregular. The shift was observed in the scan (at the distance of 0.85 m), caused by the slip of the antenna at the joint between the standard and the narrow tile (cf. Figure 2d). The reflection from the pipe was visible at the distance of 0.25 m and the depth of 0.18 m (the same as observed in the C-2 scan). The ground around the pipe was less inhomogeneous (the distance of 0.0–0.5 m) compared with the remaining part. Generally speaking, it was difficult to say whether there were any air gaps under the floor. The subtle difference between the image of the tiles with and without the air gap (observed in the numerical results) was here blurred by the ground inhomogeneities and a signal noise.

**Figure 15.** GPR B-scans for the trial pit: (a) edge 1 (trace C-1); (b) edge 2 (trace C-2); (c) edge 3 (trace C-3); (d) edge 4 (trace C-4).

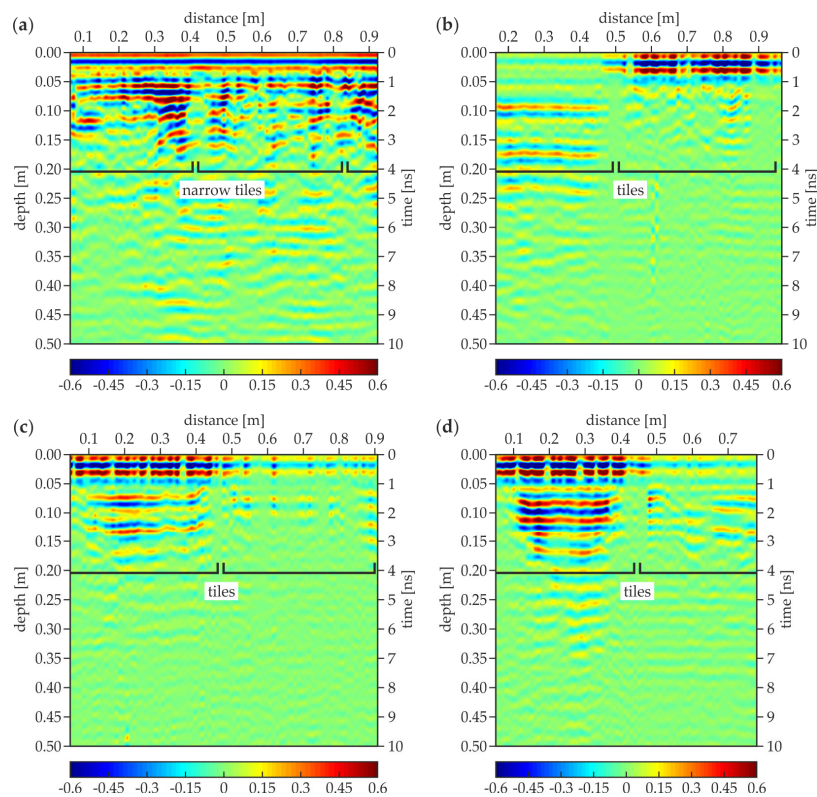
Figure 16 contains the UT B-scans corresponding to the above-discussed GPR B-scans. The C-1 scan (Figure 16a) was performed through the narrow tiles, as can be seen in Figure 7a, thus the joints of the standard tiles were not observed. In the top part of the scan (at the depth of about 0.03 m), there was a straight line denoting the regular bottom face of the narrow tiles. However, there was no regularity in the lower part of the scan, where many multiple reflections occurred. Compared with the results for the concrete slabs, it might be stated that the air gap with an irregular shape was present in this area. The non-uniform settlement of the original ground probably led to the appearance of the air gap. The C-2 scan (Figure 16b) shows the image of two different tiles. The right tile, unlike the left one, was clearly visible at the top of the scan; it was possibly removed and then placed again with the use of a different (stronger) mortar. The multiple reflections appeared under the left tile, indicating the presence of the air gap (this tile laid on the original ground). On the contrary, there were no reflections under the right tile. The pipe detected in the GPR scans was not visible, which stays in agreement with the results for the concrete slabs where the UT scans did not reveal the table tennis ball. This observation allowed concluding that concentrated inclusions could not be detected by the UT scanning. It also should be mentioned that, according to the UT antenna instruction, the diameter of the pipe did not exceed 30 mm. In the C-3 scan (Figure 16c), two tiles were also visible. The left one was much more pronounced: it could have been replaced during some renovation works. Additionally, there were multiple reflections under both tiles, indicating the presence of the air gaps (resulting from the ground settlement). However, it needs to be noted that the reflections were less intensive under the right tile because it was weakly identified itself. The possibility of detecting the tiles in the C-4 scan (Figure 16d) was also distinguished: the left one was much better imaged. Although the ground below the left tile was replaced, the multiple reflections indicating the presence of an air gap were visible under both tiles. Like in the C-3 scan, the reflections under the right tile were weaker because it was weakly imaged itself. It also needs to be added that the pipe was not observed like in the C-2 scan.

**Figure 16.** Ultrasonic B-scans for the trial pit: (a) edge 1 (trace C-1); (b) edge 2 (trace C-2); (c) edge 3 (trace C-3); (d) edge 4 (trace C-4).

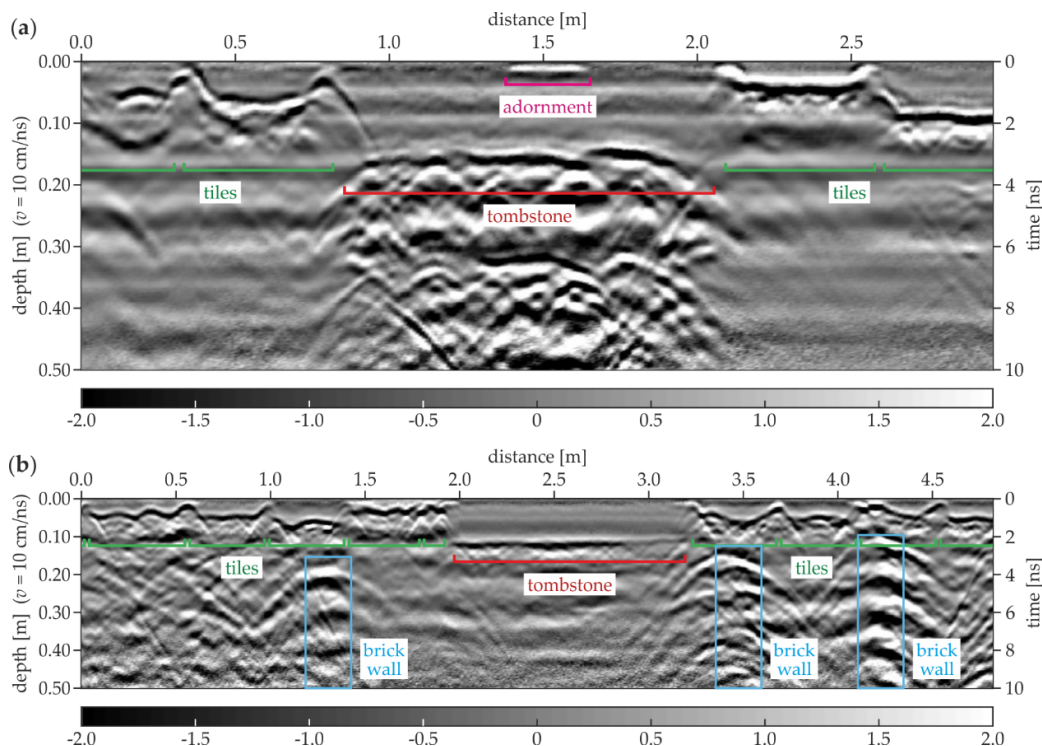
Figure 17 presents two examples of the GPR B-scans acquired in the area of the south aisle. The A-19 scan (Figure 17a) clearly reveals the location of the tiles based on the reflections from the tile grouts. The bottom faces of the tiles were identified at different depths, thus they had different thicknesses, varying between 0.04 and 0.09 m. The tombstone with a thickness of approximately 0.16 m could be observed in the center of the scan. An additional reflection denoting the tombstone adornment was also visible at the top of the scan. The ground under the tombstone had many concentrated inclusions, probably being the rubble or the human remains from the original crypts (cf. Figure 14c,d). Aside from this area, inhomogeneities were not observed. It was difficult to state whether there were any brick walls under the edges of the tombstone because the hyperbolas denoting the concentrated inclusions blurred the image. The A-117 scan (Figure 17b) shows the tiles with different thicknesses between 0.03 and 0.08 m. The tombstone was also visible; however, its shape was far more regular compared with the one from the A-19 scan. The ground below the tombstone had no strong inhomogeneities, thus it could be stated that not all the tombstones were laid in the area of the original crypts. Other interesting reflections were the hyperbolas located vertically one above another at the distances of 1.3, 3.4 and 4.2 m. They indicated the presence of three brick walls (cf. Figure 14b,d), that might be the remainders of the original supporting structures of the crypts.

**Figure 17.** GPR B-scans for the south aisle (survey A): (a) A-19; (b) A-117.

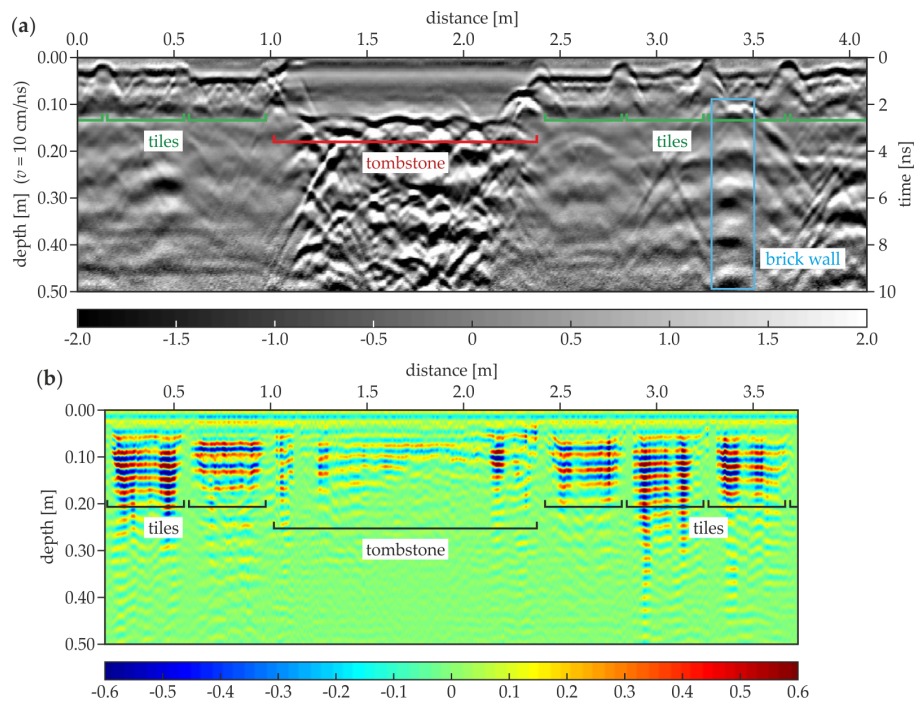
The next two GPR B-scans from the south aisle are presented together with the corresponding results of the UT scanning. In the A-121 GPR B-scan (Figure 18a), the tiles with different thicknesses (in the range of 0.02–0.04 m) were visible, and also a tombstone with the thickness of about 0.12 m was identified. The ground below the tombstone contained some concentrated inclusions (probably rubble or human remains). The brick wall was present at a distance of about 3.4 m. The UT scan (Figure 18b) clearly revealed the tile pattern, and also the tombstone was observed. The presence of the multiple reflections under each tile allowed stating that there were many air gaps below them, which agreed with the fact that the floor of the south aisle experienced significant settlement. The reflections denoting the air gaps generally did not appear below the tombstone, probably because of

its weight. What is also worth noting is that no additional reflections from the ground heterogeneities could be identified. The UT scanning did not detect concentrated inclusions, which were already observed for the pipe in the area of the trial pit and the table tennis ball in the concrete slab. The GPR B-scan for the trace A-129 is presented in Figure 19a. The tiles with different thicknesses (varying between 0.02 and 0.06 m) are clearly detectable. Two tombstones with a thickness of approximately 0.12 m and irregular shape of the bottom face were also present. The ground under both tombstones had many concentrated inclusions unlike aside from this area. The brick wall could be visible at the distance of about 4.3 m; however, the intensity of the reflections from the bricks was not as strong as in the A-121 scan. In the UT scan (Figure 19b), the tiles and the tombstones could be localized. There were no significant reflections under the tombstones, thus the air gaps were not likely to be there, unlike under the most of the tiles, where multiple reflections appeared. This observation corresponded with the settlement of the floor in the area of the south aisle.

Figure 18. GPR and UT B-scans for trace A-121 (south aisle): (a) GPR scan; (b) UT scan.

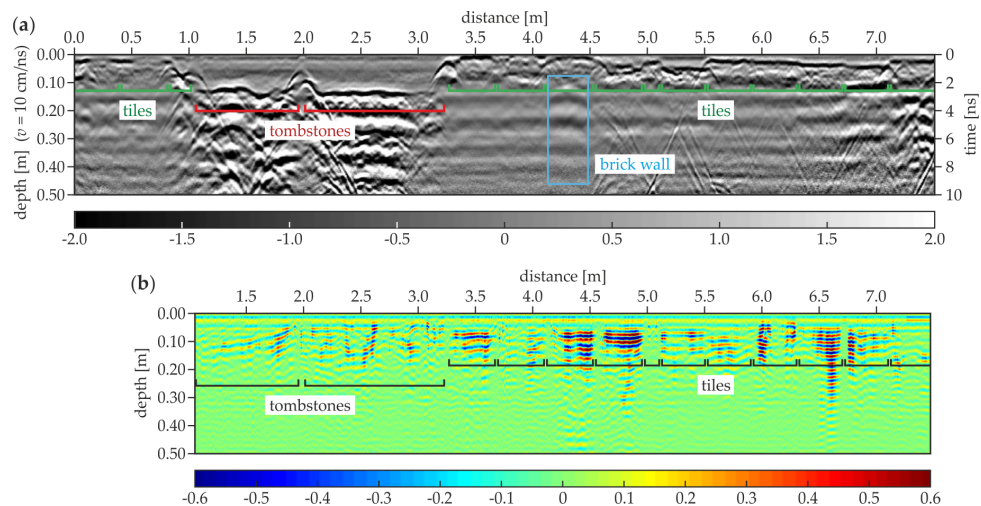
Figure 19. GPR and UT B-scans for trace A-129 (south aisle): (a) GPR scan; (b) UT scan.

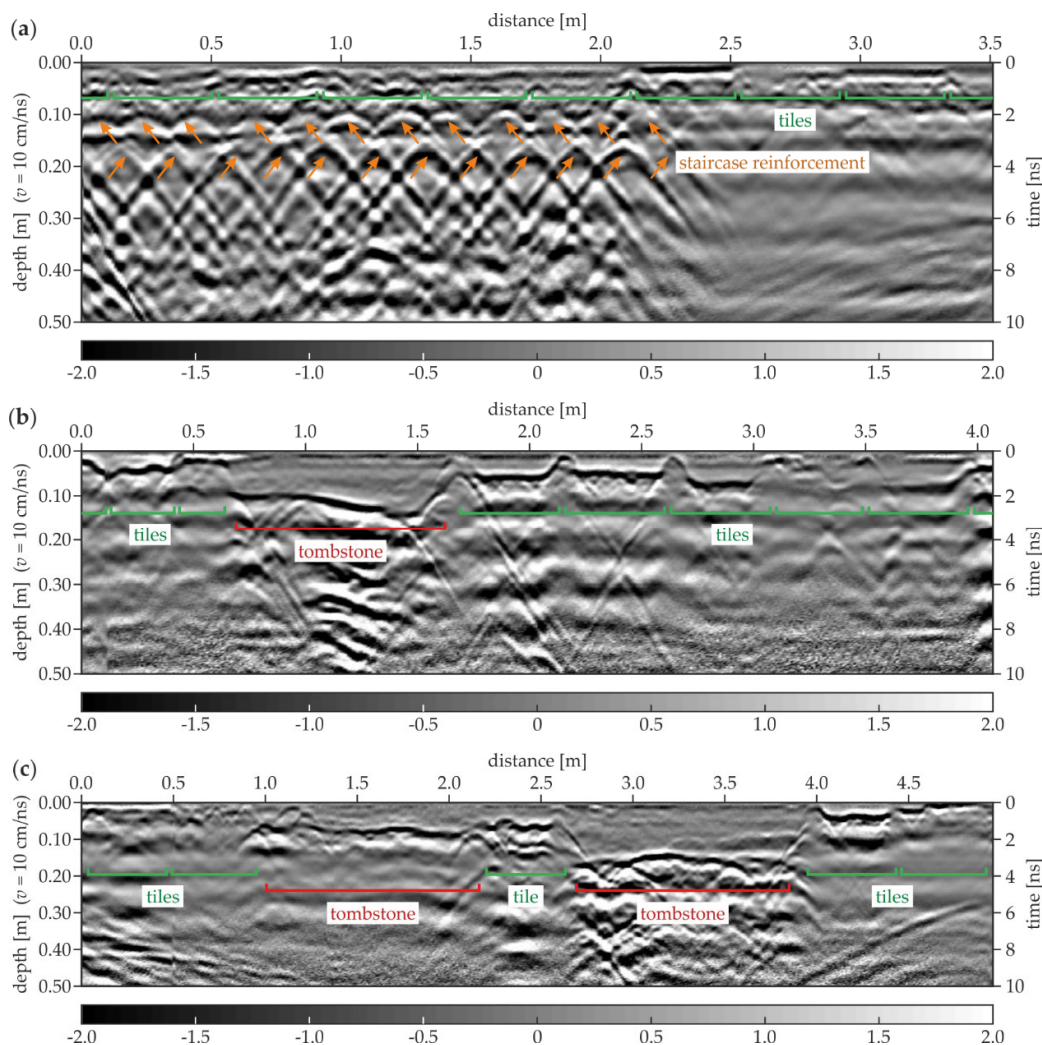
Figure 20 shows the examples of the GPR B-scans for the north aisle. The B-5 scan (Figure 20a) shows the regular pattern of tiles with a constant thickness of 0.03 m. Several evenly spaced hyperbolas were visible at two levels (the depth of 0.11 and 0.18 m) and the distance of 0.0–2.1 m. These reflections represented the reinforcement of the staircase located under the floor. The ground below the tiles aside of the staircase seemed to be devoid of significant heterogeneity. In the B-35 scan (Figure 20b), the tiles had different thicknesses in the range of 0.02–0.06 m. The tombstone had a thickness varying between 0.10 and 0.15 m and the skew shape of the bottom face. The ground below the tombstone had some concentrated inclusions. The B-143 scan (Figure 20c) presents the tiles with the thicknesses between 0.02 and 0.05 m. Two tombstones were also visible, the left one with the thickness of about 0.09 m and the right with the thickness of approximately 0.16 m. The ground under the thinner tombstone did not have inhomogeneities, unlike the ground under the second one, where multiple reflections from the concentrated inclusions occurred. This observation confirms the fact that some of the tombstones were placed aside from the area of the original crypts.

Figure 20. GPR B-scans for the north aisle (survey B): (a) B-5; (b) B-35; (c) B-143.

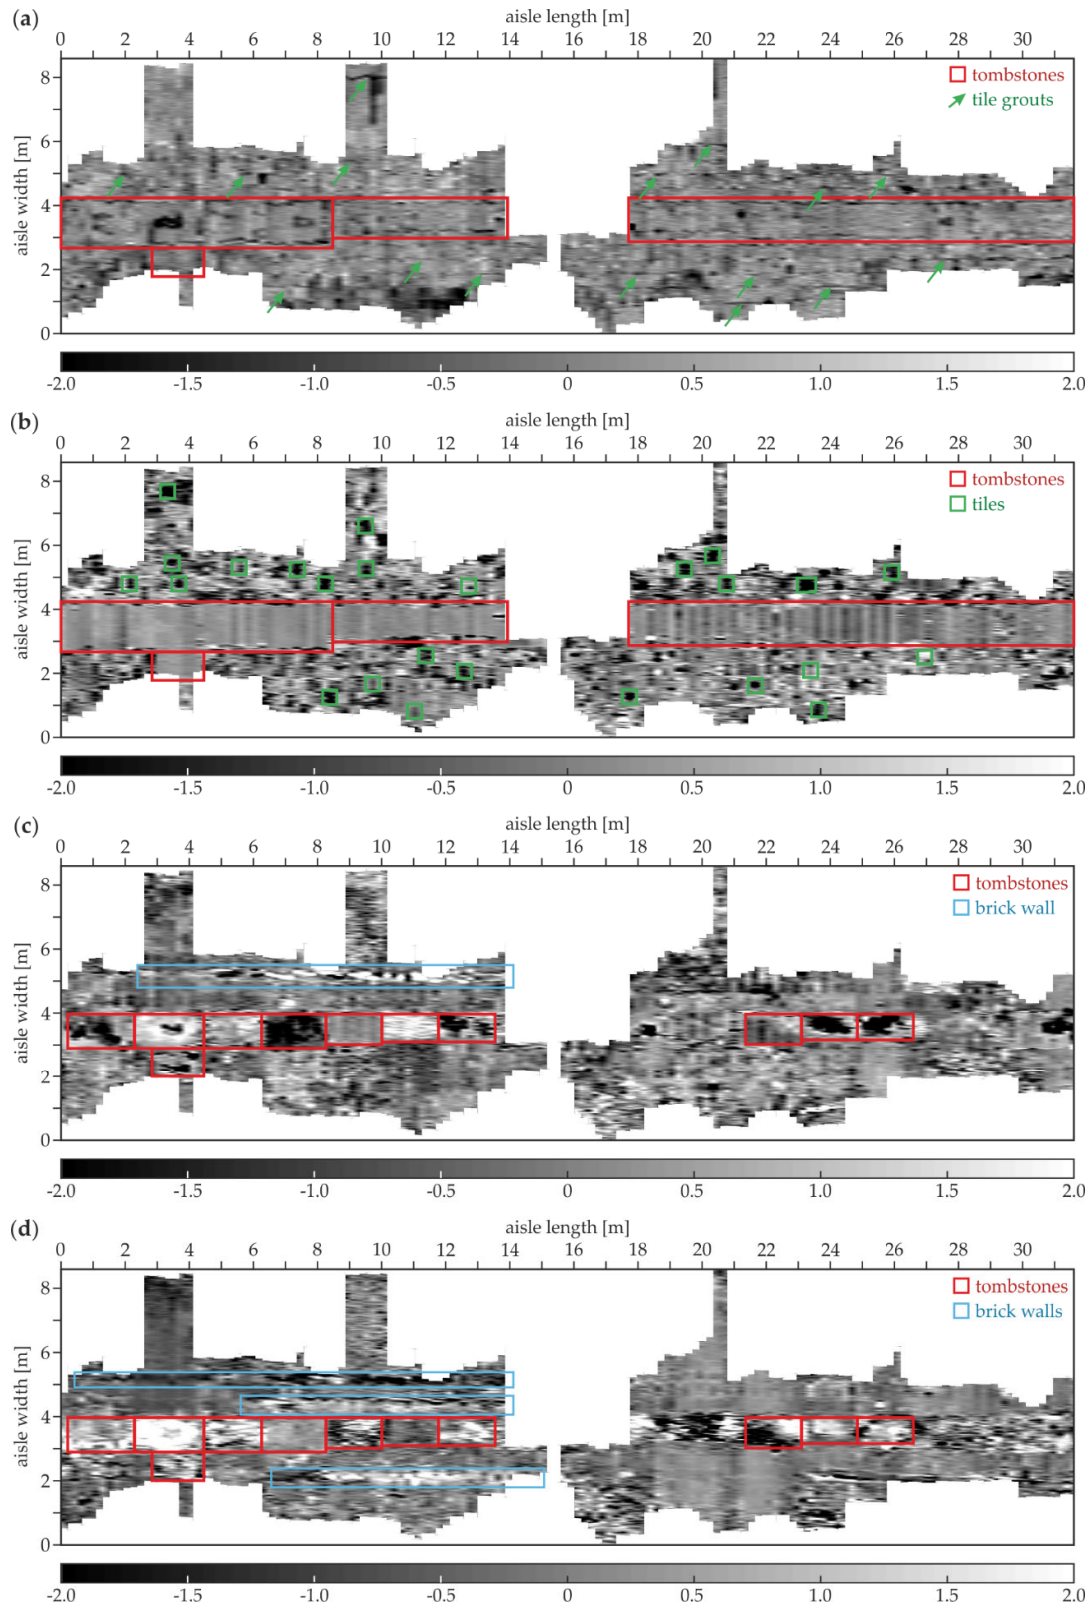
Figure 21 presents the tomographic images of the south aisle. At the depth of 0.16 m (Figure 21a), the tombstones identified in the above-discussed B-scans of the south aisle were detected. The elements were laid in a straight line along the whole aisle at the width between about 2.75 and 4.25 m. Additionally, the single tombstone was located aside from the main row at the length between 2.5

and 4.5 m (it was seen in the A-129 scan, Figure 19). The distinction of singular tombstones from the main row was not possible; the scanning was performed along the tombstone grouts, thus they could not be imaged. The singular tiles were not detected due to a single direction profiling. The tile grouts in the lengthwise direction (perpendicular to the measurement traces) were identified, unlike the crosswise grouts (oriented in the same direction as the scan traces). At the depth of 4.06 cm (Figure 21b), the imaging of the tombstones was far clearer; however, there was still no possibility to distinguish the singular elements. On the contrary, the individual tiles could be detected; the chosen tomography depth was between the minimum and the maximum thickness of the tiles, thus some of them were visible, whereas other ones could not be observed. At the depth of 12.19 cm (Figure 21c), most of the tombstones were clearly visible. The lower faces of some thicker tombstones were below the tomography depth, unlike the thinner ones, which were not detected at this level. The adornment was detected on the second tombstone from the left. The tiles could not be identified because their bottom faces were located certainly above the actual tomography level. What is more, the brick wall was moderately imaged at the width of about 5.2 m and the length between 2.2 and 13.8 m. The tombstones were still distinguishable at the depth of 23.75 cm (Figure 21d). The inhomogeneities in the ground under certain tombstones were visible, especially on the right side of the tomography. The brick wall discovered at the depth of 12.19 cm was still detectable and seemed to be longer. What is more, another two brick walls were identified: the first one at the width of 4.5 m and the length between 5.5 and 14.0 m, the second at the width of 2.2 m and the length between 6.5 and 15.0 m. All of the three walls were clearly imaged in the A-117 B-scan (see Figure 17b).

**Figure 21.** GPR tomographic images of the south aisle (survey A) at different depths: (a) 0.16 cm; (b) 4.06 cm; (c) 12.19 cm; (d) 23.75 cm.

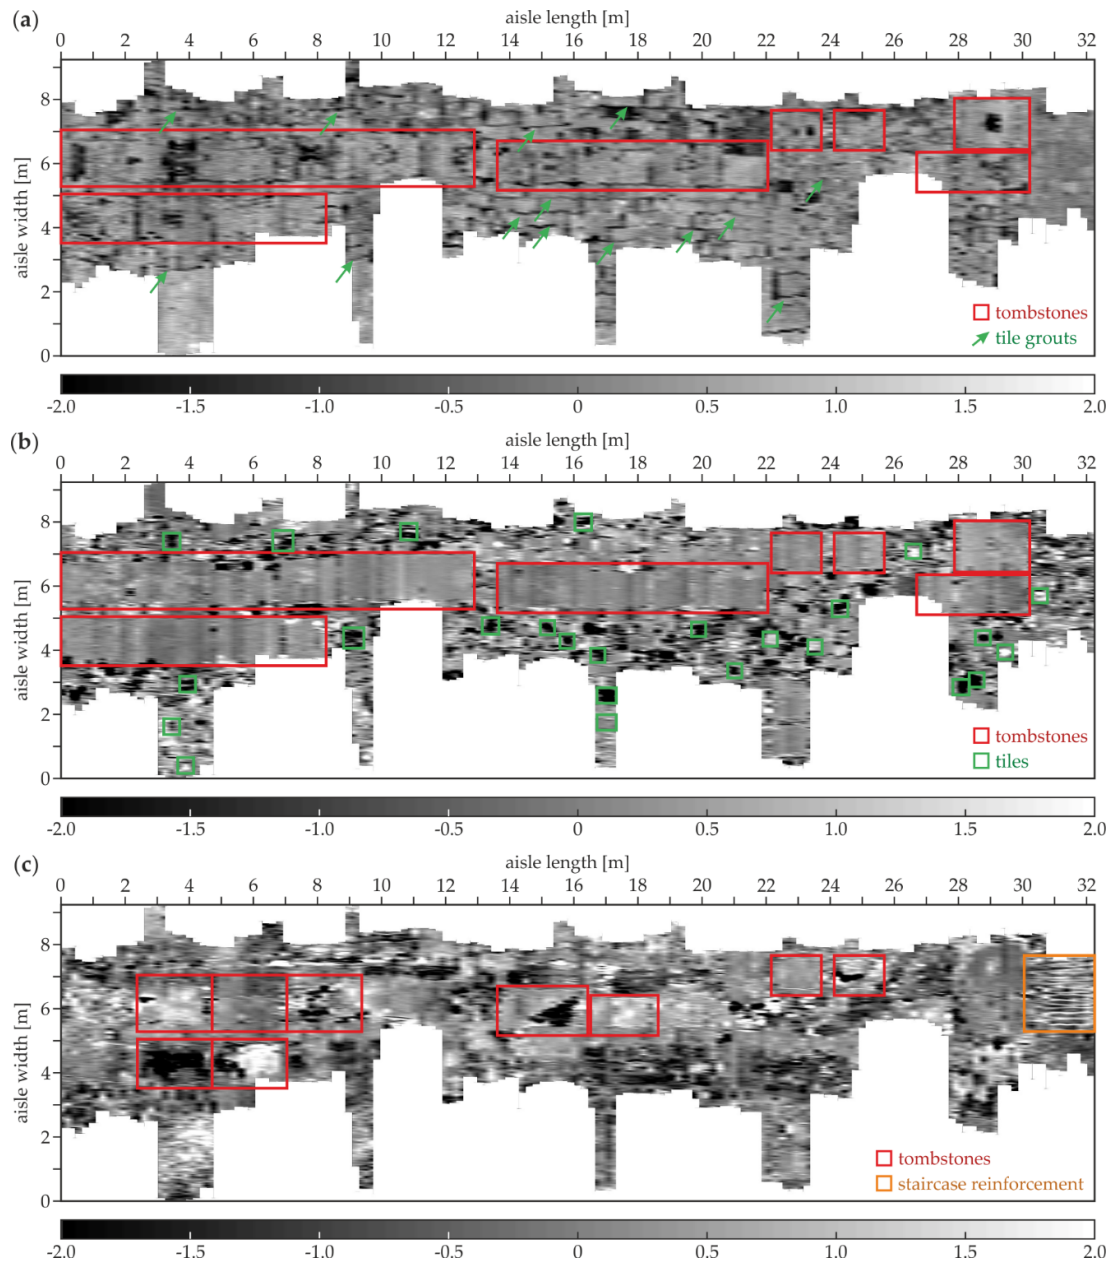
Figure 22 shows the tomographic images of the north aisle. Similarly to the results for the south aisle, the tombstones were detected at the depth of 0.16 cm (Figure 22a); however, their configuration was not so regular. The lengthwise tile grouts were also imaged, unlike the crosswise grouts. The adornments were visible on some of the tombstones. At the depth of 4.06 cm, the tombstones were shown far more clearly. Some individual tiles were also observed. At the depth of 12.19 cm, the singular tombstones could be distinguished. Some of them did not seem to be rectangular because of the irregular shape of their bottom faces. It is also worth noting that the staircase reinforcement was visible at the length of 30.0–32.0 m and the width of 5.2–7.8 m. Only the lengthwise bars were noticeable, and the crosswise reinforcement could not be imaged because of the single direction of the GPR scanning.

**Figure 22.** GPR tomographic images of the north aisle (survey B) at different depths: (a) 0.16 cm; (b) 4.06 cm; (c) 12.19 cm.
