Investigation of the 0.4C-35Cr-45Ni-Nb Alloy after Service in High-Temperature Steam and Hydrocarbons Environment

Abstract: The paper presents the results of investigation of the 0.4C-35Cr-45Ni-Nb alloy, which operated in the cracked hydrocarbon feeds and dilution steam at 1125 °C. The material originated from the pyrolytic furnace coil tubes, of which internal walls were in contact with the aforementioned medium, whereas the external walls were in contact with the flue gases. The examination included metallographic and mechanical tests on the material after service exposure, the results of which were compared with the ones obtained for the as-received non-exposed specimens. The metallographic tests revealed changes in the alloy's structure manifested by formation of significant amount of the carbides due to carburization of the alloy from the steam and cracked hydrocarbon feeds side. The central and external parts of the alloy samples (having no contact with the process medium) underwent substantial degradation but within a relatively narrow zone of the material. The investigations of hydrogen and methane content in the alloy showed a high amount of these gases, resulting from hi

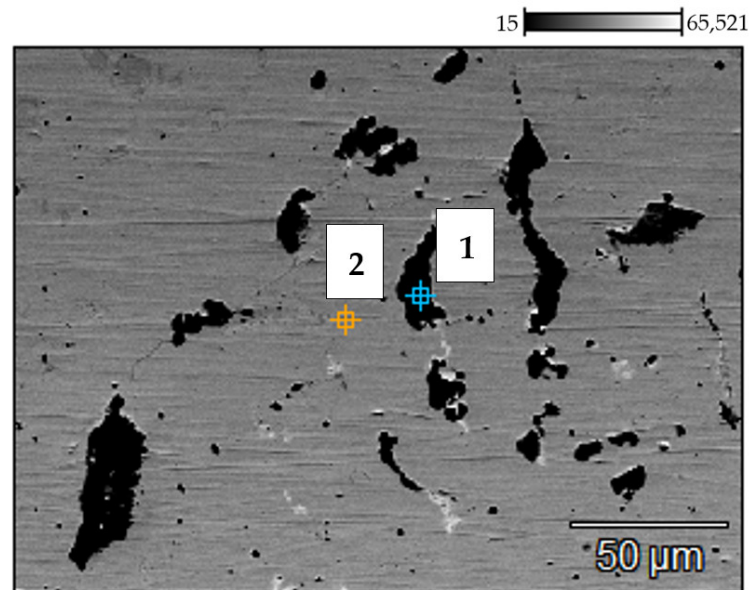
The metallographic investigations show high degradation of the alloy structure in the part of the coil tube. This degradation extends ca. 300 μm from the internal wall to the bulk of the specimen. Visible dark structures are characterized by high amount of silicon and lower content of chromium (spot 1—Figure 9) as compared to the matrix. The presence of a narrow region suffering from dechromization process is also reported in some literature sources [2,12]. Moreover, the degraded zone of the alloy is much more carburized due to the presence of coke, which is formed during thermal degradation of cracked hydrocarbon feeds. Upon service conditions, the internal part of coil tubes can be subjected to metal dusting, although no significant corrosion losses were detected [13,14].

Figure 9. BSE SEM image of the 0.4C-35Cr-45Ni-Nb alloy surface—internal part of the service exposed sample. Numbers indicate the spots of EDX analysis.

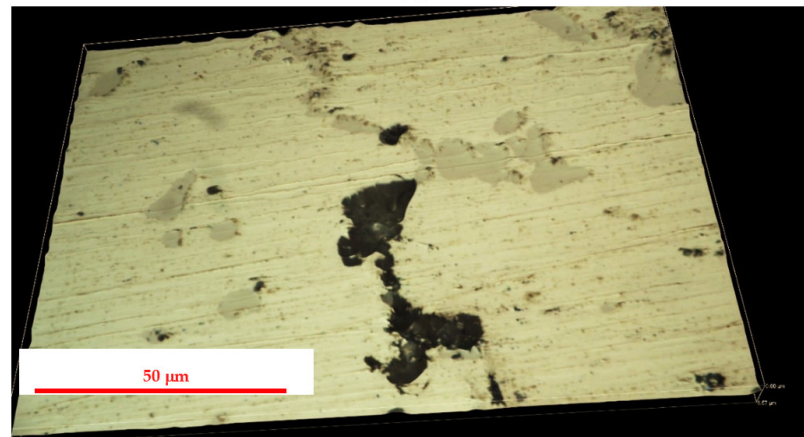
The external part of the coil tube was in contact with the flue gases used for heating of the furnace. In the analyzed case, the fuel consisted of gas hydrocarbons, mainly methane. Oxygen content in the flue gases stream was low, which indicated no risk of the oxidation mechanism [3]. The gas fuel utilized was of high purity, thus eliminating the mechanisms of fuel ash corrosion and flue gas dew point corrosion [3]. High temperature and low content of carbon compounds in the flue gases resulted in decarburization, which is evident on the metallographic images (Figure 10). It occupies a zone of ca. 200 μm , which corresponds to the region with a limited number of carbides [11]. The entire zone of significant structural degradation covers 400 μm .

Figure 10. Surface images of the 0.4C-35Cr-45Ni-Nb alloy obtained during metallographic investigations of external part of service exposed coil tube: (a) external wall neighboring region; (b) magnification of a fragment of the region presented in (a).
