## **On the current state of dovetail wall-corner joints in wooden Greek Catholic churches in Polish Subcarpathia with structural and sensitivity analyses**

Izabela Lubowiecka<sup>1</sup>, Tomasz Zybała<sup>1</sup>, Grzegorz Bukal<sup>2</sup>, Marcin Krajewski<sup>1</sup>, Marcin Kujawa<sup>1</sup>, Paweł Kłosowski<sup>1</sup>

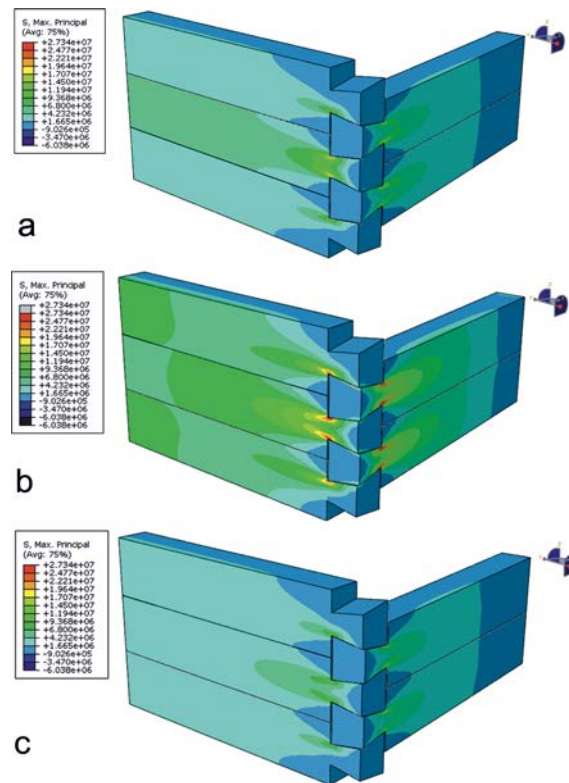
Significant deformations of the logs cause high stress on some contact surfaces. Large displacements can also expose the inside surfaces of the timber joints to environmental and biological degradation. The area of stress concentration area was therefore analysed and compared in the models considered. The principal stress and resultant force  $R_y$  were the significant quantities in the analysis. The maximum and minimum principal stress maps covering the three studied cases are shown in Figures (13-14). The comparison of the calculated values of the stress  $S$  and force  $R_y$  corresponding to the maximum lateral displacement  $u_y$  of each joint in each case studied is summarised in Table 2. The maximum principal stress is almost doubled when one member of an old joint ( $S_{max} = 12.31$  MPa) is replaced with one made of dry new wood ( $S_{max} = 22.82$  MPa).

Figure 13. Maximum principal stress in the joint where a) one log has been exchanged into a new wood; b) all logs are made of the same new wood; c) all logs are made of the same old wood.
