# Operational causes of fatigue failures within passages of gas turbine engines

Zbigniew Korczewski, Assoc. Prof.  
Gdansk University of Technology

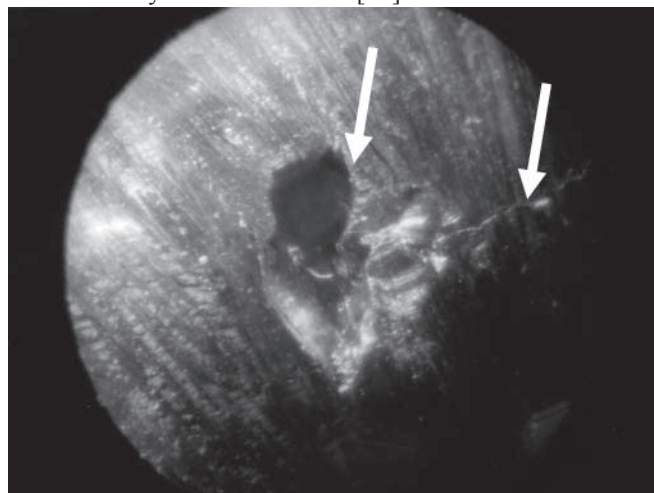
Another hazard to engine reliability, which results from rotor seizing in engine body, consists in possible cracking of the compressor body, Fig. 6. The presented failure has been identified during endoscopic examination of a GTU6a single-shaft engine (of block structure) driving ship electric generating set. Compressor's body was made of 40HNMACr-Ni low-alloy steel of a higher metallurgical purity. The situation occurred as a result of immediate switching-off the engine from operation under nominal load and passing over the cooling phase under idle running. Such decision of operators resulted from a fire observed in exhaust gas channel and entering the engine into unsteady operation range. After that the engine was dismantled and sent to its producer. Repair of the body consisted in vacuum electron-beam welding the crack.

On the basis of the character of the appeared failure of the compressor body it can be concluded that the initial cause of the crack was a material defect, e.g. presence of sulfides at place of fracture. In effect of action of dynamic loads the fatigue fracture propagating just from the edge of the material defect, was initiated. As a result of rotor seizing in the compressor body in the temperature of about 700-800 K, further propagation of the gap took place in the form of cleavage fracture. As the body was cooled more fast than the rotor the gap became separated mainly due to tensile forces (axial ones) with an influence of shear forces.

Designers of gas turbine engines take into account possible stopping the engine working under high load with passing over the cooling phase under idle-running. It is covered by manufacturer's testing program. Therefore the seizing of rotor units in engine body should not happen at all. However in the described case the engine immediate stopping was preceded by its unsteady work when a flash-back towards engine intake took place causing an inadmissible, very intensive rise of compressor material temperature much over its permissible value of 520K, determined by the manufacturer [15].

**Fig. 6.** Internal surface of GTU6a turbine engine compressor body, showing a fatigue fracture (acc. endoscopic examination)
