# Renovation works in buildings in the area of former defensive fortifications

Maciej NIEDOSTATKIEWICZ<sup>\*1</sup>, Tomasz MAJEWSKI<sup>2</sup>, Adam BARYŁKA

## Abstract

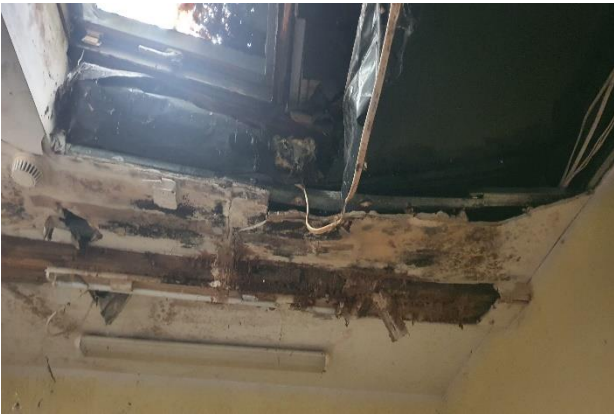
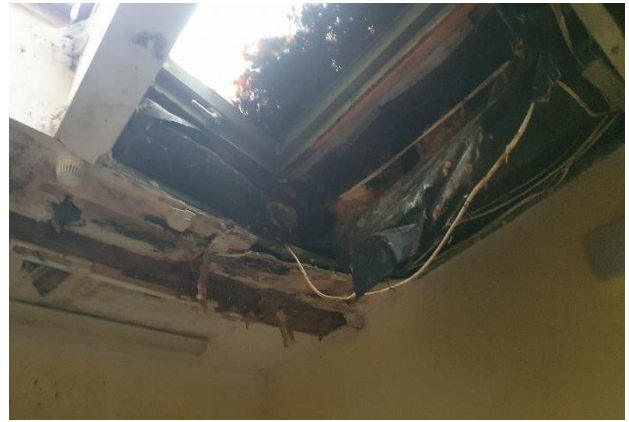
In the summer, in the room of the former office premises (A) adjacent to the defensive embankment, a random event occurred involving the collapse of a fragment of the roof structure (Photo 5). The roof, made as a ceiling on wooden beams with mineral wool insulation, has collapsed. Damage to the roof caused the ingress of rainwater into the interior of the rooms, contributing to the dampness of the walls and floor.

During the inspection, a local collapse of the flat roof structure (roof collapse) was found, made as a ceiling on wooden beams with mineral wool insulation. The direct cause of the damage to the roof structure was the breaking of the beams caused by biological corrosion of the wood, its rotting, probably the result of long-term dampness of the wood and the fungus and mold. It is worth noting that the roof damage occurred in the place where snow bags formed in winter, i.e. the wet wooden beams, weakened by biological corrosion, were subjected to an increased load from the weight of the snow. With the passage of time and the progress of corrosion, the wooden beams weakened so much that during the next winter, after snowfall, their bearing capacity was exhausted and the roof collapsed.

A visual assessment of the wood in the area of the damaged flat roof, in the zone of rooms adjacent to the top of the defensive rampart, clearly allowed to classify the wood as wet.

It was also very important that the roof surface had undulations, i.e. on fragments of the slope there were depressions in which the roofing could be felt. This is a characteristic symptom for wooden roof trusses with wooden elements damaged by biological corrosion. Depressions (sinks) were particularly perceptible in the zones in front of the skylights, where there were no fenders (baskets), i.e. in places where there were water pools. In the case of leaks in the roofing felt, these places are particularly exposed to moisture, and the depressions of the pavement indicated that such damage occurred in these places.

**Photo. 5:** Zapadnięty dach w części nad dawnymi pomieszczeniami biurowymi (A) Collapsed roof in part above former office spaces (A)

- perform temporary protection of the damaged flat roof as a matter of urgency:
  - ❖ in the space of the collapsed ceiling, place wooden square timber vertically, which will ultimately serve as a supporting structure for the roof over the damaged fragment of the roof,

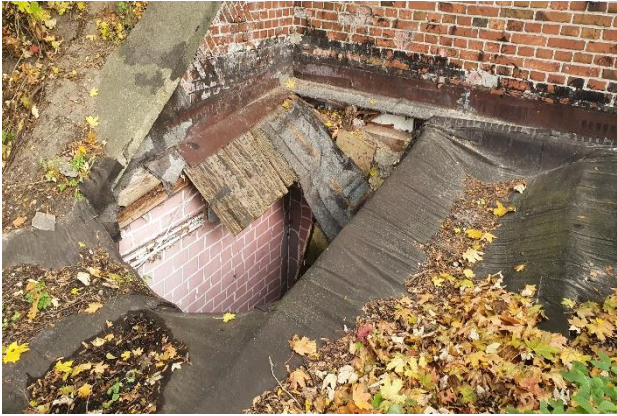
The damaged roof in the area of the former office spaces (A) (Photo 7) had additional lighting in the form of roof skylights (Photo 8). In front of the skylights, there were no fenders (so-called kozubków), as a consequence of which pools of water formed at the windows, the lack of baskets hindered the flow of rainwater.

Photo. 7: Collapsed roof over former office spaces (A)

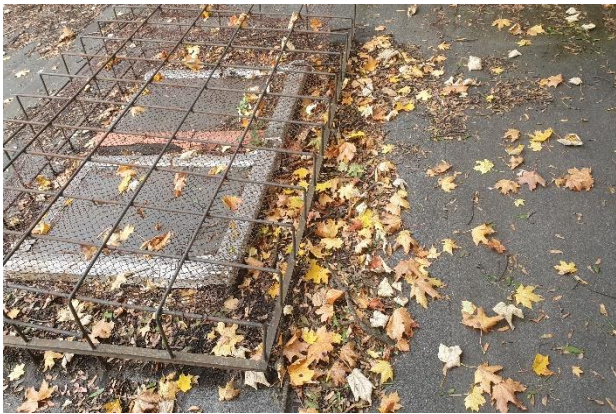
Photo. 8: No bumpers (bumpers) in front of the windows next to the windows on the roof above the former office spaces (A)
