# Revitalizing the Sacral Complex of the Parish of the Sacred Heart of Jesus in Gdynia: A Comprehensive Restoration Project in Alignment with Monument Conservator's Guidelines and Technical Prerequisites

Maciej NIEDOSTATKIEWICZ<sup>\*1</sup>, Jacek BRAMORSKI<sup>2,3</sup>

<sup>1</sup> Department of Engineering Structures, Faculty of Civil and Environmental Engineering,  
Gdańsk University of Technology, Gdańsk, Poland

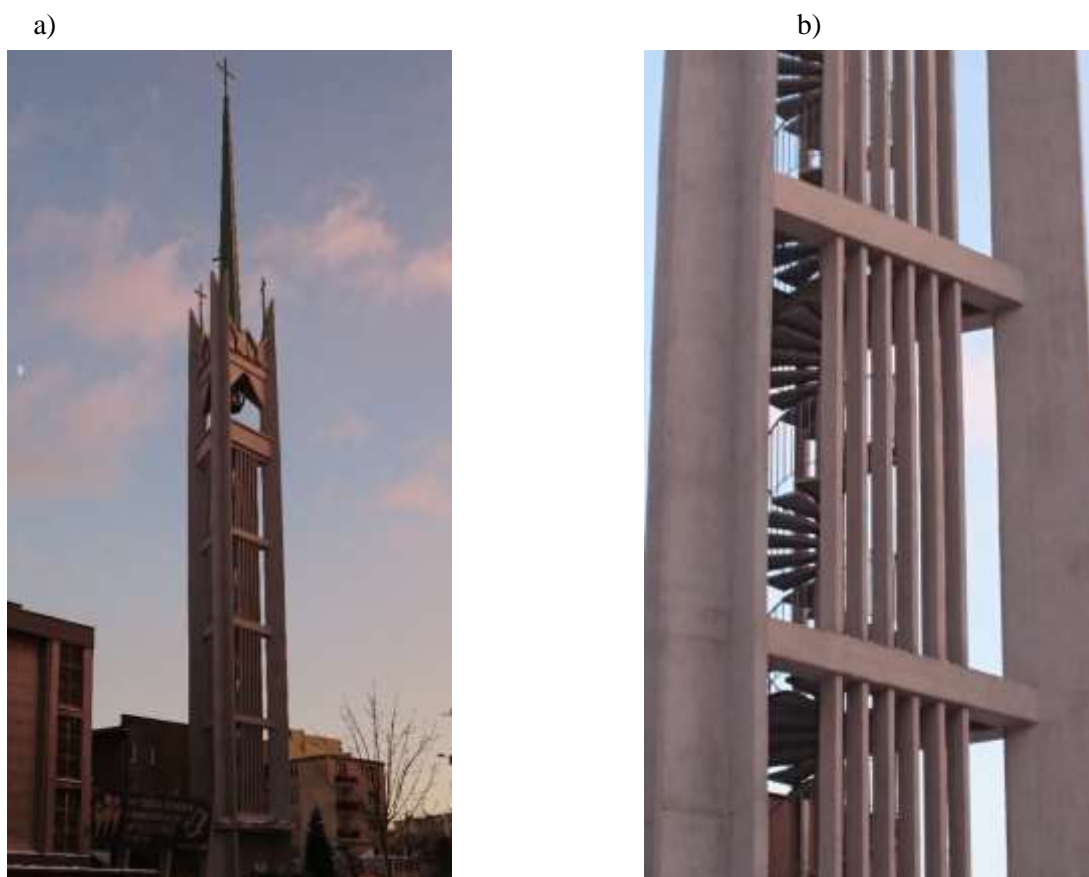
**Photo 1.** The bell tower of the Church of the SHoJ in Gdynia: a) general view, b) close-up of the internal staircase (photo by Maciej Niedostatkiewicz)

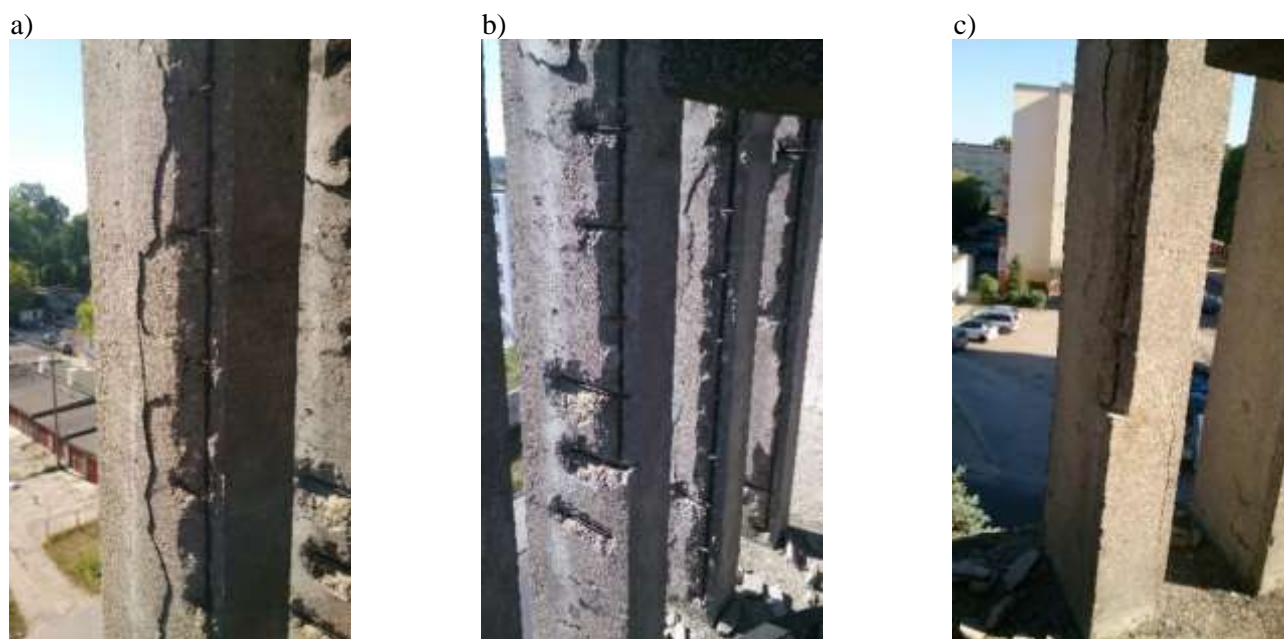
**Photo 4.** Examples of damage to the reinforced concrete prefabricated pillars of the belfry tower: a), b), c) losses of the concrete cover and corrosion of the reinforcement bars (photo by Maciej Niedostatkiewicz)

- structural elements (main columns in the axes A, B, C, prefabricated auxiliary posts, as well as transoms and beams at the level of technical platforms from 1 to 6) were reprofiled with the use of PCC and PCC II repair compounds,
- scratches on the column of the spiral stairs between levels 2-3 were secured by the use of adhesive injection. It was assumed that if the cracking of the column reappeared, it would be necessary to strengthen it and protect it by gluing carbon mats, creating the form of closed rings around the column between the prefabricated steps of the stairs,
- after the reprofiling, the surfaces of the reinforced concrete elements were covered with hydrophobing agents that minimize the migration of moisture and compounds contained in the air into the concrete, at the same time minimizing the progress of concrete carbonation.

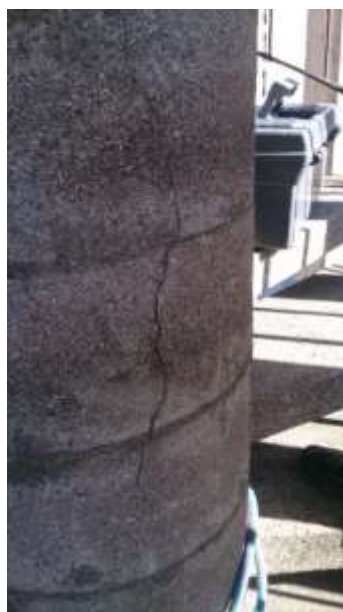
Corrosion damage at levels 4-5 and 5-6 was more intense than at levels 2-3 and 3-4. Occurring damage to the tower made it necessary to shut down the carillon, which had been operating continuously for almost 35 years, due to the danger of moving around the internal staircase in order to activate the bell. Vertical cracks were visible on the column formed from the assembly of prefabricated stairs, in the section between levels 2-3 (Photo 5).

**Photo 5.** Outlined, in the line of the axial anchorage, prefabricated steps of the spiral stairs leading to the top of the belfry tower (photo by Maciej Niedostatkiewicz)

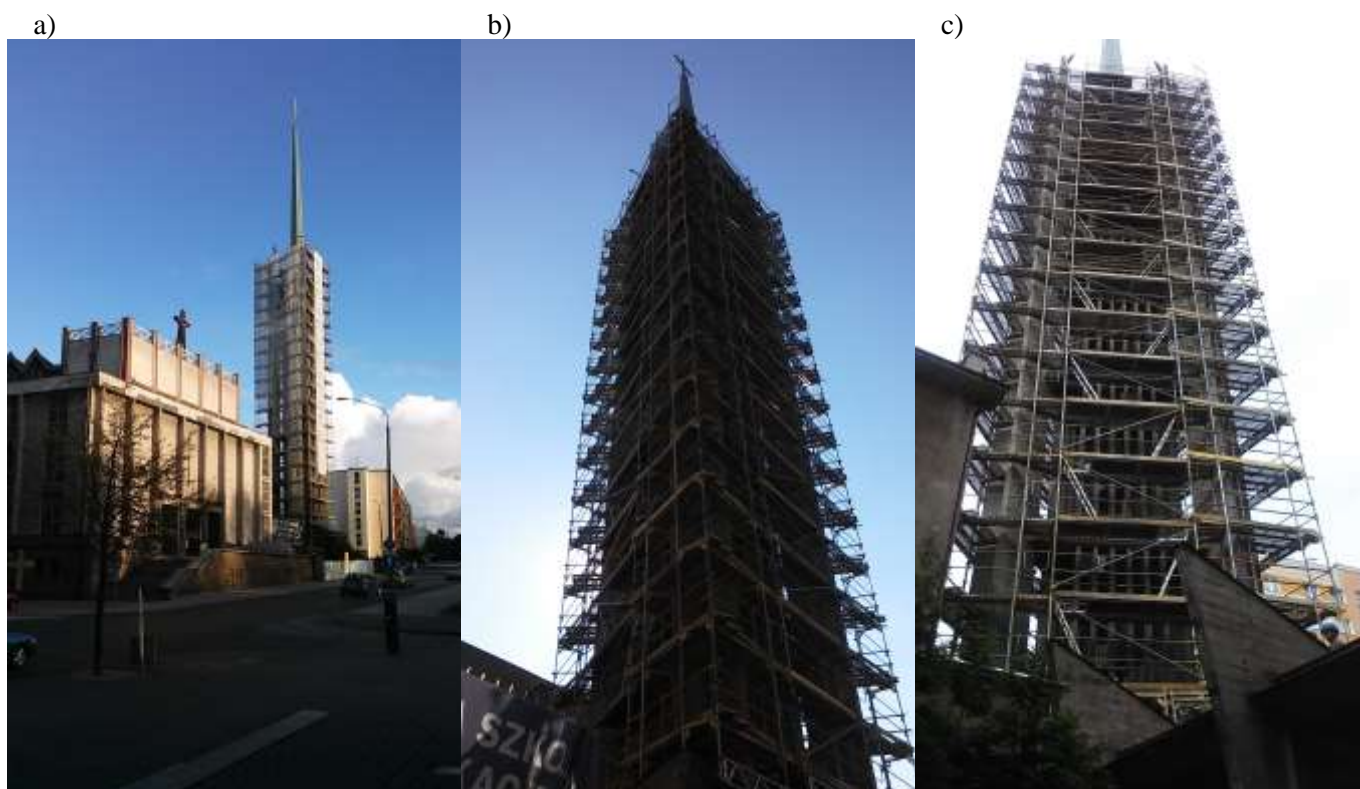
**Photo 7.** Reinforced concrete belfry tower during renovation works: a) general view, b), c) close-up details of the scaffolding (photo by Jacek Bramorski)

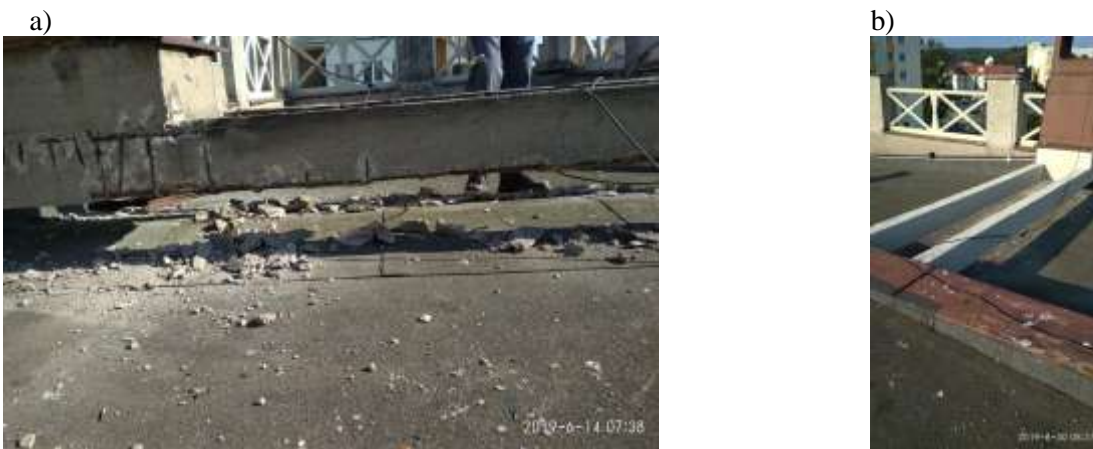
**Photo 11.** Reinforced concrete, monolithic beams of the grate supporting the cross from the west elevation (along 3 Maja Street) - condition: a) before, b) after renovation (street names as of 2023) (photo by Maciej Niedostatkiwicz)

As part of the repair work on the reinforced concrete elements of the roof slope above the central nave, the reinforced concrete beams supporting the cross placed on the roof, visible from the side of the front façade, were also reprofiled (Photo 11).

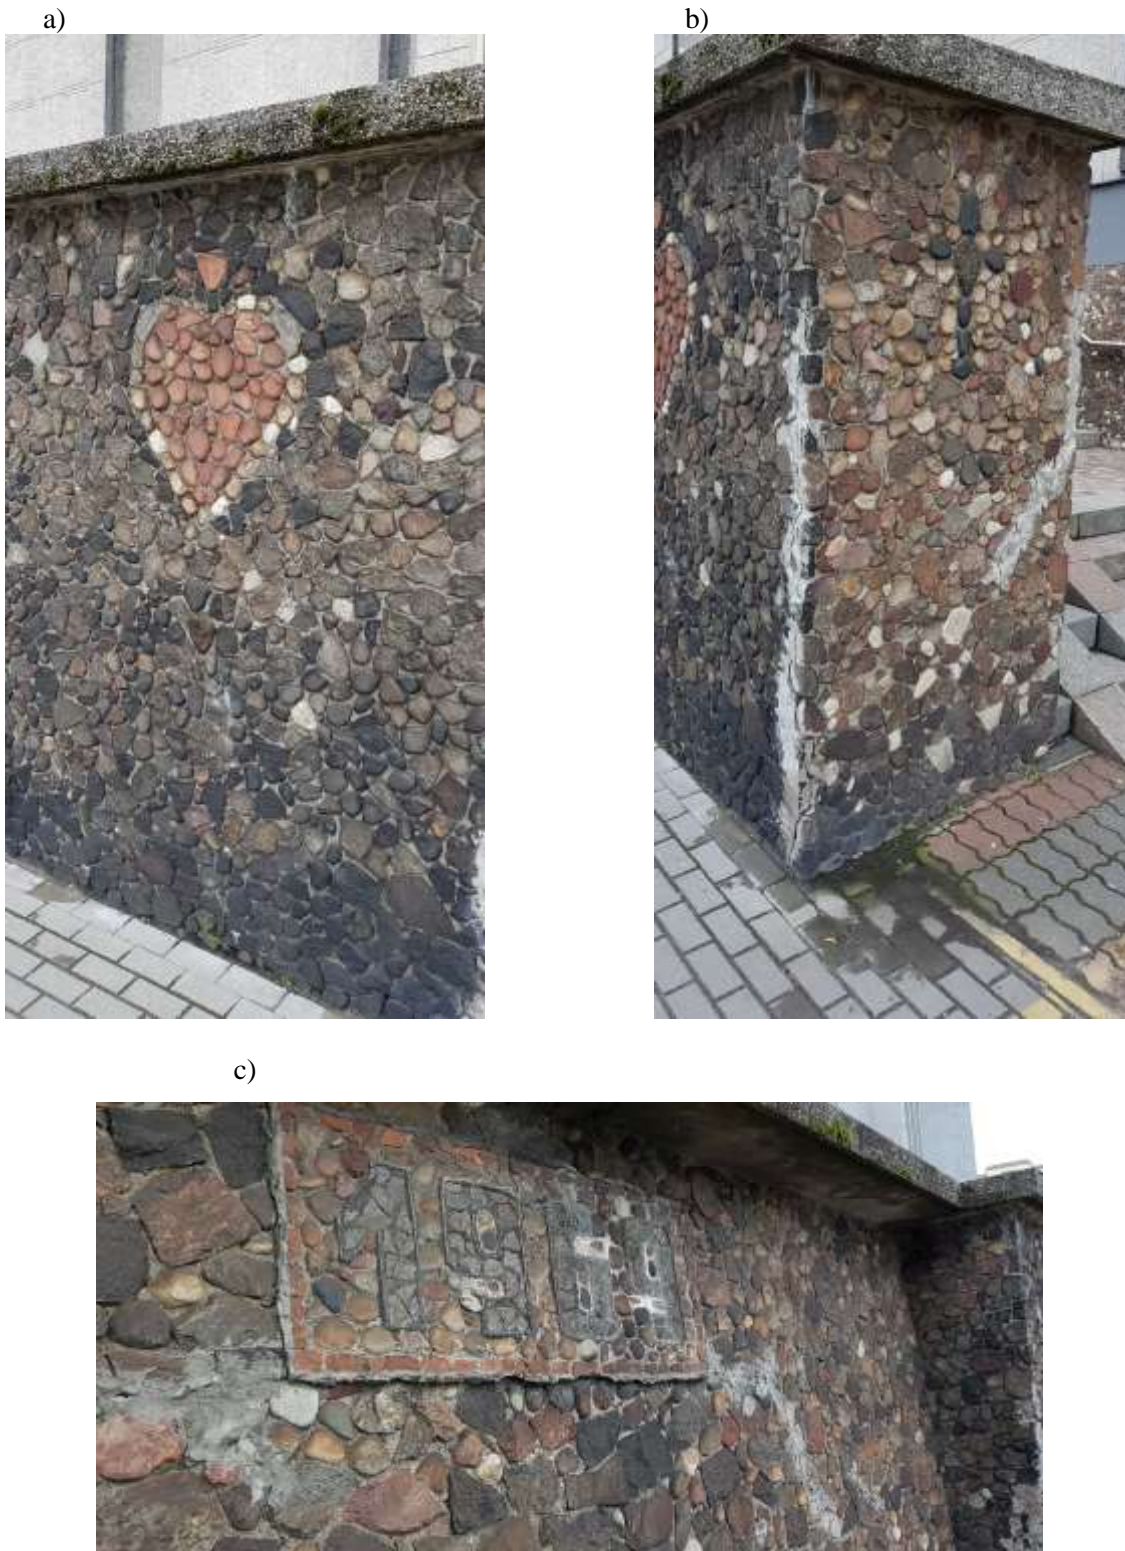
Decorative elements made on the cladding - religious symbols in the form of a heart and a cross and the date (year of completion of the construction of the Church) have not stratified over the years of operation (Photo 13), but it was noted that the date is detached from the structural wall.

**Photo 13.** Characteristic symbols made in the stone cladding of the wall from the west elevation (along 3 Maja Street): a) heart, b) cross, c) 1969 (year of completion of the construction of the church) (street names as of 2023) (photo by Maciej Niedostatkiwicz)

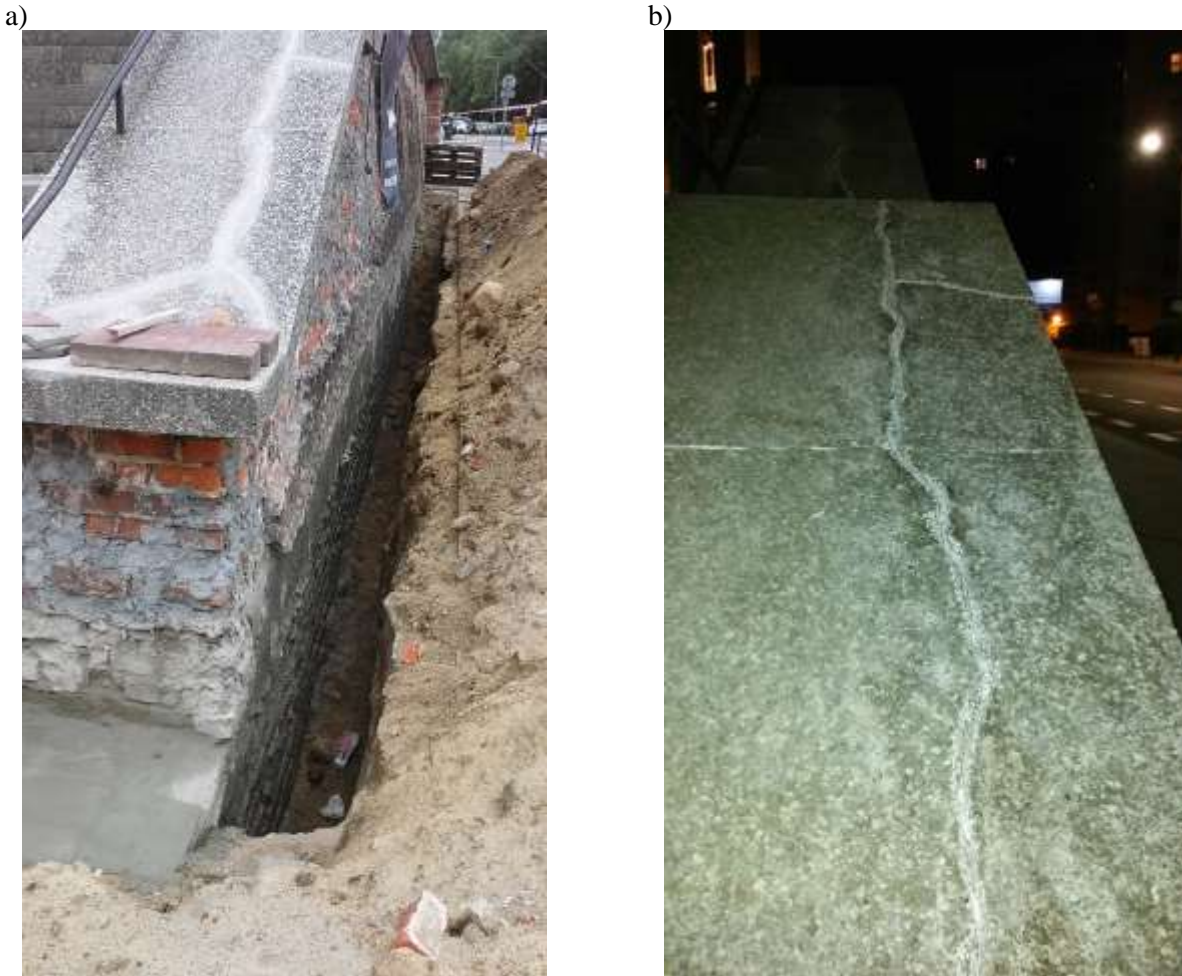
**Photo 14.** The wall at the entrance from the west elevation (along 3 Maja Street) during renovation works: a) dismantled cracked stone cladding and implementation of vertical damp-proof insulation, b) repaired cracks in the terrazzo cladding of the wall cap (names of the street as of 2023)  
(photo by Jacek Bramorski)

As part of the renovation works, the cladding was dismantled, locally down to the foundation level (Photo 14a), its stable fragments were left along part of the length of the wall. The cladding was rebuilt with recovered stones, after their prior mechanical cleaning and bathing in a paste solution with the addition of ammonium fluoride. A vapor-permeable, low-shrinkage packaged mortar with a reduced amount of lime was used to build the stone cladding. The laying of the cladding was preceded by the implementation of anti-moisture insulation on the footing and on the outer wall in the ground zone (Photo 14b). The insulation was made of a mineral mortar based on polymer-modified microsilica. As part of the work related to the execution of insulation, a facet was profiled at the junction of the continuous footing and the structural wall.

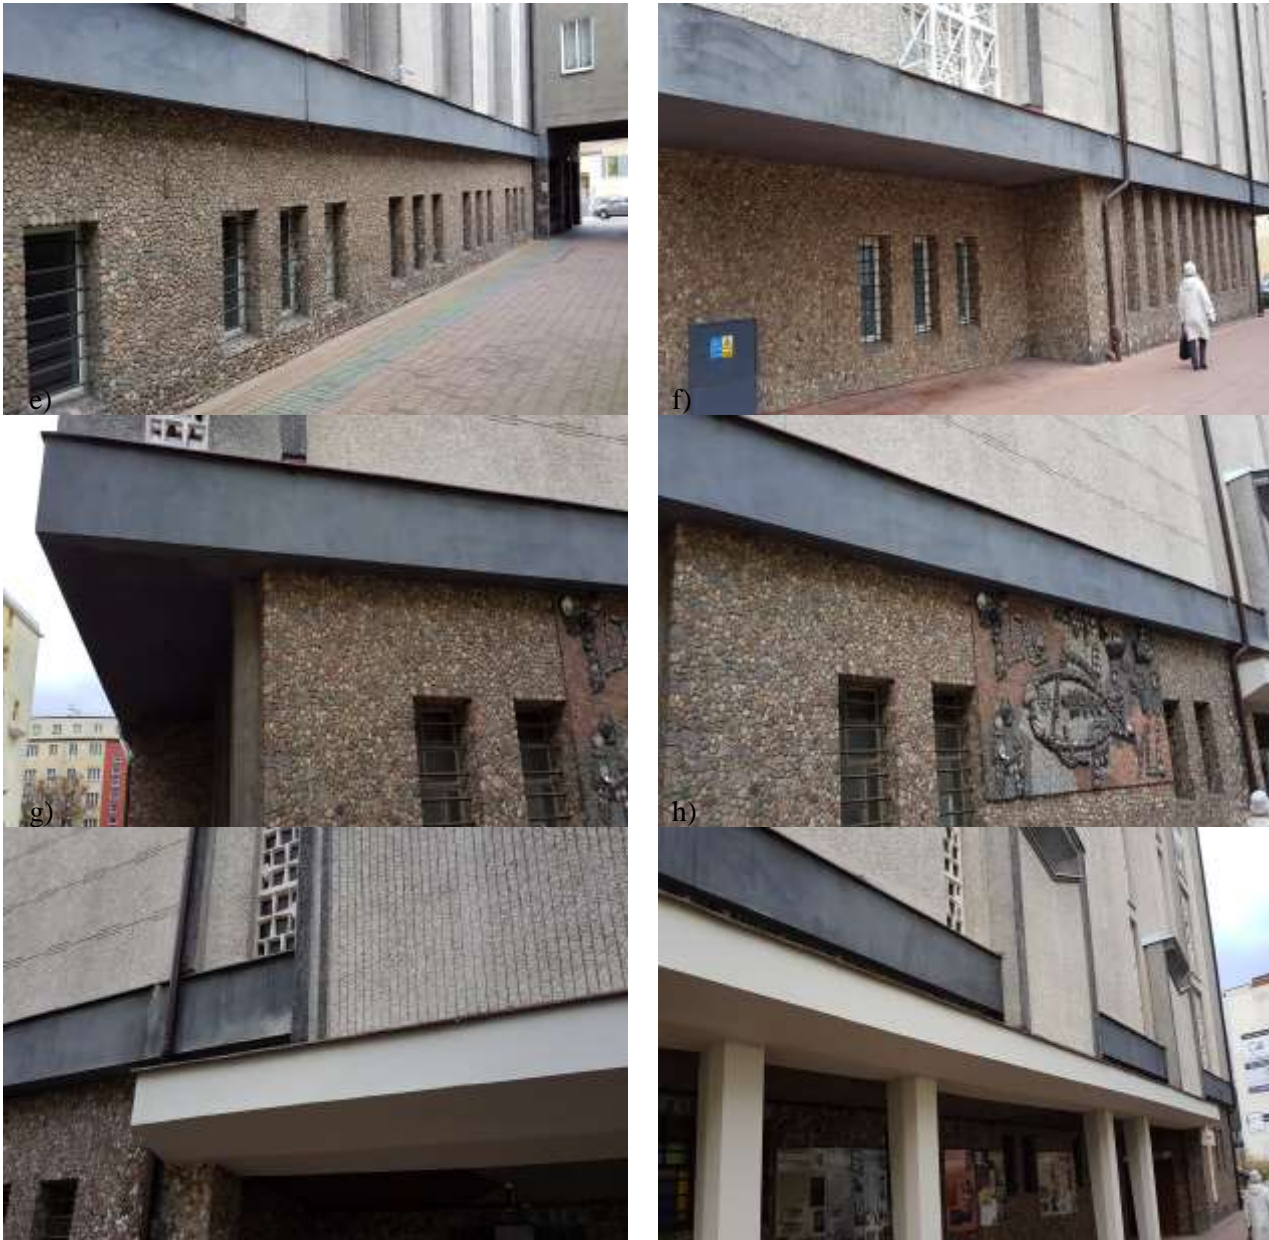
**Photo 15.** Base cornice after completion of renovation works: a), b) along the western elevation (from the side of 3 Maja Street), c) from the southern elevation (along Armii Krajowej Street), d) along the eastern elevation (from the side of Monsignore Hilarego Jastaka Street), e), f) from the northern elevation (along Stefana Batorego Street) (street names as of 2023) (photo by Maciej Niedostatkiwicz)

The lower part had damage similar to damage to the stone cladding of the wall at the main entrance. The stones were dirty, covered with a coating. Single stones were loosened, some of the joints were chipped. As part of the renovation works, the entire surface of the lower part of the plinth was first wetted with water at a temperature of  $\sim 30^{\circ}\text{C}$ , and then a thin layer of ammonium fluoride-based cleaning paste was applied to the surface of the plinth using a bench brush and the plinth was again washed with warm water. After cleaning, loose stones were glued in, and then the jointed stone cladding was supplemented with the materials used to repair the stone cladding of the wall at the main entrance.

The upper part of the plinth had damages in the form of plaster burns from the concrete base, the entire surface of the plaster was discolored and faded. As part of the renovation work, the scalded plaster was chipped off and restored. The new plaster was made as a layered plaster, with a primer layer and a top layer, after prior priming of the substrate and making a bond bridge. The top layer of the plaster was made as colored in the mass, with the use of fine quartz aggregate, with the use of a trass mortar dyed in the mass. The newly made external plaster on the plinth was made as rubbed plaster, with a structure matched to the structure of the plaster fragments left. After the local plaster repairs were completed, its entire surface was secured with an additional protective paint coating, in accordance with the conservation guidelines - a silicone facade paint was used, characterized by high water vapor diffusivity. As part of

the repair work, the flashings on the upper surface of the plinth were also replaced. The original flashings were made of zinc sheet, joined with the use of reflected and smooth coils, they were replaced with flashings made of steel-titanium sheet joined with standing seams.

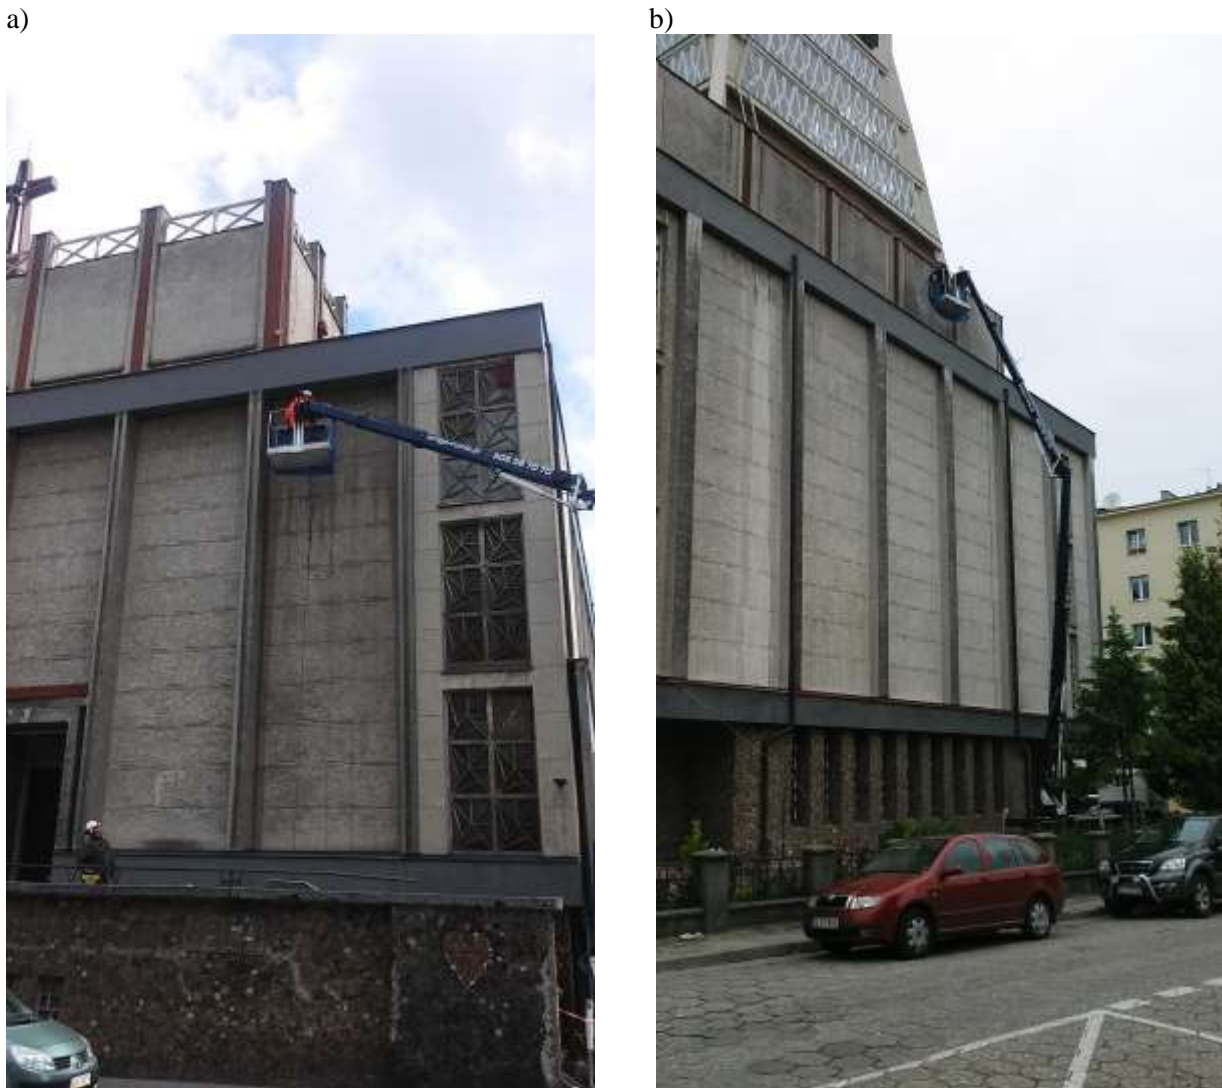
**Photo 16.** Church facades during their cleaning: a) western (from the side of 3 Maja Street) and b) eastern (from the side of Monsignore Hilarego Jastaka Street) (street names as of 2023) (photo by Jacek Bramorski)

The next stage of the renovation works of the Church building was the cleaning of the elevation (Photo 16). All facades of the building were subjected to restoration works, which were cleaned using the hydromonitoring method (Photo 17), using hot water at a temperature of 30°C. As an addition to the purification, an agent with a neutral  $pH$  was used, containing surfactants, i.e. surfactants that lower the surface tension of water. Thanks to the emulsifying properties of the agent used, the washed dirt and impurities were bound, especially the layer of grease and dust accumulated over the years of operation on the surface of the plaster made as the so-called. scraper. After cleaning, the facades were not additionally secured with a protective paint coating with the addition of anti-algae and anti-fungal agents, it was assumed that the protection would be provided by preservatives used in the production of the detergent in order to obtain its durability.

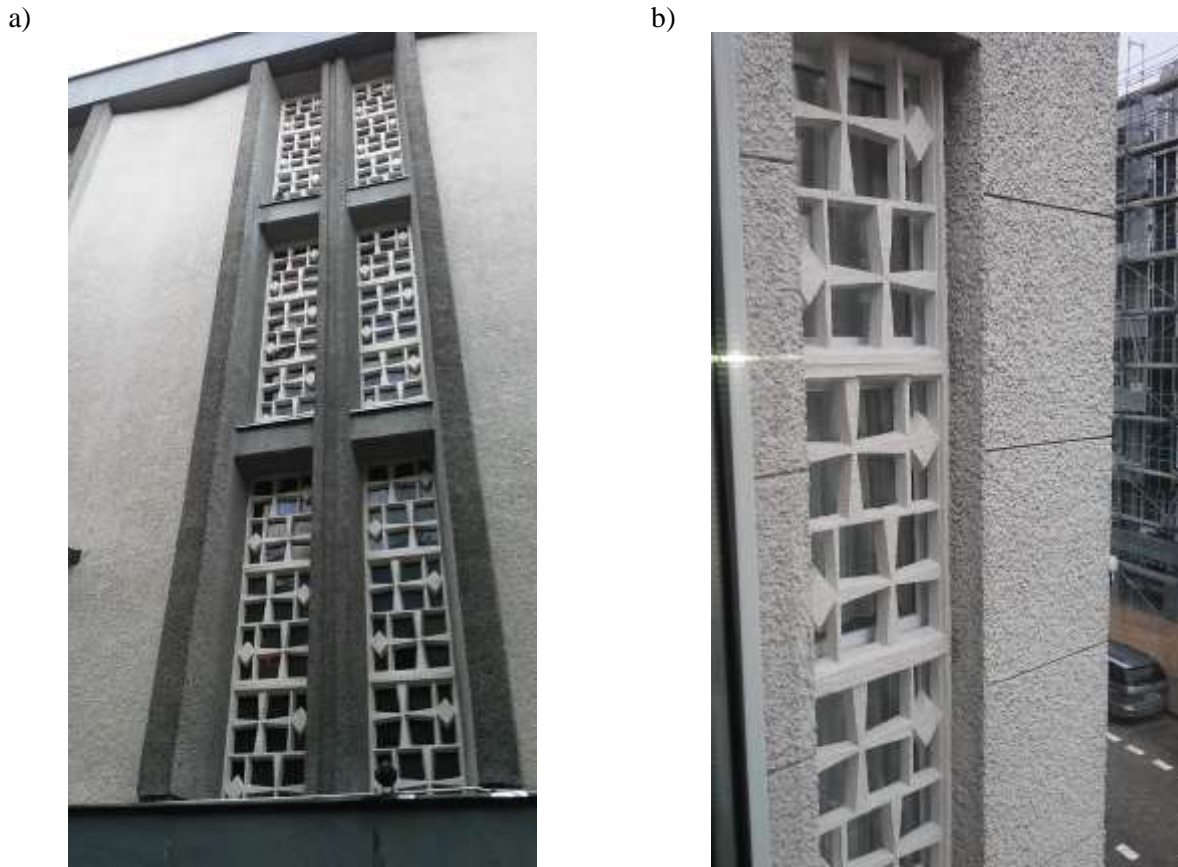
**Photo 18:** The condition of the facade from the south (along Armii Krajowej Street) after cleaning: a) view of the facade plaster, b) concrete window frames after revitalization (name of the street as of 2023) (photo by Jacek Bramorski)
