Research paper

Settlement of a historic building due to seepage-induced soil deformation

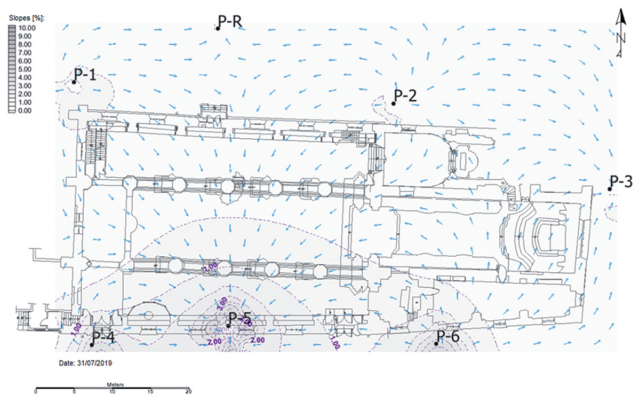
Fig. 11. Map of local groundwater table declines with seepage directions for a) 12/7/2019 and b) 31/7/2020, against the background of the Basilica basement level plan
