## Studies of the mechanism of metal dusting of 10CrMo9-10 steel after 10 years of operation in the semi-regenerative catalytic reformer

The purpose of this paper is to present a metal dusting mechanism for 10CrMo9-10 steel operated for 10 years in the semi-regenerative catalytic reformer.

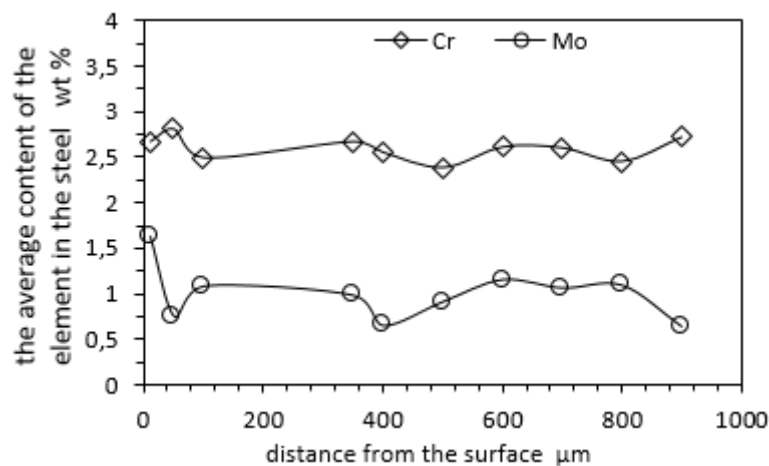
Fig. 5. Average content of the chromium and molybdenum in the steel as a function of distance from the inside surface (IS) of the tube measured by EDS

As is apparent from Fig. 5 the average content of the alloying elements Cr and Mo as a function of distance from the surface of the inner pipe is approximately constant. There is no the outward diffusion of elements forming carbide, i.e. chromium and molybdenum, as it did in the case of steel tubes X11CrMo9-1 furnaces operated in the platformer CCR [19].
