The effect of long-term service at elevated temperatures on structure and mechanical properties of Cr-Mo-V steel

Design/methodology/approach: Examinations were conducted on 273 mm diameter, 32 mm wall thickness tube made of 13HMF (14MoV6-3) steel. The tube was a segment of stem pipeline used in power plant at 540°C. The service time is 168,000 hours. Microstructure of the material has been examined with the use of light optical microscopy and scanning electron microscopy (SEM). The energy dispersive X-ray spectrometry (EDS) analysis was used for phase chemical composition identification. Transmission electron microscopy (TEM) of thin foils was used for carbides structure identification. The mechanical properties of the tube material were evaluated in static tensile tests at room temperature, hardness tests and impact Charpy U tests.

Examinations were conducted on one segment of $\varnothing 237 \times 32.0$ mm fresh steam pipeline connecting the steam boiler with turbine. Tube was made of 13HMF according to PN-75/H-84024 (14MoV6-3 according to PN-EN10216-2) steel grade and was operated for approximately 168 000 hours at 540°C under 14 MPa pressure. The chemical composition of tes

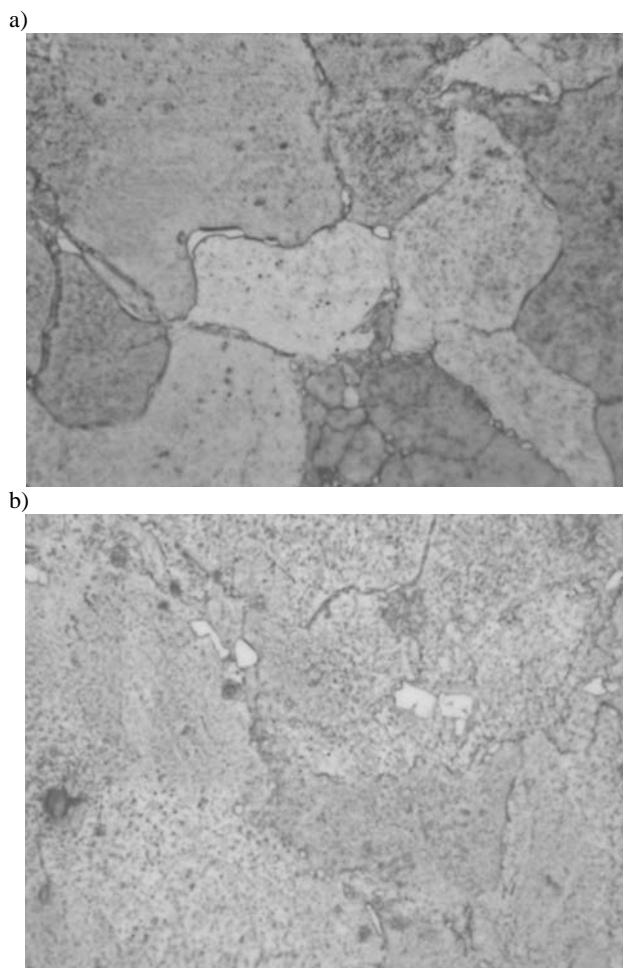
Fig. 1. Microstructure of 13HMF steel tube $\varnothing 273 \times 32$ mm, Magn. 1000x

The structure of the tube material has an advanced degree of degradation. On Fig. 1 it can be seen separate coagulated cementite particles and carbides at the grain boundaries of ferrite and bainite areas. Visible are large single precipitates and precipitates occurring in the form of strings deployed along the grain borders. Assessment of structure degradation according to the criteria [10] corresponds to the model of SIII. There were no decohesion changes in the tube steel microstructure.

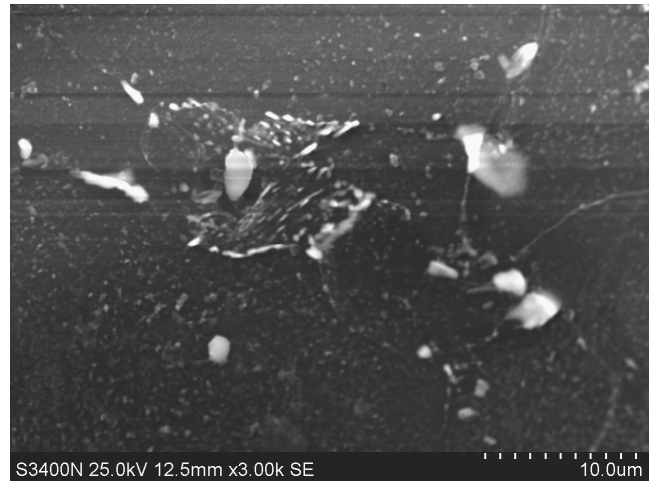
Fig. 4. Carbides morphology in 13HMF steel microstructure, tube $\varnothing 273 \times 32$ mm. Extraction replica, SEM, detector SE

Carbides morphology disclosed on a replica is shown in Figs. 3,4.

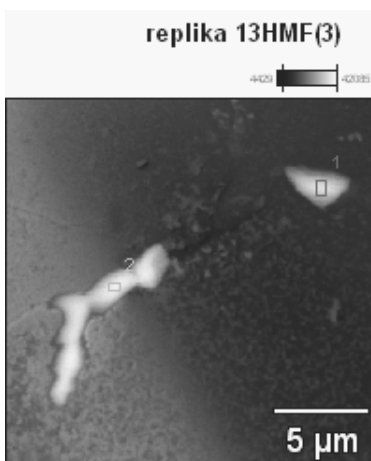
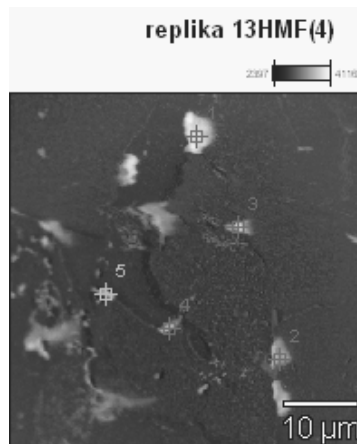
Fig. 5. EDS chemical microanalysis and morphology of carbides in 13HMF steel, tube $\varnothing 273 \times 32$ mm. Extraction replica, SEM, detector SE

Example results of chemical composition investigations of carbides are presented in Fig. 5. It was found that carbide content by weight is about: 14% Mo, 8% Mn, 7% Cr and 1% V. It should be noted that the EDS analysis of low volume carbide precipitates is a qualitative analysis and does not give the exact chemical composition of the phase only by informing the elements are present.

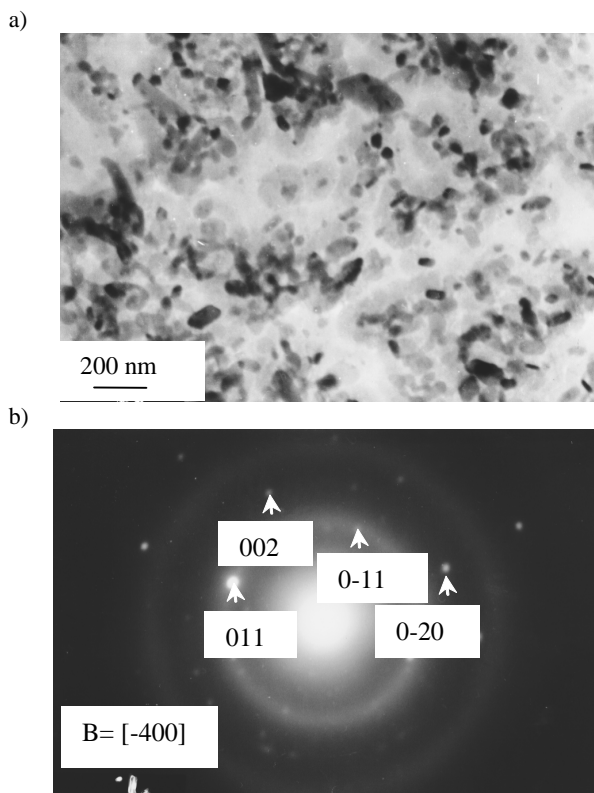
Fig. 5. a) Dispersed MC precipitates, TEM image b) Diffraction pattern of MC precipitates

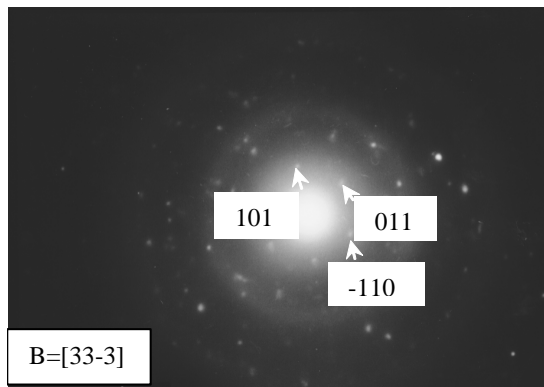
Fig. 8. Diffraction pattern of particle shown by arrow in Fig. 7, $M_{23}C_6$ precipitate

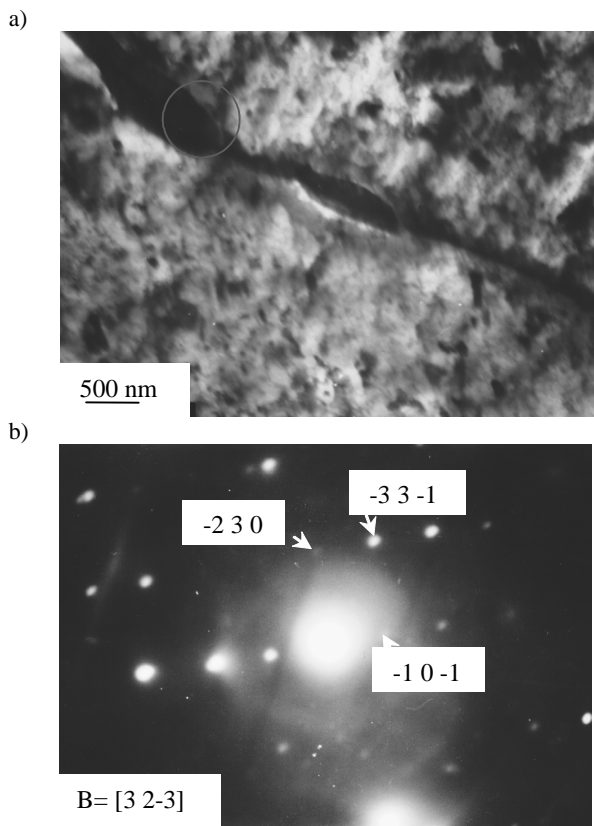
Fig. 9. a) Dispersed M_7C_3 precipitates, TEM image b) Diffraction pattern of M_7C_3 precipitates
