The effect of long-term service at elevated temperatures on structure and mechanical properties of Cr-Mo-V steel

Design/methodology/approach: Examinations were conducted on 273 mm diameter, 32 mm wall thickness tube made of 13HMF (14MoV6-3) steel. The tube was a segment of stem pipeline used in power plant at 540°C. The service time is 168,000 hours. Microstructure of the material has been examined with the use of light optical microscopy and scanning electron microscopy (SEM). The energy dispersive X-ray spectrometry (EDS) analysis was used for phase chemical composition identification. Transmission electron microscopy (TEM) of thin foils was used for carbides structure identification. The mechanical properties of the tube material were evaluated in static tensile tests at room temperature, hardness tests and impact Charpy U tests.

Examinations were conducted on one segment of $\varnothing 237 \times 32.0$ mm fresh steam pipeline connecting the steam boiler with turbine. Tube was made of 13HMF according to PN-75/H-84024 (14MoV6-3 according to PN-EN10216-2) steel grade and was operated for approximately 168 000 hours at 540°C under 14 MPa pressure. The chemical composition of tes

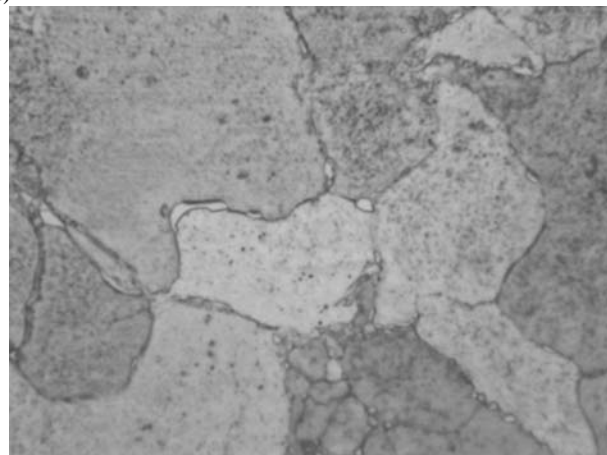
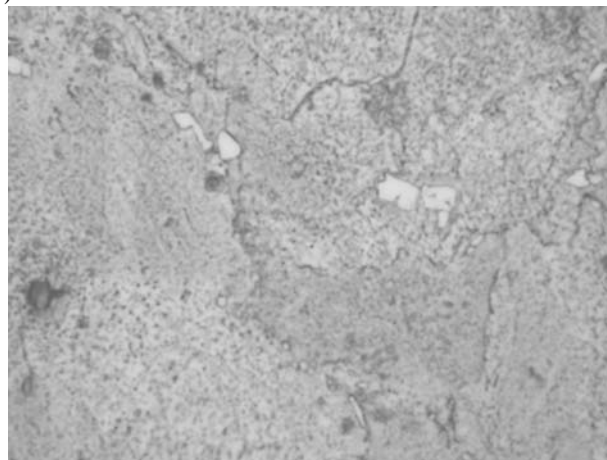
Fig. 1. Microstructure of 13HMF steel tube $\varnothing 273 \times 32$ mm, Magn. 1000x

The structure of the tube material has an advanced degree of degradation. On Fig. 1 it can be seen separate coagulated cementite particles and carbides at the grain boundaries of ferrite and bainite areas. Visible are large single precipitates and precipitates occurring in the form of strings deployed along the grain borders. Assessment of structure degradation according to the criteria [10] corresponds to the model of SIII. There were no decohesion changes in the tube steel microstructure.

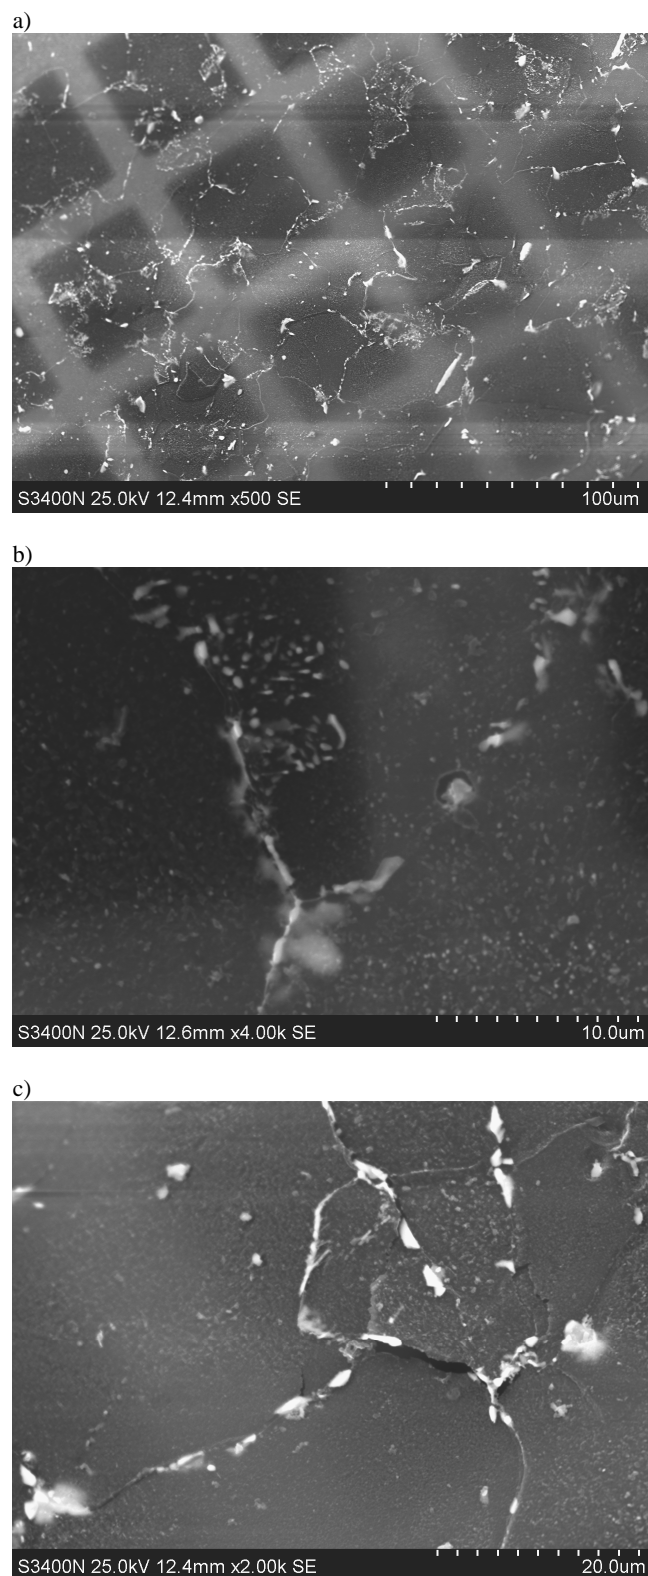
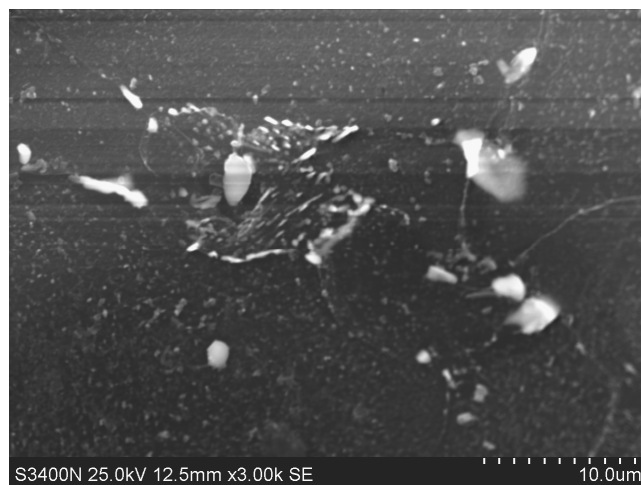
Fig. 3. Carbides morphology in 13HMF steel, tube $\varnothing 273 \times 32$ mm. Extraction replica, SEM, detector SE

Fig. 4. Carbides morphology in 13HMF steel microstructure, tube $\varnothing 273 \times 32$ mm. Extraction replica, SEM, detector SE

Carbides morphology disclosed on a replica is shown in Figs. 3,4.

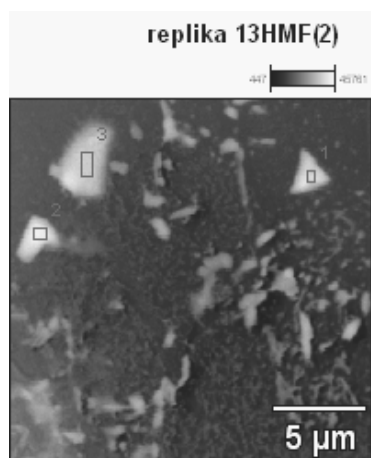
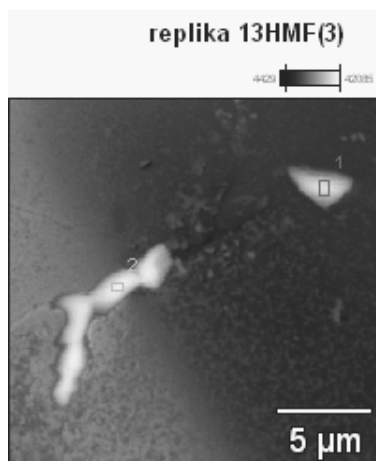
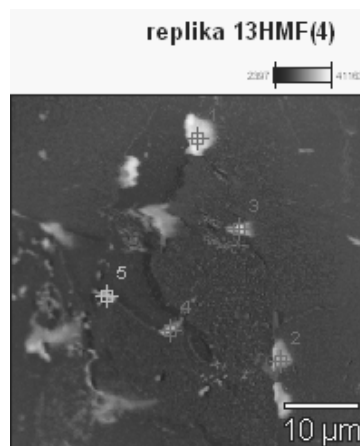
Fig. 5. EDS chemical microanalysis and morphology of carbides in 13HMF steel, tube $\varnothing 273 \times 32$ mm. Extraction replica, SEM, detector SE

Example results of chemical composition investigations of carbides are presented in Fig. 5. It was found that carbide content by weight is about: 14% Mo, 8% Mn, 7% Cr and 1% V. It should be noted that the EDS analysis of low volume carbide precipitates is a qualitative analysis and does not give the exact chemical composition of the phase only by informing the elements are present.

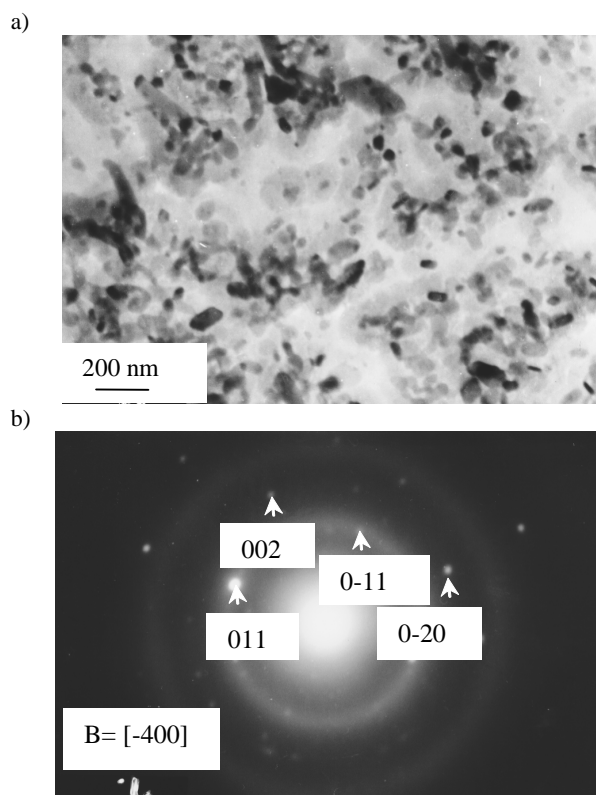
Fig. 5. a) Dispersed MC precipitates, TEM image b) Diffraction pattern of MC precipitates

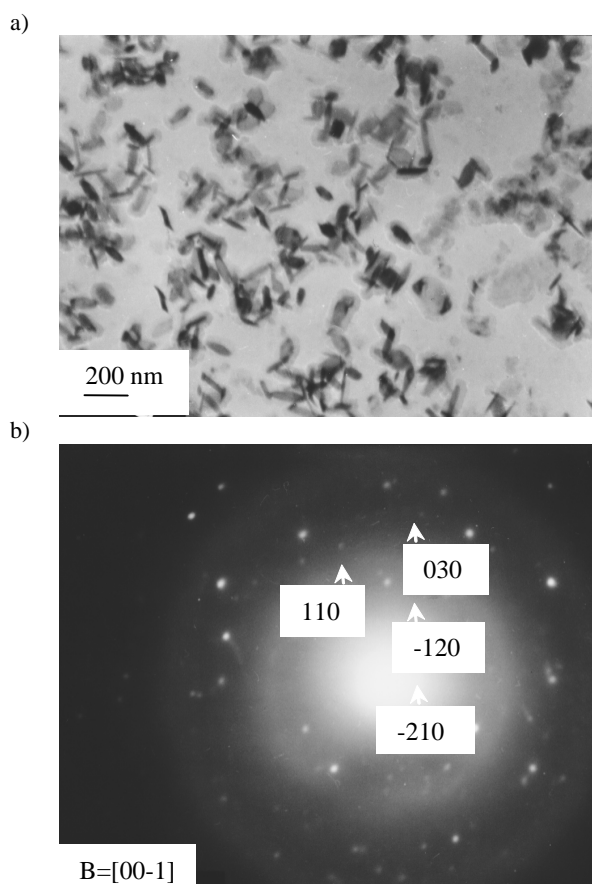
Fig. 6. a) Dispersed M_2C precipitates, TEM image b) Diffraction pattern of M_2C precipitates

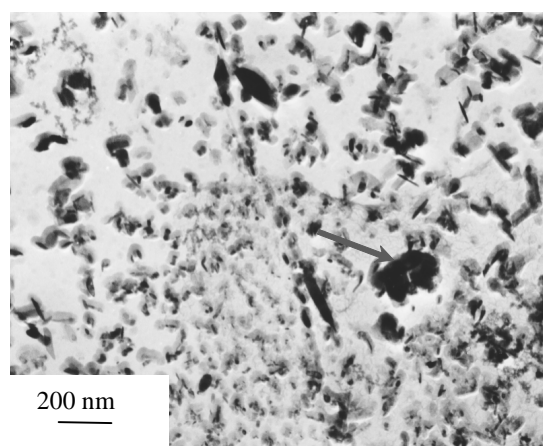
Fig. 7. The diverse morphology of the precipitates. Arrow marked the precipitation where the diffraction was performed

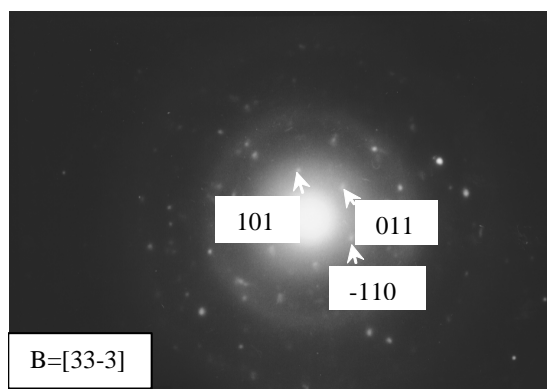
Fig. 8. Diffraction pattern of particle shown by arrow in Fig. 7, $M_{23}C_6$ precipitate

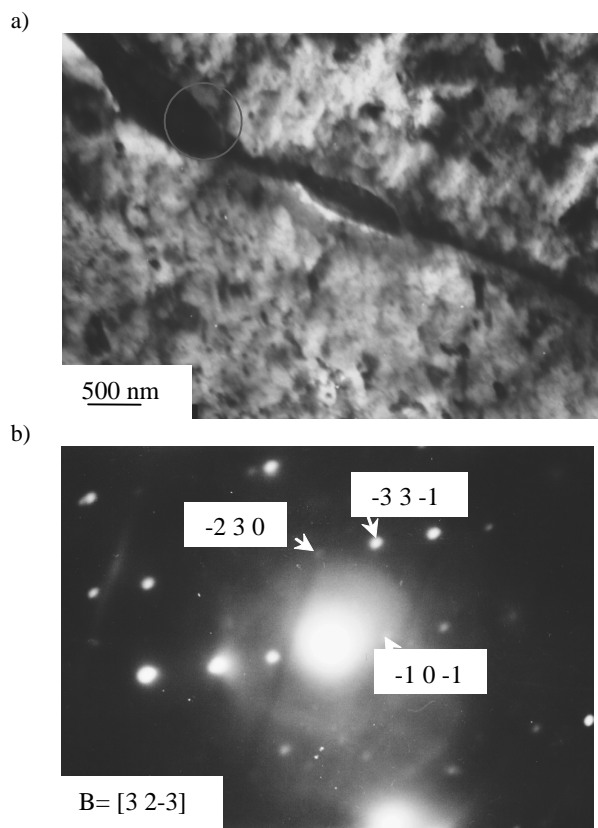
Fig. 9. a) Dispersed M_7C_3 precipitates, TEM image b) Diffraction pattern of M_7C_3 precipitates
