The Impact of Material Selection on Durability of Exhaust Valve Faces of a Ship Engine – A Case Study

Hanna Smoleńska¹, Włodzimierz Kończewicz², Sylwia Bazychowska^{2*}

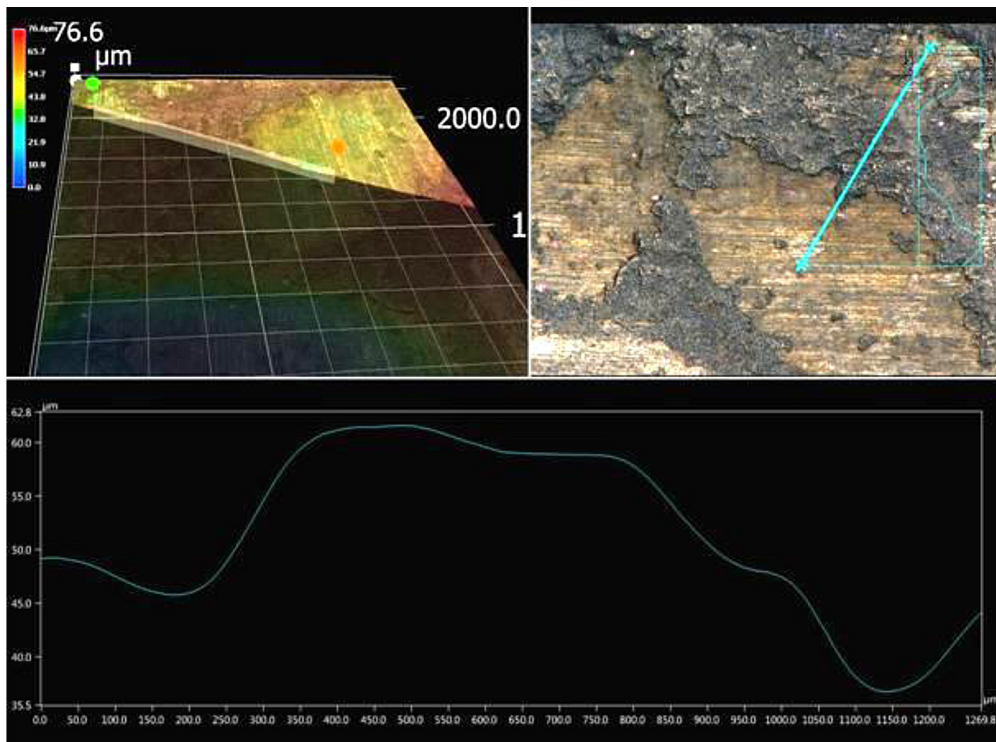
Fig. 6. Surface profile of L12 valve face after operation –visible regions of existing scale. Analyse made by laser profiler KEYENCE

surface of the outlet valve face has been slightly degraded. Keyence equipment was used for surface analysis. This equipment is a microscope coupled with a profilograph and allows measure the surface profile of targets in X and Z directions. The height, width or gap on a surface profile can be measured. Observation of the face surface showed the presence of crumbling scale and areas of the exposed metal surface. In

Figure 6 a multilayer scale with a tendency to crack and delaminate is visible. However, the largest layer thickness did not exceed 60 μm. SEM analysis of the valve face marked L12 showed the slight plastic deformation of the surface was observed, which can be interpreted as the effects of plastic deformation during work, this is illustrated in Figure 7.

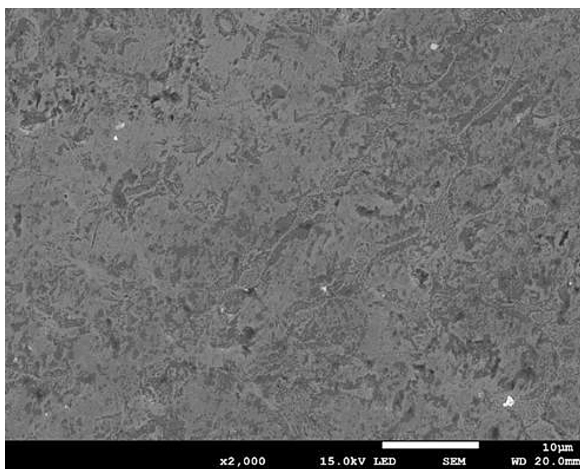
Fig. 7. L12 valve face after operation – plastic deformation

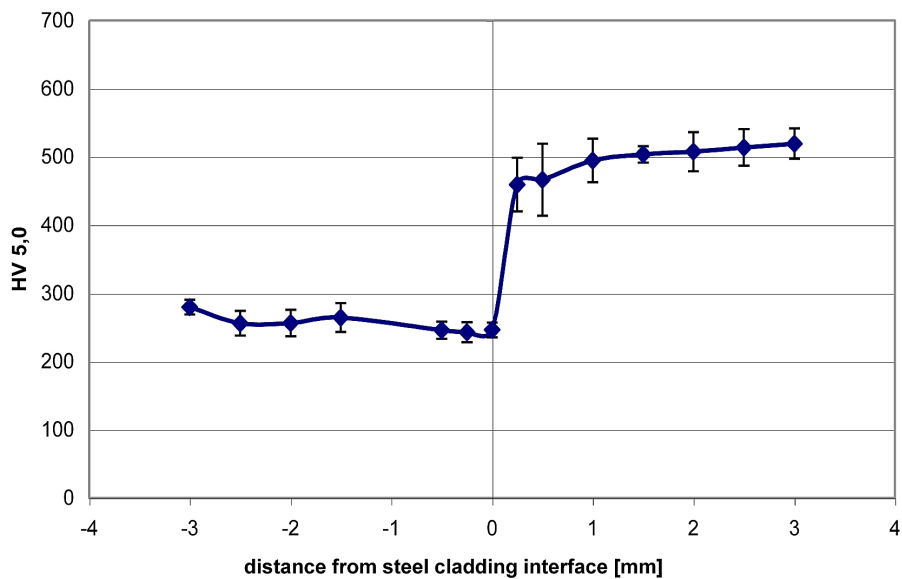
Fig. 10. Statistical analysis of the hardness measurements for the L12 valve after 3000 hours of operation

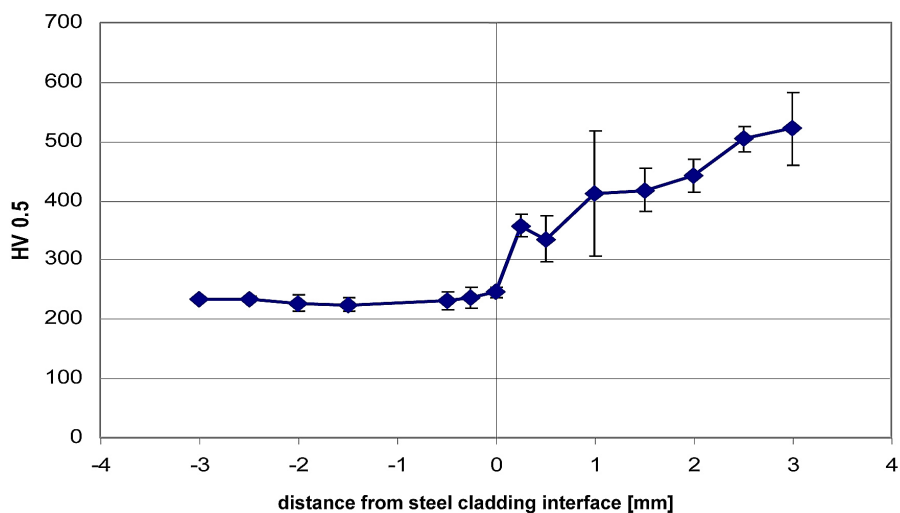
Fig. 11. Statistical analysis of the hardness measurements for N valve after 2000 hours of operation

found in the range 480 to 581 HV5.0 at distance 3mm from the steel-clad interface (close to clad top surface) – similar to L12, but in the deep of the clad hardness decreases up to 195-447 HV5.0. In means large changes in hardness on the cross-section. In both cases no significant decrease in hardness was observed close to the top surface, which indicates that despite the formation of the oxide layer, no degradation of the material will occur.

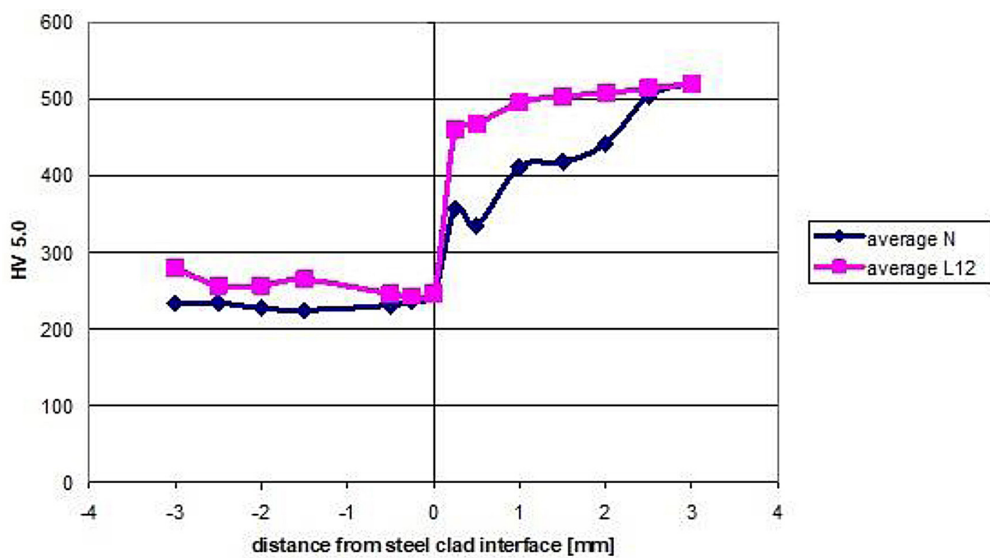
Fig. 12. Comparison of average values of hardness of the N and L12 faces claddings

3. Hardness measurements showed stable hardness of the L12 surfacing weld, higher than the hardness of the substrate. While a constant decrease in the hardness of the N-weld surfacing across the thickness is observed which could affect its durability.
