Typology, current state and non-destructive testing of timber roof trusses of historic churches in the West Vistula Delta, Poland

Tomasz Zybała^{1*}, Monika Zielińska¹, Magdalena Rucka^{2,3}, Jarosław Przewłócki¹ and Karol Grębowski¹

Abstract

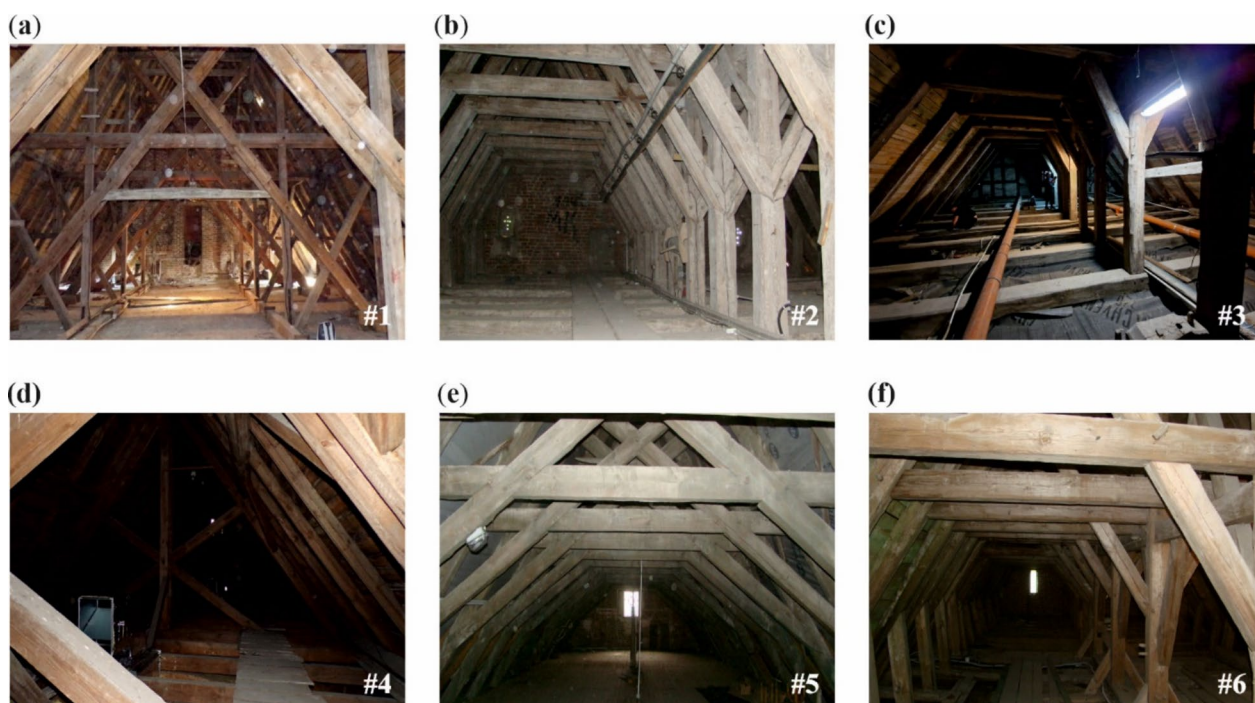
Fig. 5 Roof trusses in: **a** Miłobądz (#1), **b** Pruszcz Gdański I (#2), **c** Kieźmark (#3), **d** Pruszcz Gdański II (#4), **e** Kozłiny (#5), **f** Trutnowy (#6)

The analysis shows that the most common type of roof truss in the historic churches located in Żuławy is the king post truss (Figs. 4, 5b, c, f). In church #5 (Fig. 5e) there is a collar beam truss with struts, in church #4

(Fig. 5d) there is a scissor truss. In the church #1 (Fig. 5a) there is an attic truss shaped similar to that of the previous structure, that one from before the war damage.

(Fig. 2). The state of conservation of the trusses is good, the roofing is waterproof and the gravity ventilation of the attics is intact (Table 1). Only the roof trusses built before the twentieth century (churches #2, #3, #5, #6) have carpentry marks (Fig. 7).

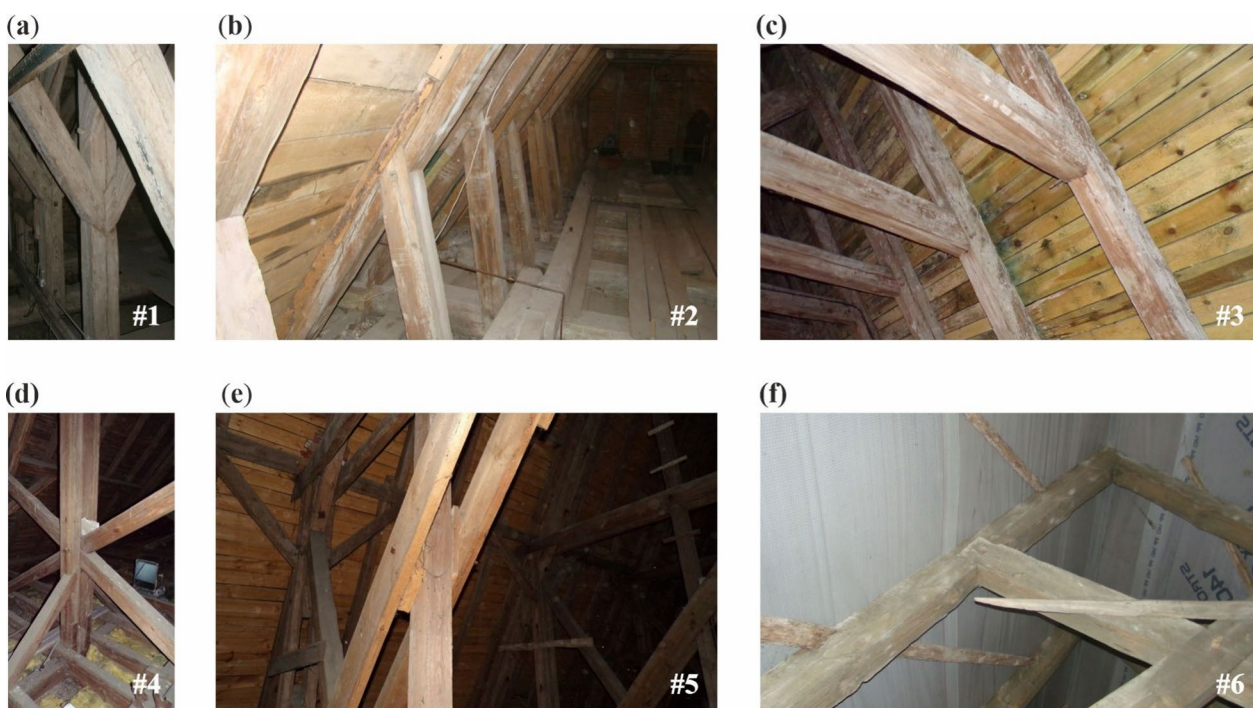
Fig. 6 Carpentry joints in church roof trusses: **a** Mitobądz (#1), **b** Pruszcz Gdański I (#2), **c** Kiezmark (#3), **d** Pruszcz Gdański II (#4), **e** Koźliny (#5), **f** Trutnowy (#6)

The rafters in the ridge of churches #2, 3, 5, 6 are connected with a bridle joint (Fig. 6f). The connections of rafters with collar beams are more varied. In churches #3 and #5 they are the same: mortise and tenon (Fig. 6c), in church #6 it is the dovetail log. The king post with struts is connected with a dovetail log (Fig. 6a) in church #2. The rafters and angle ties are connected with a lap joint in church #6 (Fig. 6b). In the roof trusses constructed in the twentieth century (churches #1 and #4), the carpentry joints are pinned and bolted (Fig. 6d, e) (Tables 1 and 2).

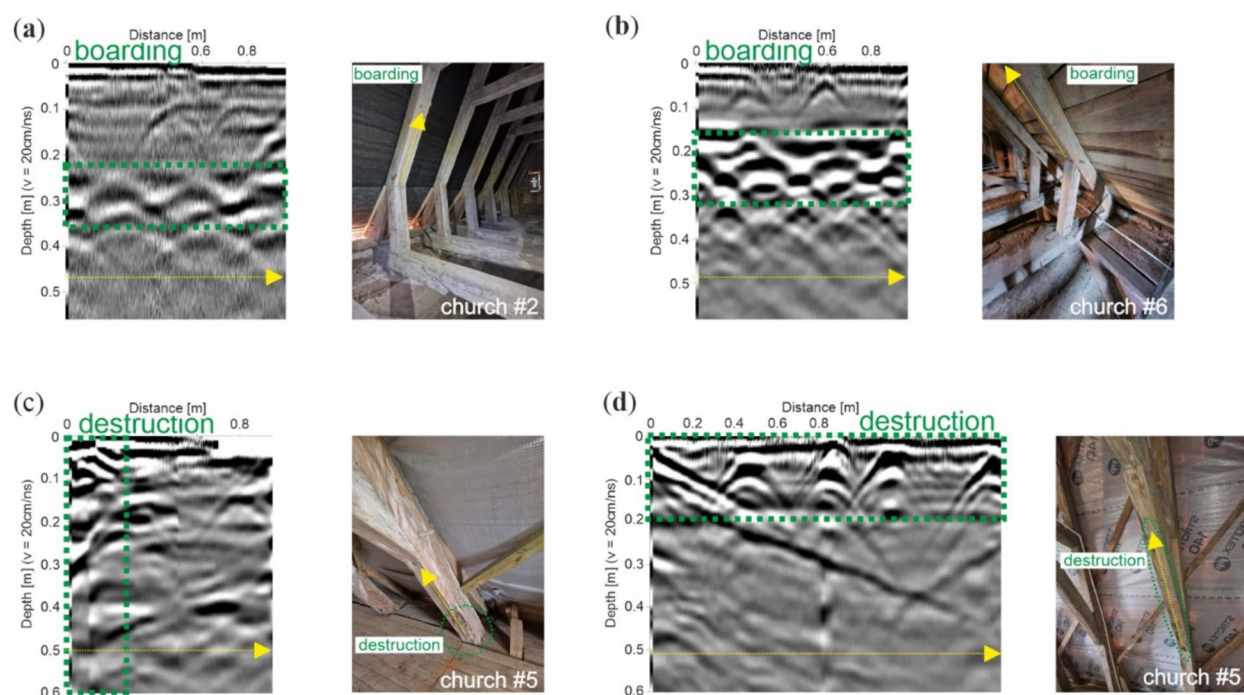
Fig. 9 GPR radagrams locating carpentry joints for electric cables in timber beams: **a**) Milobadz (#1); **b**) Koźliny (#5); **c**) Pruszcz Gdański I (#2); **d**) Koźliny (#5)

The reflections from the boarding are also characteristic and they form a sequence of evenly spaced hyperbolas on the radargrams, indicating the locations of board joints (Fig. 10a, b). Damage to timber elements causes disturbances in GPR radargrams. Figure 10c shows a local failure on the lower part of the beam. The beam shown in Fig. 10d is completely and shallowly damaged, causing numerous reflections. Figure 11 shows beams from three different girders from the churches in Trutnowy, Pruszcz Gdański I, Kiezmark, and Koźliny, respectively which show varying degrees of destruction. The scans prepared for undamaged beams can be considered as reference. The reflections from the bottom of these beams are visible here, which allows the thickness of the element to be assessed. The scans prepared for the damaged beams indicate a significant disturbance in the propagation of electromagnetic waves. This demonstrates high sensitivity of the GPR method to any defect in a timber element. The reference scan is not always feasible, but it makes the interpretation of the results much easier.

- Damage and air voids in the timber beams affected the path of electromagnetic waves in the wood, causing severe distortions.
- Comparing the results for several beams made of the same material, being the same age, shape, dimensions and location allowed for a more accurate analysis of the technical condition of the tested beams. With the undamaged reference element, it was possible to

accurately assess the location of decay in the damaged beams.
