ASSESSMENT OF EVAPORATOR TUBES CORROSION IN LOW-EMISSION STEAM BOILERS

Degradation examinations of outer surface of low-emission steam boiler evaporator tubes are presented in the paper. Metallographic evaluation of scale morphology, its micro sites chemical composition analysis and distribution of elements on cross sections have been performed. Water-wall tubes were exposed in steam boiler for up to two years period. Common tubes made of 16Mo3 steel suffered sulfide and molten salts corrosions. Thermal sprayed tubes with the single layer of 70%Ni 30%Cr alloy show better corrosion resistance, but become also susceptible to sulfide corrosion due to presence of internal voids and cracks. Double layer Al₂O₃/Ni-30Cr coatings withstand corrosion attack for more than one year operation, then failed due to internal heterogeneity and cracks generation.

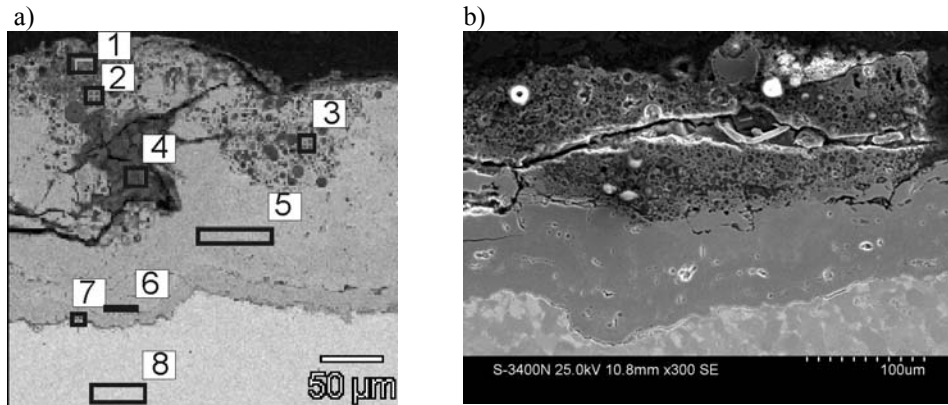
Fig. 3. Cross section of $\varnothing 57 \times 5.0$ mm evaporator tube after one year exploitation; a) places for chemical analysis (EDS), b) general view

Table 1. Chemical analysis at the points indicated in Fig. 3a (wt.%)

Na	Mg	Al	Si	S	K	Ca	Fe
pt1		0.63	20.88	28.86		1.95	0.84	46.06
pt2		2.16	23.27	35.04		4.68		33.77
pt3	1.20	0.44	20.11	24.65	7.88	1.88		43.84
pt4	2.24		1.88	32.16	2.79			60.93
pt5					14.55			85.45
pt6					21.76			77.61
pt7				0.56	4.68			94.76
pt8				0.43				98.91
