**J. Hucińska, G. Gajowiec**

Gdansk University of Technology, Mechanical Engineering Faculty, Gdansk, Poland

## **ASSESSMENT OF FITNESS FOR SERVICE OF Cr-Mo STEEL TUBES IN CATALYTIC REFORMING CHARGE HEATERS**

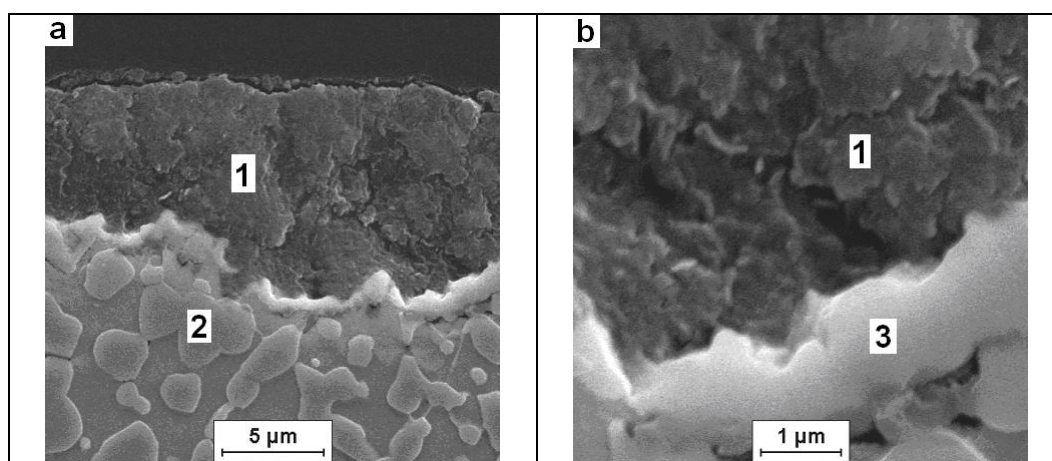
Fig. 1(a) presents a SEM micrograph of the cross section of 2.25Cr-1Mo steel sample close to the IS of the tube. The surface is rough and covered with dark compact corrosion products (1). Beneath the surface, big spheroidal and elongated carbide particles (2), uniformly distributed in the metal matrix are present. Some of the particles are linked together. Just at the surface, the carbides are so closely distributed that they form a thin not uniform layer (3). The layer reaches a thickness of about 2  $\mu\text{m}$  and is ruptured in some places. At higher magnification of Fig. 1(b) some discontinuities between the layer and the underlying material can clearly be seen. It is possible to conclude that metal losses seem likely to form by separation of fragments of the subsurface layer from the substrate. The SEM/EDS analyses have revealed that the carbides within the layer and in the underlying material contain about 2-4 wt.% of chromium, 1-2 wt.% of molybdenum and 0-4 wt.% of silicon. The rest is iron. Some results of the examinations and the errors are shown in Fig. 2(a), (b).

Fig. 1(a), (b). Micrographs of the cross-section of 2.25Cr-1Mo steel tube wall close to the IS: 1 – corrosion products, 2 – big carbides in the metal matrix, 3 – a carbide layer at the surface

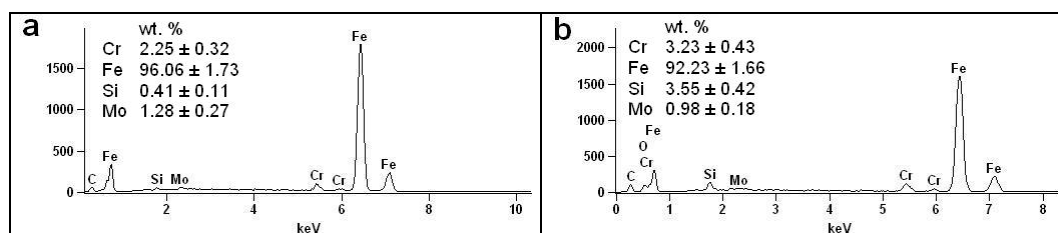
Fig. 2(a), (b). Results of SEM/EDS analyses of carbides in 2.25Cr-1Mo steel: (a) at point 2 indicated in Fig. 1(a), (b) at point 3 in Fig. 1(b)

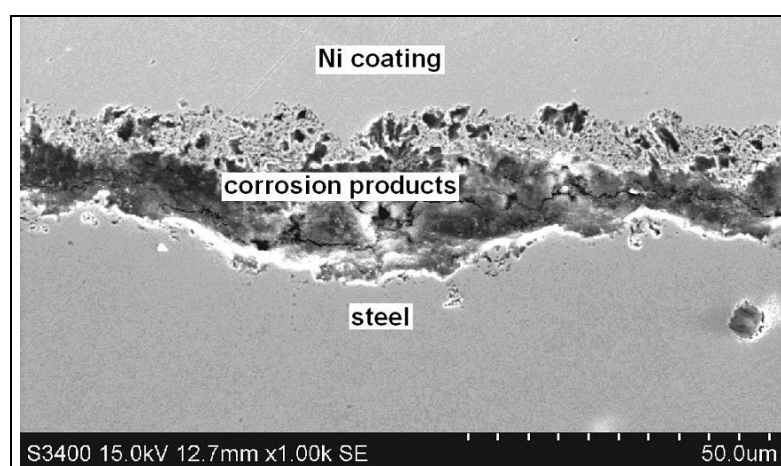
In Fig. 3 a SEM micrograph of the cross section of 9Cr-1Mo steel sample close to the IS of the tube is shown. It can be noted that the steel surface is rough, covered with fragile

and porous corrosion products, and many fine pits and fissures develop in the subsurface zone of the steel.

**Fig. 3.** Corrosion products on the IS of 9Cr-1Mo steel tube and a porous steel zone beneath the surface

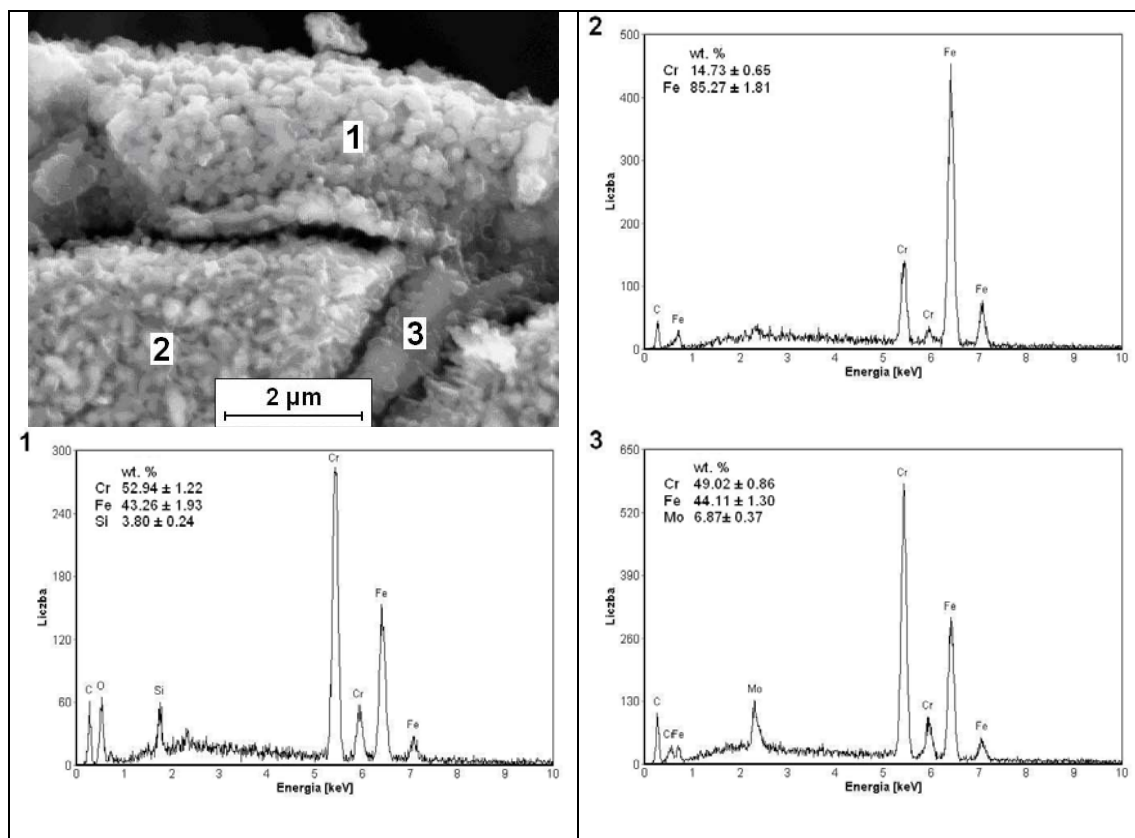
Detailed SEM examinations have revealed a complex microstructure of the subsurface steel zone. According to a micrograph in Fig. 4(a), a thin layer of about 2  $\mu\text{m}$  in thickness composed of fine precipitates (1) exists just beneath the surface. There is about 50-55 wt.% of chromium and 0-4 wt.% of silicon in the layer on the average. The rest is iron. The layer is followed by a not-coherent zone containing big degraded primary carbides (2), i.e. the carbides that were present in the steel before service and underwent some unavoidable transformations. The carbides are situated in a 'matrix' composed of fine globular carbides (3), instead of alloy ferrite. The amount of the alloy elements, i.e. chromium and molybdenum in the precipitates is differentiated. Bigger primary carbides contain about 20-25 wt.% of chromium and 2-4 wt.% of molybdenum. The fine carbides which form the 'matrix' contain less of the alloy elements than the bigger primary carbides. However, the concentration of chromium and molybdenum in the 'matrix' is higher than in the alloy ferrite before service: about 14-18 wt. % and 1-3 wt.% in comparison with about 9 and 1 wt.%. Some results of the analyses are shown in Fig. 4(b). Because of the material porosity and small dimensions of the precipitates, the results refer to groups of the particles and have a comparative meaning.

**Fig. 4.** A micrograph of the cross-section of 9Cr-1Mo steel tube wall close to the IS and results of SEM/EDS analyses: 1 – a layer of fine carbides at the steel surface, 2 – a 'matrix' composed of fine carbides, 3 – degraded primary carbide

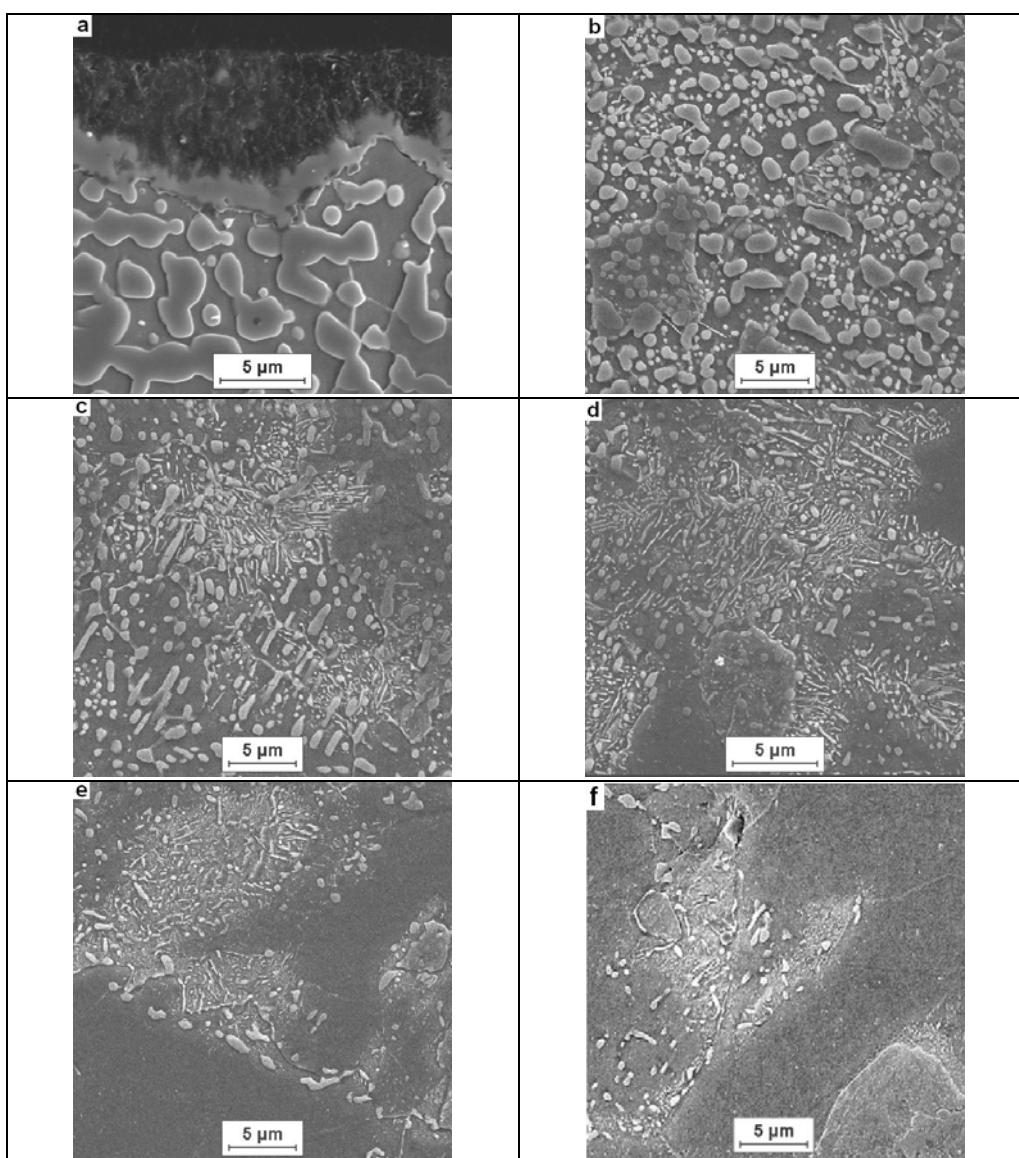
Figs. 5(a) through (f) illustrate the microstructure across 2.25Cr-1Mo steel tube wall, starting from the IS and down to the middle-wall situated at a depth of 3 mm. It can be seen that the morphology of carbides on the section is diversified: Fig. 5(a) indicates that beneath the IS, big spheroidal and elongated particles of diameter/length up to about 5 μm prevail. The particles are quite uniformly distributed in the metal matrix covering about 50 % of the area. Much smaller particles are present at a distance of 150 μm from the IS in Fig. 5(b). However, they also cover about 50 % of the area and their distribution in the matrix is rather uniform. Some thin, plate-like particles can also be noted. As illustrated in Figs. 5(c) through (e), the fraction of the carbides gradually decreases towards the middle-wall, the distribution of the particles in the matrix becomes not uniform, the carbides become smaller, and the fraction of the plate-like precipitates increases. In the middle-wall, fine carbides of not uniform distribution in the matrix dominate, Fig. 5(f).

**Fig. 5(a)-(f).** Micrographs of the cross-section of 2.25Cr-1Mo steel tube wall: (a) the IS, (b)-(f) 150  $\mu\text{m}$ , 500  $\mu\text{m}$ , 750  $\mu\text{m}$ , 1 mm, 3 mm from the IS

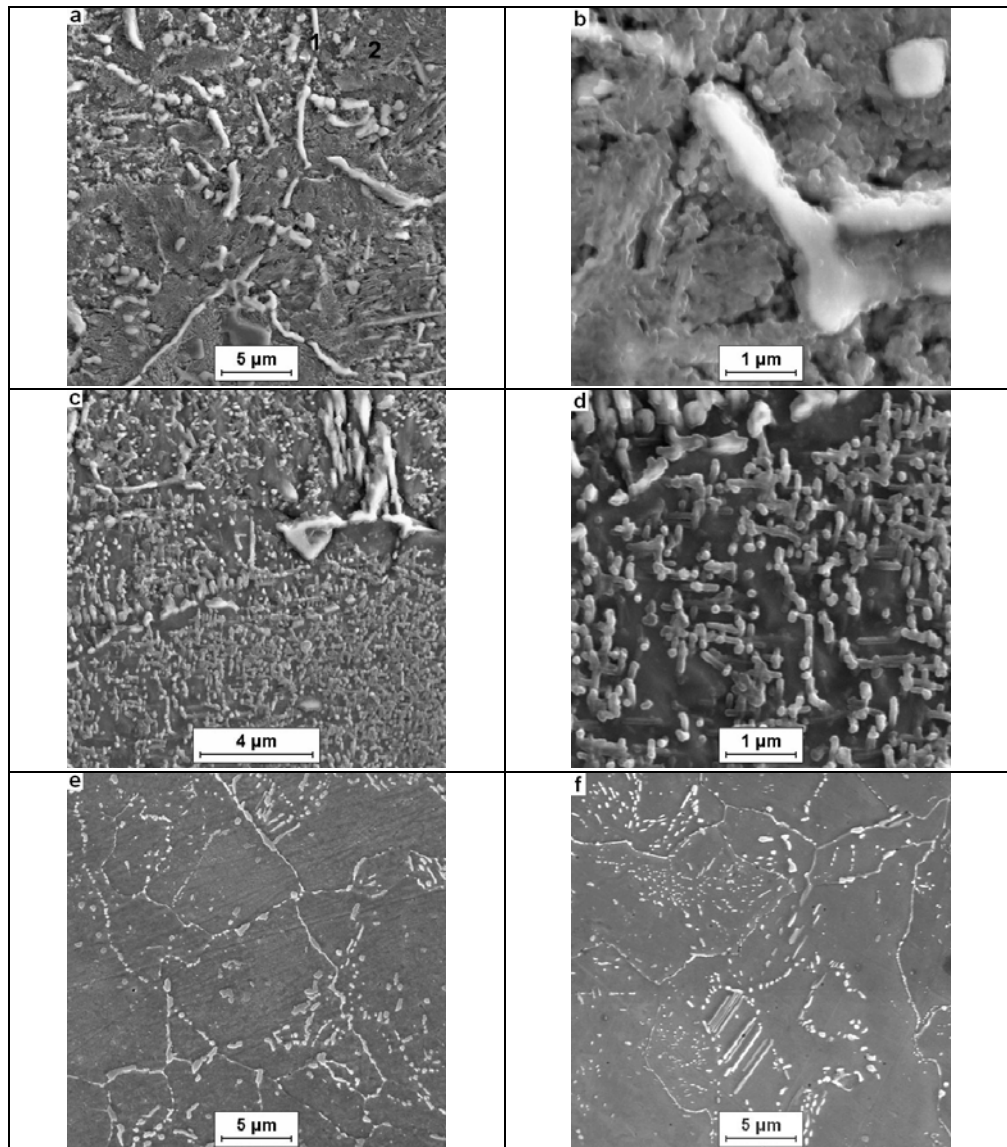
The microstructure features across 9Cr-1Mo steel tube wall are presented in Figs. 6(a) through (f). Like the zone situated close to the IS, which is shown in Fig. 4, the material situated at about 50  $\mu\text{m}$  from the surface is composed of big degraded primary carbides surrounded by a 'matrix' comprising carbide precipitates instead of alloy ferrite. The microstructure of this zone is shown in Fig. 6(a), (b). According to a micrograph in Fig. 6(c), (d), some areas of the ferrite matrix with a dense network of fine carbides may be seen at about 200  $\mu\text{m}$  from the surface. At a depth of 700  $\mu\text{m}$ , the ferrite grains and fine carbides mainly occurring at grain boundaries are illustrated in Fig. 6(e). The microstructure in this area is the same as the microstructure of the middle-wall material situated at a depth of 3 mm, Fig. 6(f).

**Fig. 6 (a)-(f).** Micrographs of the cross-section of 9Cr-1Mo steel tube wall. Distances from the IS: (a),(b) 50  $\mu\text{m}$ , (c),(d) 200  $\mu\text{m}$ , (e) 700  $\mu\text{m}$ , (f) 3 mm

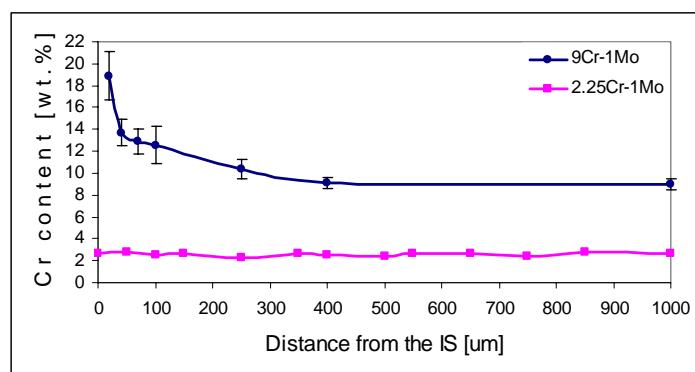
It is shown in Fig. 7 that chromium content beneath the surface of 9Cr-1Mo steel is higher than in the middle-wall, where about 9 wt.% Cr is noted. A maximum concentration of about 19 wt.% is reached at a distance of about 20  $\mu\text{m}$  from the steel surface. In 2.25Cr-1Mo steel tube however, the chromium content across the wall section is uniform. Because of low concentration of molybdenum in the steels, the profiles of this element are not presented. Of course, some enrichment of the subsurface areas of 9Cr-1Mo steel was recorded up to about 2 wt.%.

Fig. 7. Profiles of chromium from SEM/EDS analyses in areas of 10 μm x 100 μm
