# Assessment of Technical Conditions in Adapting a Historic Warehouse's Space Functionality

The aim of the paper is to present the results of the analysis of the technical condition of a historic Warehouse building located in the former shipyard area in connection with the planned construction in the place of the existing location of the production hall warehouse building.

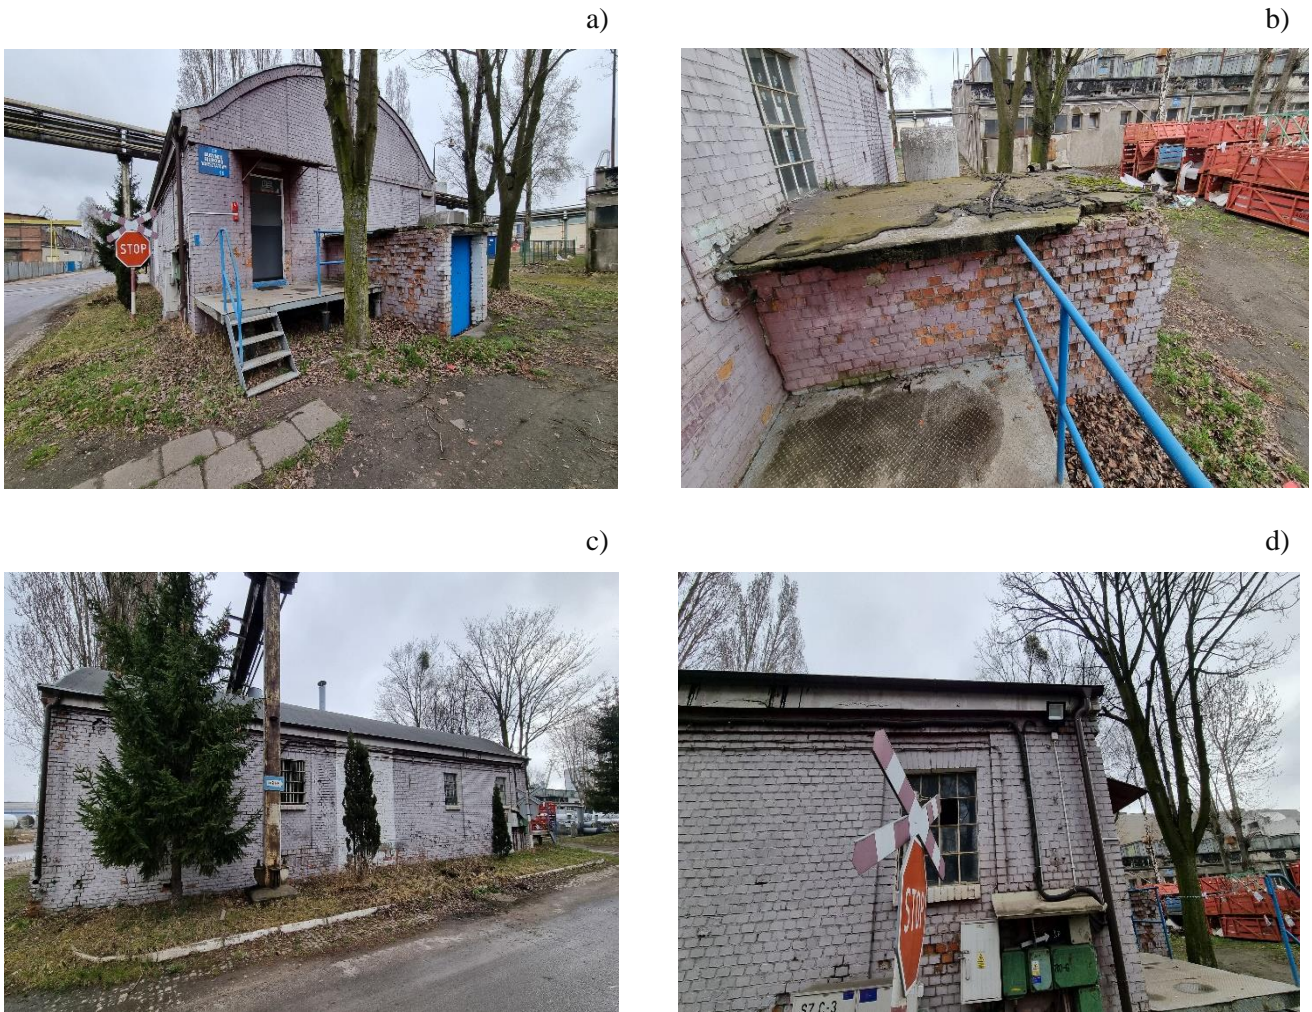
**Photo 2.** Warehouse building - elevations: a), b) south-eastern, c), d) south-west

Adjacent to the gable wall of the building on the south-eastern façade was an extension made of solid ceramic bricks, 25 cm thick, in which there were gates (entrance doors) to the rooms in the basement level (Photo 2a, b). The walls of the extension, especially under the covering slab, had very extensive mechanical damage, numerous chips and cracks. The level of the top of the annex roof was at the level of the top of the window strip of window openings in the gable wall of the Warehouse building. In the gable wall, the entrance to the Warehouse building led through a steel ramp.

In the view from the south-west façade, the external wall is made of solid ceramic bricks, 25 cm and 38 cm thick, with local thickenings, every ~400 cm, to the interior of the building, resulting from the structure of the covering. The wall was not plastered, like the other facades of the building (Photo 2c, d). There were scratches visible on the wall surface, especially above the bricked-up window arches at the basement level (Photo 2c). Locally, mechanical damage was visible on the wall surface - chipping and missing bricks, weathered joints, some of the joints were empty.

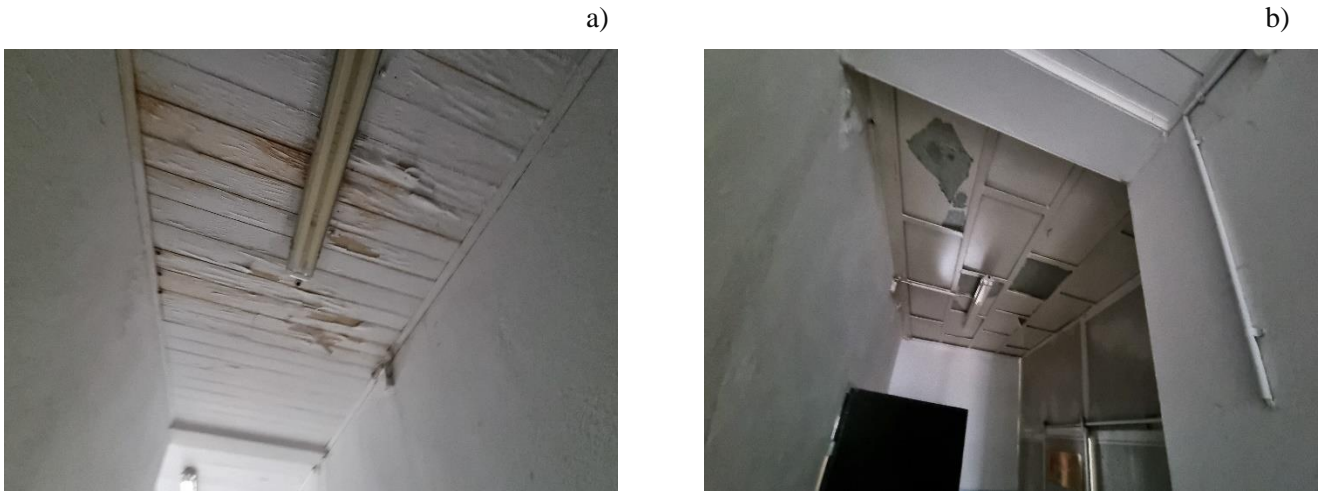
**Photo 4.** Warehouse building - covering the communication corridor on the ground floor:  
a) wooden ceiling lining, b) reinforced glass in steel frames

The rooms on the ground floor were also unused, as was the case with the basement floors. In most cases, the rooms were empty and there were no visible signs of moisture on the external walls. Wire and pipe installations were mostly dismantled, and the hygiene and sanitary rooms were inoperable. In the southern part of the building, the ceiling consisted of a wooden soffit mounted to the structural elements of the covering (Photo 4a), in the central part, at the ceiling level, there was a reinforced glass covering (Photo 4b), while in the northern part the finishing was made of plasterboards.

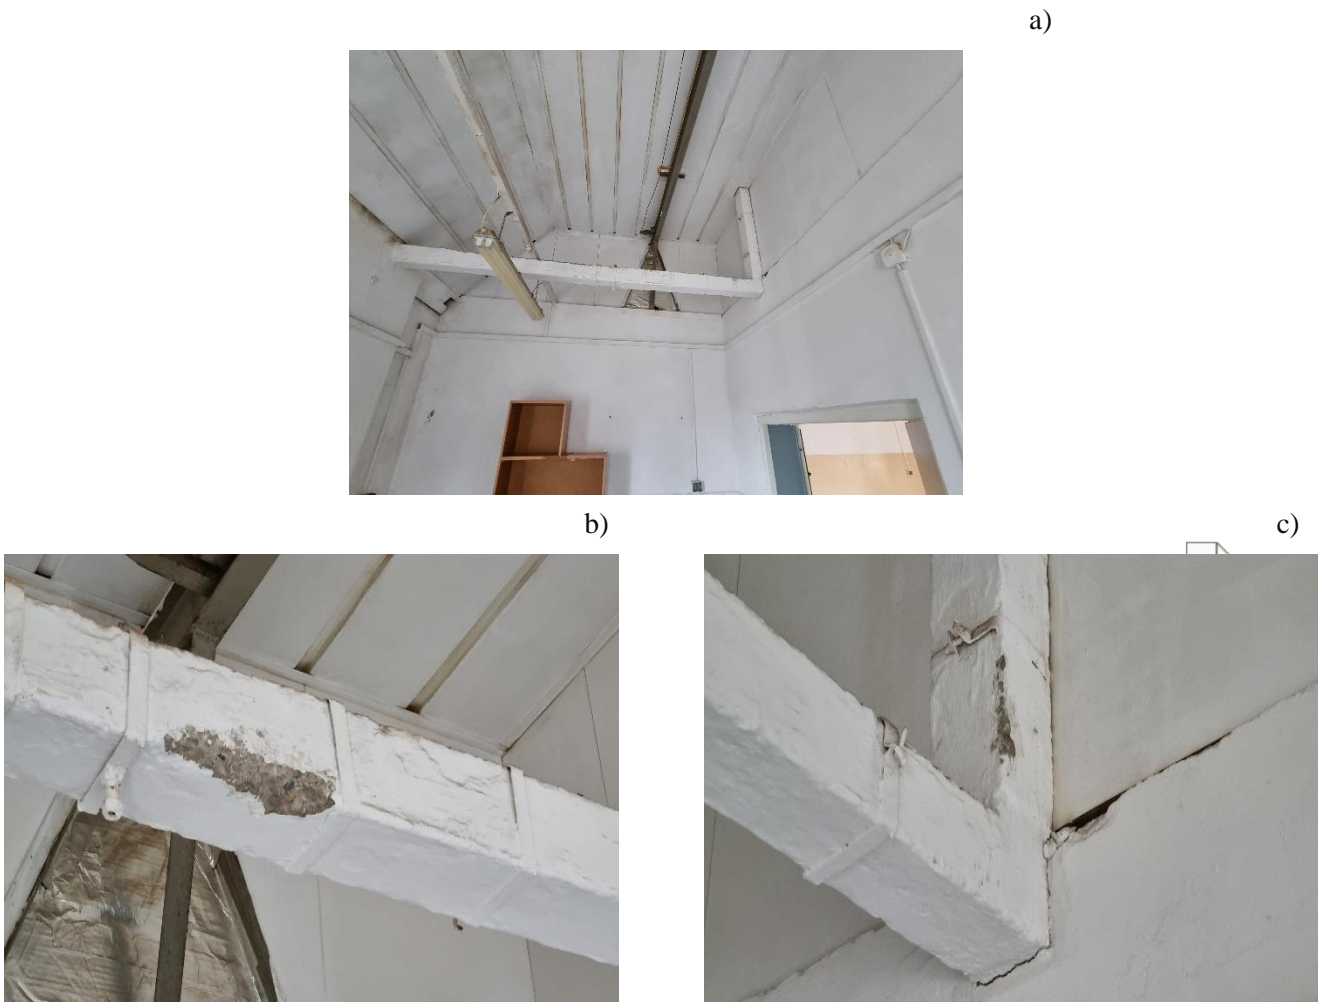
**Photo 5.** Warehouse building - reinforced concrete tie in the view from the rooms on the ground floor:  
a) general view, close-up: b) horizontal element - horizontal tie, c) vertical element - post

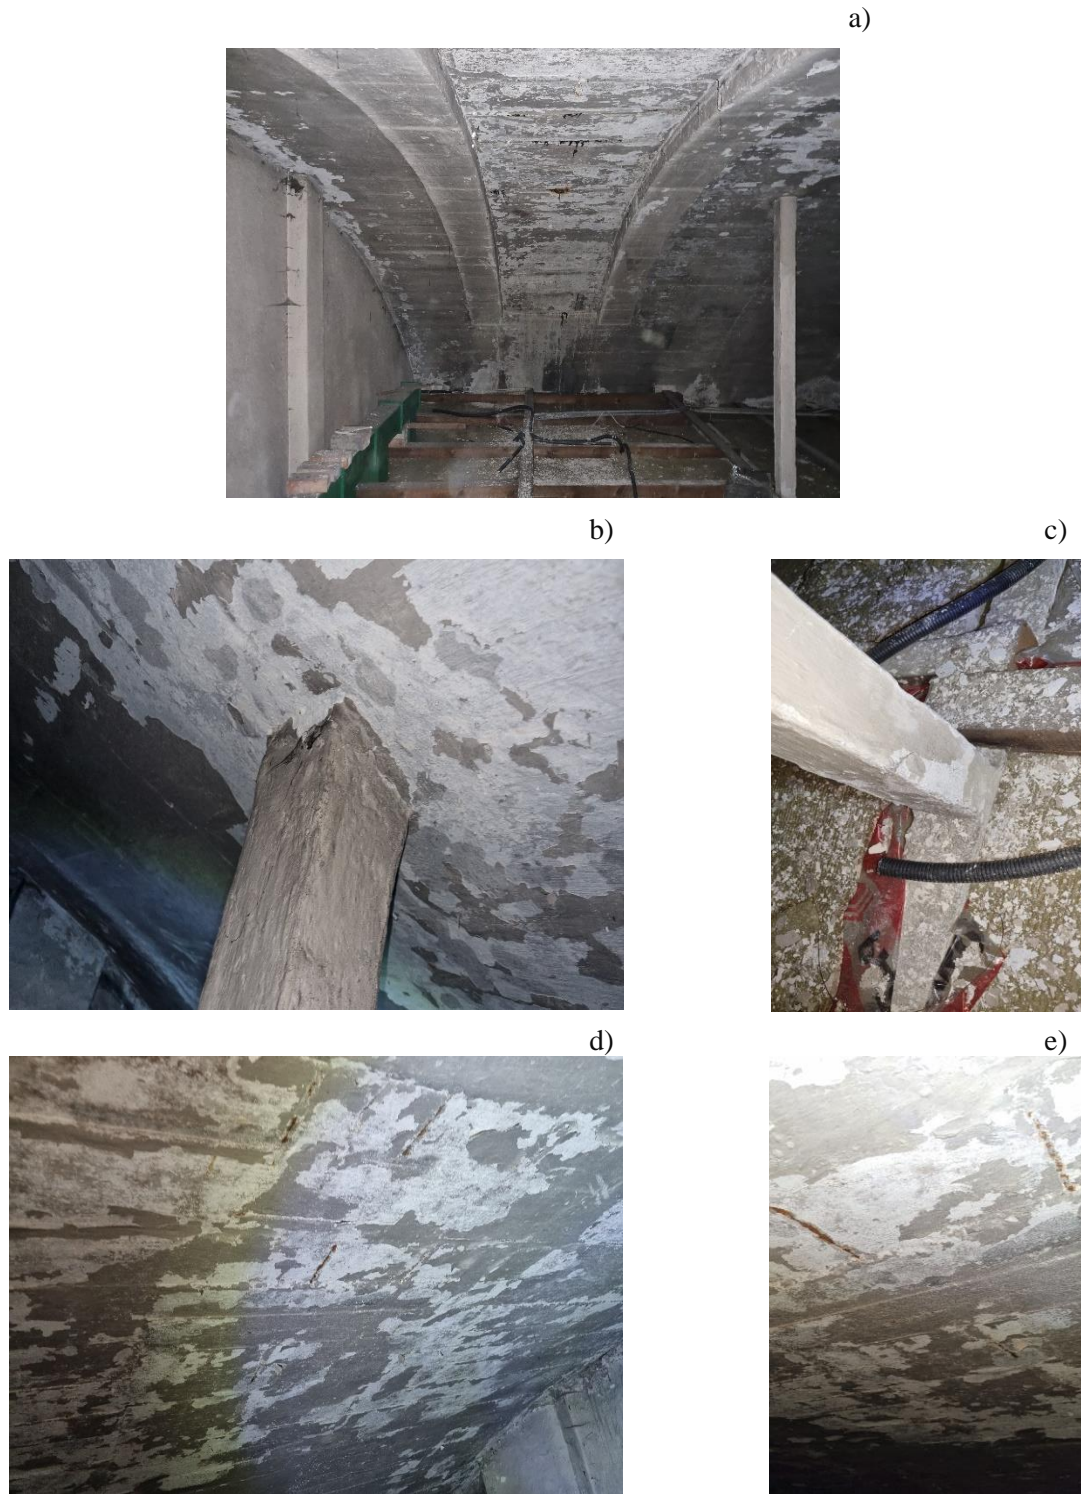
**Photo 6.** Warehouse building - attic space: a) stiffening ribs below the curvilinear covering slab, connection: b) post - curvilinear covering slab, c) post - horizontal tie, d), e) damage to the concrete cover of the reinforcing bars of the curvilinear covering slab

During the inspection, only part of the attic was possible (Photo 6a). The view from the bottom of the slab arch showed traces of moisture, the concrete cover was falling off locally, and corrosion of the reinforcing bars was visible (Photo 6a, d, e). The spacing of the reinforcing bars was on average 30 cm. There were no visible signs of damage where the posts were connected to the slab arch (Photo 6b), similarly to the case where the posts were connected to the tie (Photo 6c).

The curved surface of the arch, viewed from the bottom, showed traces of the reinforcing bar cover falling off, which was caused by swelling corrosion of the reinforcement resulting from the moisture of the concrete element.

There was no visible damage in the places of installation (suspension) of the reinforced concrete posts to the bottom of the slab arch surface - no detachment of the posts from the roof surface was observed. The connections of the posts with the tie rods were also undamaged - there were no visible scratches. During the inspection, no buckling of either the posts or the tie rods was found. In the place where the slab arch rests on the longitudinal walls, in the view from the bottom of the covering, no damage in the form of cracks or scratches was identified.

A completely technically and economically justified solution, and at the same time recommended from a technical and economic point of view, was the demolition of the existing roofing constructed as a slab arch with ties and the possible subsequent use of fragments of the original elements, in accordance with detailed conservation recommendations.

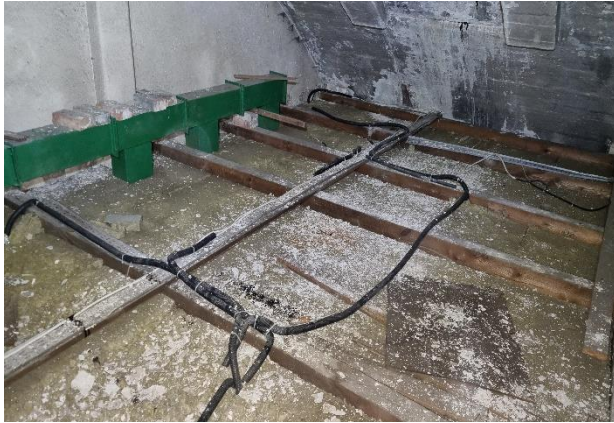
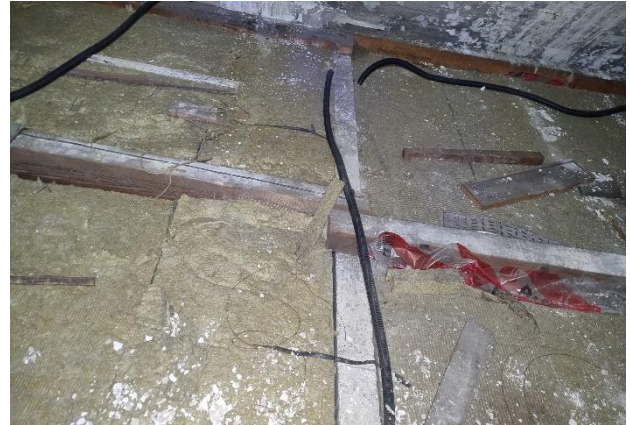
**Photo 7.** Warehouse building - attic space: a) arrangement of wooden ceiling beams of the covering structure above the ground floor, b) supporting wooden ceiling beams on a horizontal tie
