# Assessment of Wooden Beams from Historical Buildings Using Ultrasonic Transmission Tomography

The main goal of this study was non-destructive evaluation of wooden elements using ultrasonic waves. The inspection was carried out on wooden beams from a historical object. Elastic wave signals were processed by ultrasonic transmission tomography to obtain imaging of the internal structure of tested elements without disturbing their state and integrity. The focus was on the influence of wood anisotropy on the propagation of ultrasonic waves. A novel method of determining the position of the cross-section pith was proposed. The study presented that the proposed imaging approach was capable to assess the technical condition of historic wooden beams by determining the degree of wood damage and the location of discontinuities, scratches or fibrosis in the tested cross-section.

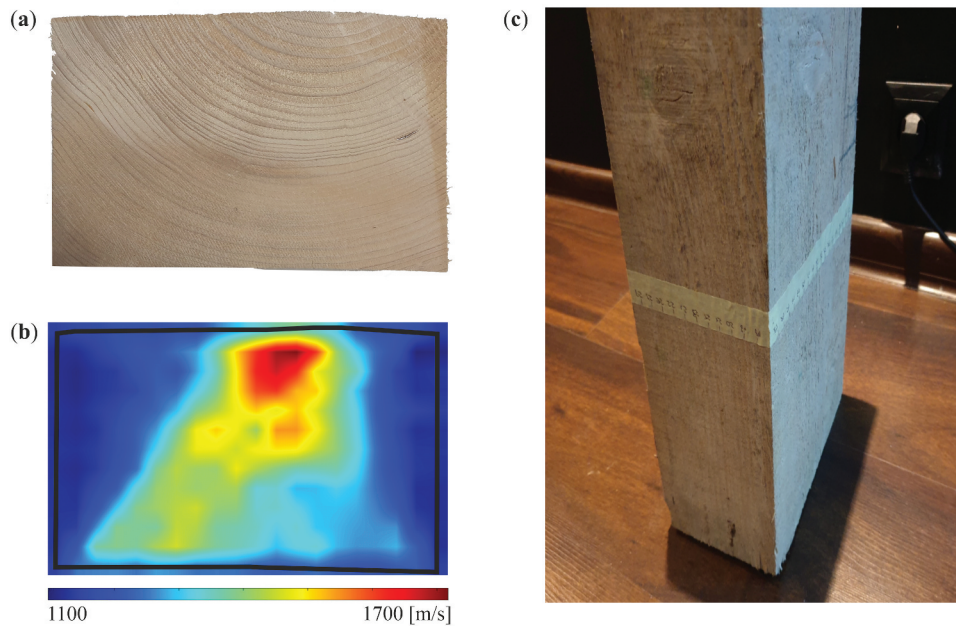
The first laboratory model (#1) was a new pine beam. The edges of this beam were straight and the beam did not have any significant damages or cracks. **Figure 8** shows the resulting tomography velocity map for beam #1 together with the photograph of its cross-section. Significantly higher values of wave velocity were observed in the upper part of the image. This area indicates that the pith can be located near the upper edge of the cross-section or even outside of it. The measured values of the wave velocity for beam # 1 ranged from 929.7 m/s to 1637.0 m/s, thus the difference

between the lowest and the highest velocity was 707.3 m/s. The average value of the velocity for this beam was 1231.5 m/s. The variability of measurements along different paths was determined were: SD equal to 154.2 m/s and CV equal to 12.5%.

**Figure 8.** Results obtained for beam #1: (a) top view of the beam, (a) ultrasonic tomography image, (c) side view of the beam.

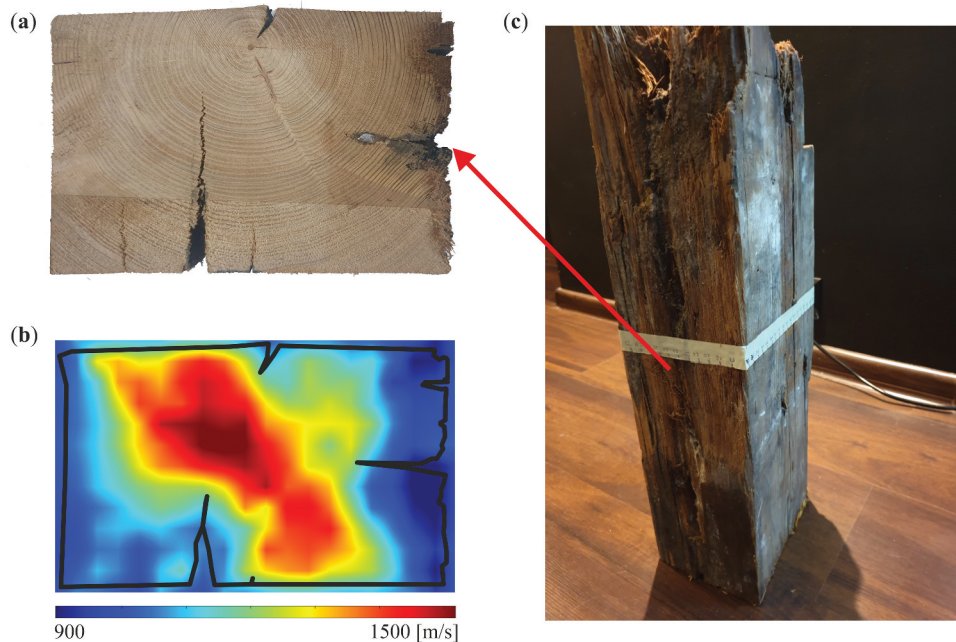
Beam #2 was taken from the historical roof framework. One of its sides included major wood fibrosis (see **Figure 9a**). The remaining three contained cracks. The ultrasonic tomography image clearly indicates the places where the beam is damaged (**Figure 9b**). The edge with the wood fibrosis showed the reduced wave transfer velocity. A similar effect was observed in the places where the cracks were located. Furthermore, an increased velocity may be spotted at the location of the pith, similar to the reference beam (#1). The wave propagation velocity varied between 632.7 m/s and 1442.3 m/s. The difference between the minimum and maximum velocity was, therefore, greater than in the reference beam (#1) and equal to 809.6 m/s. The average velocity of wave propagation was 1093.3 m/s, the standard deviation was 137 m/s. Both of these values are smaller than in the undamaged beam. The coefficient of variation was equal to 12.5% and it was at the same value as for reference beam #1. However, it should be noted that the pith of the undamaged beam is outside the cross-section, while in beam #2, the pith is within the tested cross-section.

**Figure 9.** Results obtained for beam #2: (a) top view of the beam, (a) ultrasonic tomography image, (c) side view of the beam.

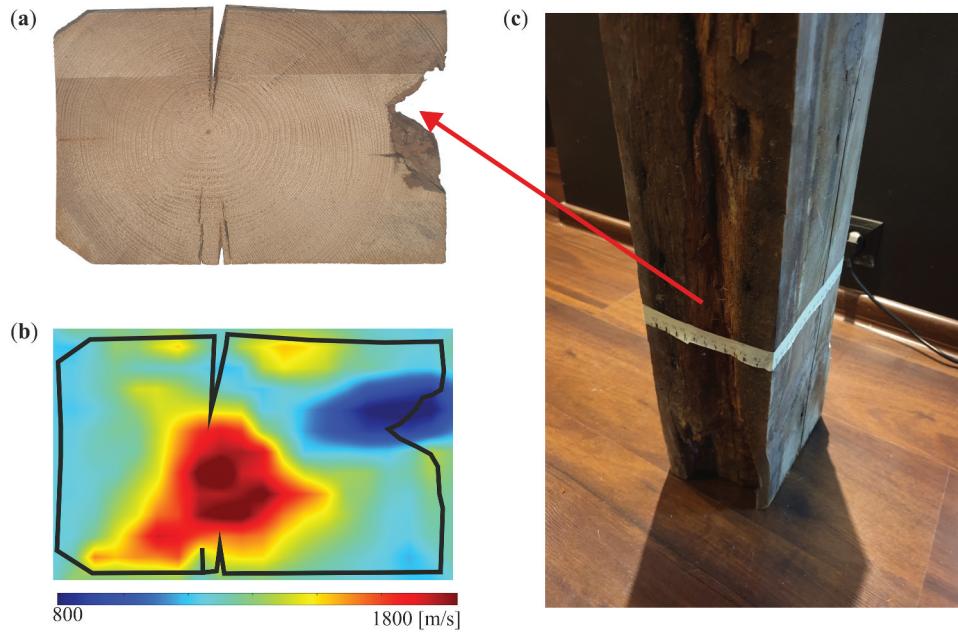
Beam #3 had the highest level of degradation. One of the sides included a significant cavity caused by insects (**Figure 10a**). This place is marked in blue on the ultrasonic tomography map (**Figure 10b**). The remaining sides included cracks. The biggest crack is marked on the tomographic image. Similarly to beams #1 and #2 the greatest concentration of the wave propagation velocity determined the location of the pith. The

propagation velocity of ultrasonic waves was between 478.6 m/s and 2262.3 m/s. The difference between the minimum and maximum velocity was the largest compared to the other two beams. It was twice as high as in the reference beam. The average velocity was 1462.3 m/s. The standard deviation (SD) was 293.4 m/s, while the coefficient of variation (CV) is 20.1%. Such a high value indicates significant damage to the beam.

Figure 10. Results obtained for beam #3: (a) top view of the beam, (a) ultrasonic tomography image, (c) side view of the beam.

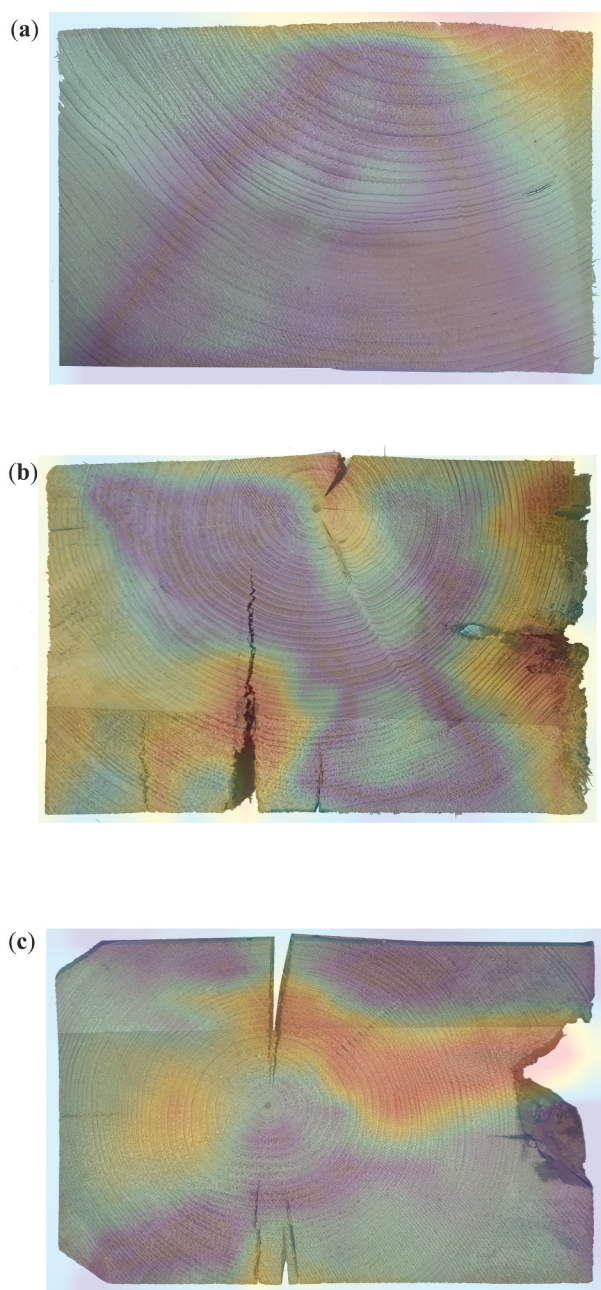
propagation velocity due to discontinuities, voids, scratches or fibrosis are visible on these maps. The final ultrasound tomography maps with a visible beam cross-section are shown in Figure 14.

**Figure 14.** Final ultrasonic tomography maps imposed on cross-sections of tested beams.
