Bunker demolition located in a conservation protection zone in the light of technical, national defense, functional-utility and economic conditions

Maciej NIEDOSTATKIEWICZ^{*1}, Tomasz MAJEWSKI²

¹ Department of Engineering Structures, Faculty of Civil and Environmental Engineering, Gdańsk University of Technology, Gdańsk, Poland

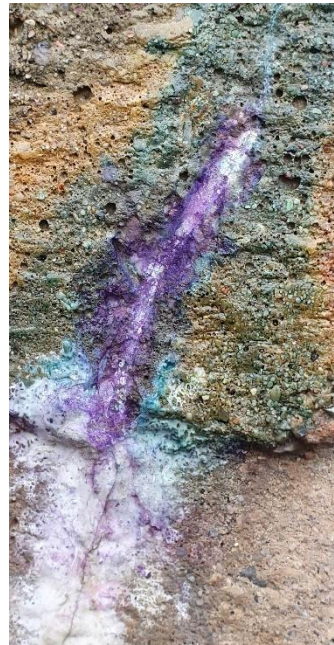
On the walls of Bunker, based on chemical tests, high carbonation of concrete, i.e. low pH value (~ 10 pH) was found (Photo 4). This means that the concrete cover has lost its natural ability to protect the reinforcement against corrosion, which results in the acceleration of the destruction of the concrete structure on the one hand, and on the other hand, it means that the process of corrosion of the reinforcement bars is active and progressing, which was confirmed by brown-rust tarnish on the concrete surface. Photo 5 shows the study of the degree of concrete carbonation on the external wall in the place of a wet crack.

Photo 5: Discoloration of concrete after the Rainbow Test on the concrete surface, in the place of a crack on the wall of the right annex - test site after the test: a) view, b), c) close-up: green-violet coloration indicates advanced carbonation of concrete and its reduced ability to protect the reinforcement, the orange color indicates advanced carbonation of the exposed concrete surfaces, washing out of calcium carbonates is visible in the area of cracked concrete fragments
