Case study of masts damage of the sail training vessel POGORIA.

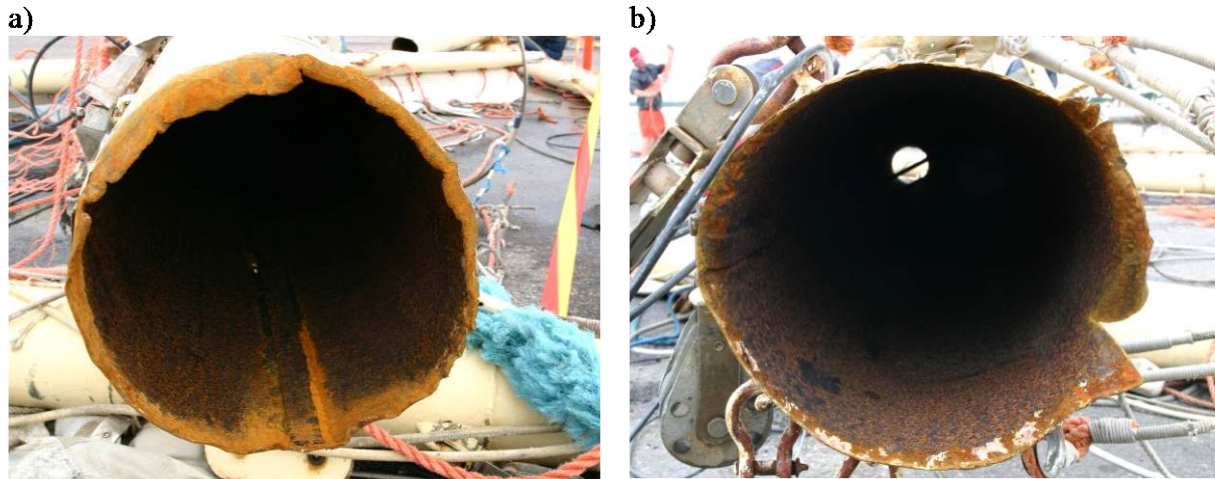
Fig. 4. Examples of the clear sharpness at the bottom parts of the broken tubes: a) foremast; b) mainmast.

Undoubtedly, the synergic cooperation both **the design and technological factors** caused to acceleration of the skin material corrosion of Pogoria masts (Fig. 6b). Such phenomenon has been proved by analysis carried out directly after the accident. It allowed us to unambiguously affirm that all mast fractures had the clear wedge sharpness at their bottom parts (Fig. 4) and the characteristic stratification at their upper parts (Fig. 5).

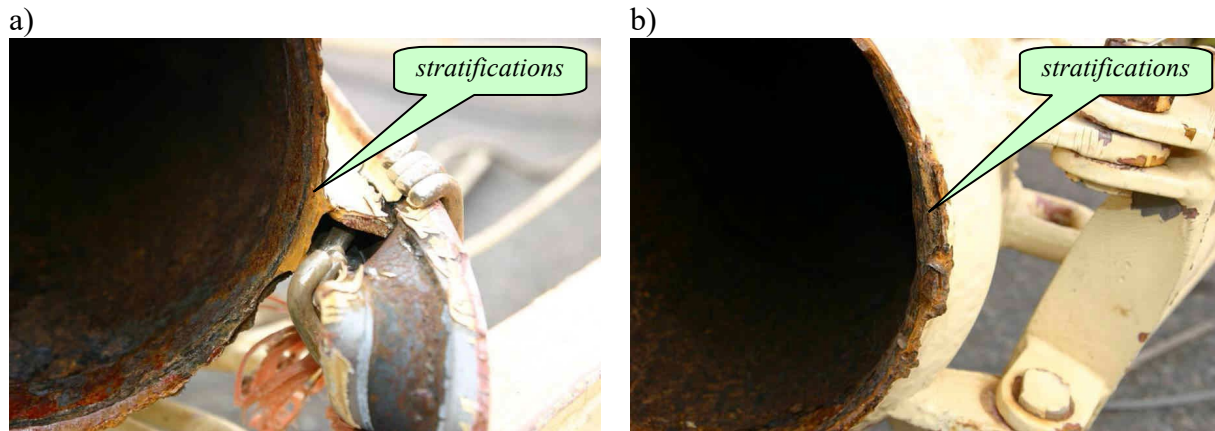
Fig. 5. Examples of the characteristic stratifications at the upper parts of the broken tubes: a) foremast; b) mainmast.

In our opinion, due to both the high transverse strain and the mast skin poor ductility in the through-thickness direction such situations occurred in welded joints of Pogoria masts because the surface of the fracture was fibrous and 'woody' with long parallel sections (Fig. 5). The orientation of the tears in butt welds of Pogoria masts are presented in Figure 6a.
