## Cast Iron Staircase in Aleksandrów Kujawski (Poland) - History, Construction, Architectural Form

Michał Kwasek<sup>a,\*</sup>, Aleksander Piwek<sup>a</sup>

The text presents historic cast iron staircase, which is situated inside the railway station building in Aleksandrów Kujawski. Since the moment of creation in the 19<sup>th</sup> century for a long time that station, located at the border of Prussia and Kingdom of Poland, was an important transit point. Nowadays it is situated in the central of Poland. The staircase was built in 1870's as a result of an extension of the railway station building which happened because of the planned visit of the tsar of Russia. Due to that reason stairs have extremely prestigious design. It consists of repeatable elements casted in iron. This has provided easy mounting and interesting, rare artistic form. The staircase in Aleksandrów Kujawski was broadly analysed. Modular, openwork, prefabricated structure is presented. Photographs, architectural stocktaking drawings and 3D models reveal that unique object, which combines functionality and high aesthetic qualities. Stratigraphy examination of paint coats shows, that the stairs were renovated

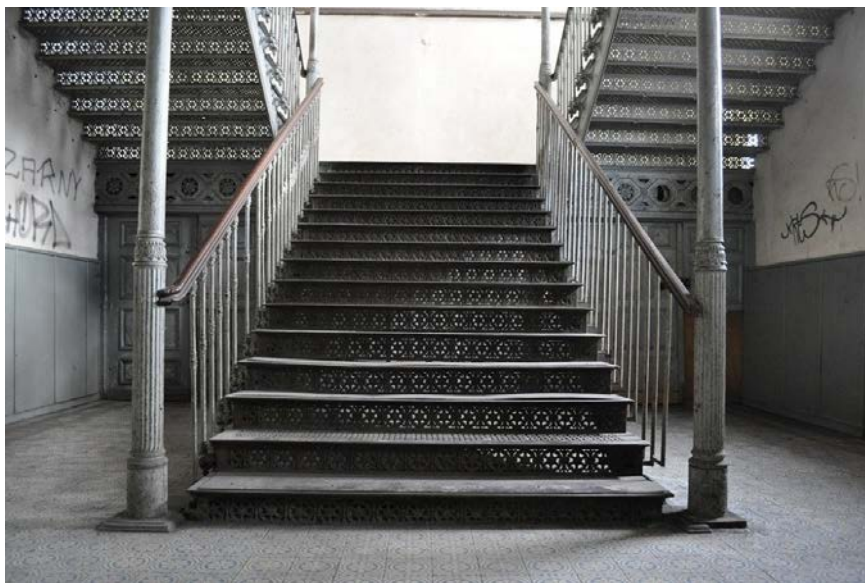
The railway station complex is entered in the register of monuments and remains under the protection of Kujawsko-Pomorskie Voivodship Regional Heritage Conservator. However the current condition of the stairs should be assessed as bad. Most parts of the barriers are damaged. Lack of some vertical bars, cast iron ornaments are broken off, or complete lack of them. The condition of some treads was so poor that, in order to further use of the steps it was necessary to mount on them additional items of flat sheet. Wooden stairs' walls which are partially damaged were repaired temporarily by the residents of the building by placing fibre panels. Interim actions allow to use that vintage construction, but it is still deteriorating (Fig. 1).

Fig. 1. Cast iron staircase: general view.

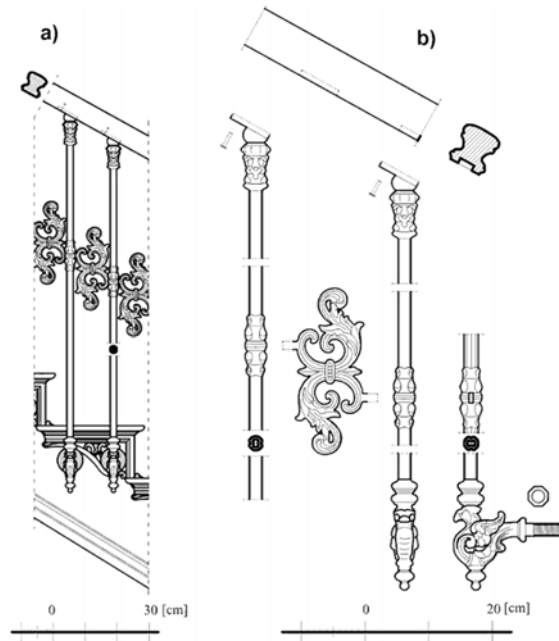
The height of the sloping railing is 90 cm and the height of the horizontal railing on higher platform is 85 cm. Both of them consists of casted in iron, vertical elements (pipes) with external diameter of 2 cm. They are mounted to the side of notch boards (B2). The lower part of that railing is unusual and extremely decorative feature (Fig. 6). Simultaneously it is a threaded element, used for screwing railing to the load-bearing beams of the flight of stairs. The decorated top part of cast iron railing has special diagonal metal blade. It is parallel to the wooden handrail, mounted to the metal element by nails. All joints are invisible, because of being dipped in wood. The handrail is fastening to each vertical element of railing and also in the similar way to the column or the lantern. It consists of few parts, connected together and forming in one long element. Approximately in the middle of height of railing casted in iron ornaments are situated. Beside decorative aspects they are additional stiffening of the barrier. For joining them no extra connector is necessary. It also has some rectangular metal blades, which can be placed inside fitting hole in vertical element of railing. Mounting all elements of the barrier must have been undertaken at the same moment. To already installed vertical bar, the decorative stiffening was putted in and only then the next bar was mounted. All elements trig themselves together. In result, removal of one of it would require uninstalling at least few neighbouring ones.

Fig. 6. Cast iron staircase barrier, stocktaking: (a) general view; (b) vertical bars with both decorative and technical elements.

Because the substantial construction of the stairs is in quite good condition, it is necessary to repair small components in the first place. There are several reasons that will make it easy. First of them is facilitated finding

of prototype for restoration. The staircase is built of repetitive elements and some of them are still well-preserved. It is therefore justified to claim that new elements will be very similar to the origin ones. The second reason involve material of elements. Reconstructed parts should be made of material as close as possible to that used for creation of historical elements. It does not cause any problem considering fact that also nowadays it is possible to cast architectural details in iron. However, it is recommended to examine and then to change the chemical composition of used cast iron in comparison with the 19<sup>th</sup> century material. It is due to retain difference between authentic and reconstructed elements.
