Causes of damage and methods of repairing floor made on polystyrene concrete

Lukasz Drobiec^{1,*} and *Pawel Piotrkowski*²

Abstract. The paper describes damages, tests and repair of the floor made on existing ceiling and expanded polystyrene concrete underlay. The floor was built on a reinforced concrete ceiling with an area of about 1050 m². Significant damage in the form of cracks, detachments and unevenness was found in the floor. In order to determine the causes of damage, in situ tests and laboratory tests were carried out. It was found that the damage was caused by numerous performance errors. A test repair of the damage (4.7x6.0 m) was carried out, and then the repair method was applied on the entire floor surface.

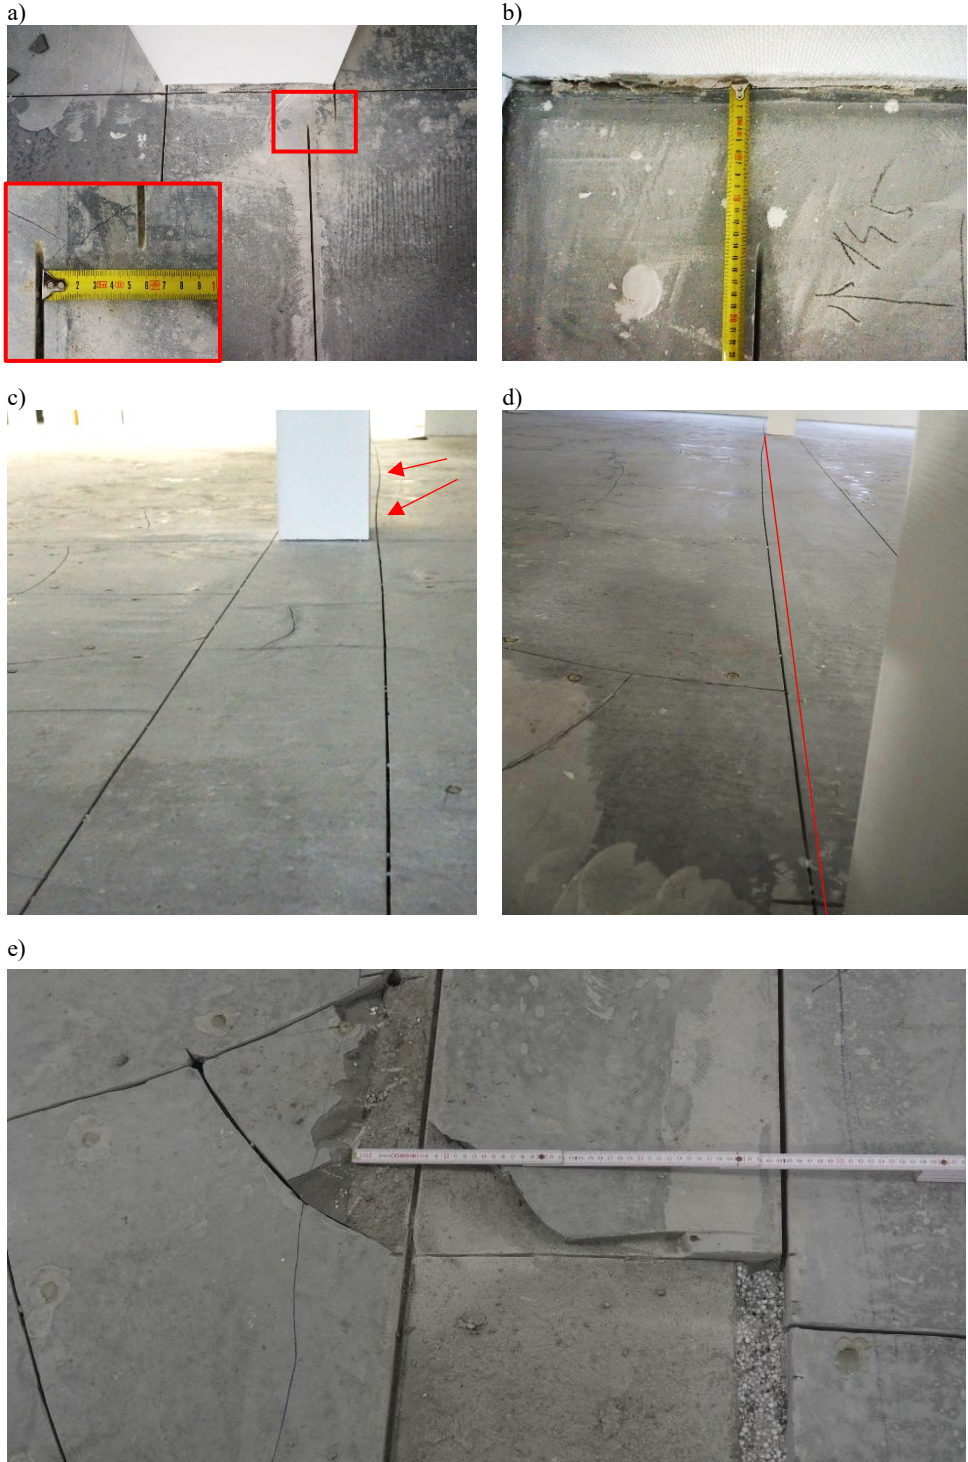
Visual inspection determined several performance errors, including uneven thickness of screed and EPSC, lack of precision in the execution of expansion joints and stratification of the concrete (up to three layers). The floor was clearly uneven - the slope of several slabs reached up to 16 mm/m, while spacing under two-metre-level and floor was up to 7 mm. It was observed that floor cracks protruded beyond expansion joints, which proves that the cuts were made too late.

Fig. 5. Imprecise expansion joints: a) lack of continuity, b) improper cut near the wall, c), d) uneven cuts e) inverted beam exposure. Expansion joints are at the distance of 7 cm.

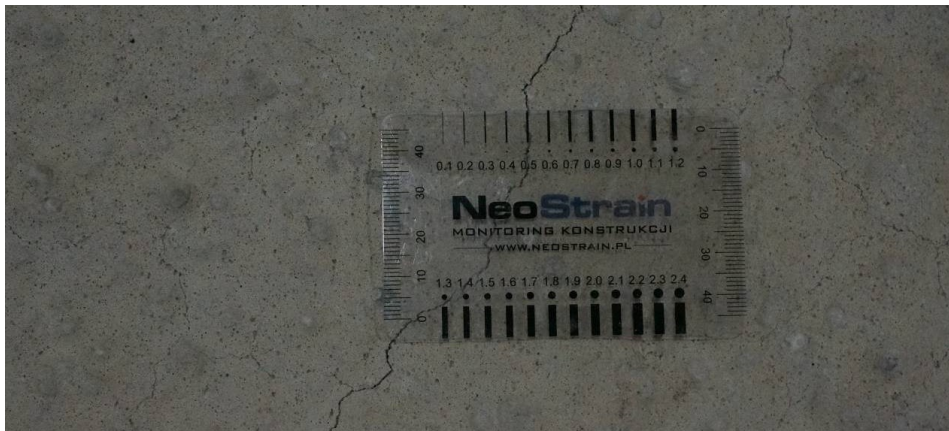
The visual evaluation of the samples was being conducted for over 2 months. The observations lasted over 2,5 times longer than the time in which the cracks occurred in analyzed floor. After 49 days first three samples did not exhibit any signs of cracking. The last sample exhibited small shrinkage cracks. Local width of the crack reached between $0.1 \div 0.5$ mm. The cracks on the surface of the EPSC occurred after two weeks due to lack of curing. The cracks are shown in Fig. 10.

Fig. 10. Measurement of the cracks in sample no. 4.

Comparative tests have shown that it is possible to make a self-levelling screed for the designed floor. Lack of curing resulted in the occurrence of cracks in the EPS concrete.
