COMPREHENSIVE MONITORING OF CHANGES IN THE GEOMETRIC STRUCTURE OF A HISTORIC BUILDING THE "SALA BHP" IN GDAŃSK

Jacek SZTUBECKI¹, Maciej NIEDOSTATKIEWICZ², Maria MRÓWCZYŃSKA³,
Tomasz MAJEWSKI⁴

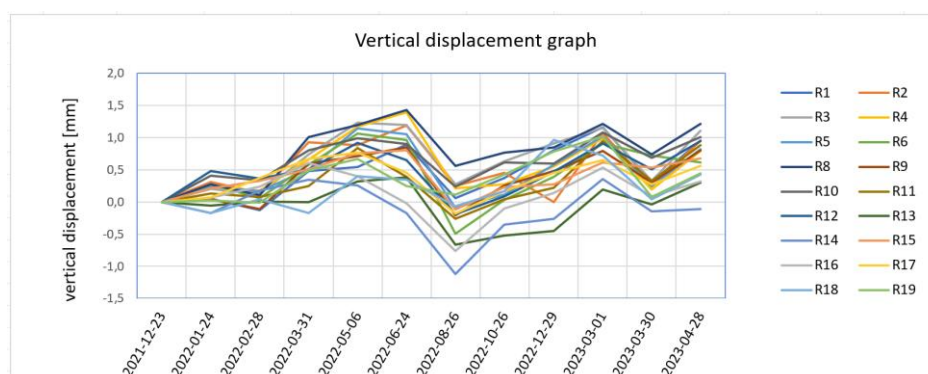
Fig. 16. The vertical displacements of the control points R1- R19

The values of measured vertical displacements of controlled bench-marks mounted on the walls of the monitored facility ranged from -1.12 mm (R14) to +1.43 mm (R8). The average errors of the determined vertical displacements, in most of the measurement series, did not exceed 0.35mm. The exception was the series of 2022.10.26, for which the average error slightly exceeded 0.50mm. These

values are lower than the Serviceability Limit State (SLS) recommended by the Building Research Institute (ITB).

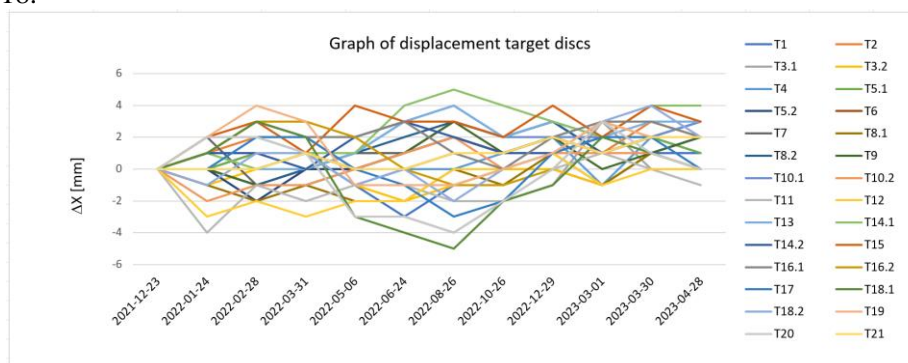
Fig. 17. Horizontal displacements of the discs in the X direction

The maximum horizontal displacement was recorded for the T15 disc in the Y direction and amounted to -8 mm. In the alignment process, errors in the position of the points of the controlled network in relation to the reference points were determined. The values of these errors were a maximum of 1.5mm. According to the currently applicable standard [9], the values of horizontal displacements are permissible in the case of brick buildings, which are considered up to 20 mm on each floor and up to 50 mm along the entire height of the wall.

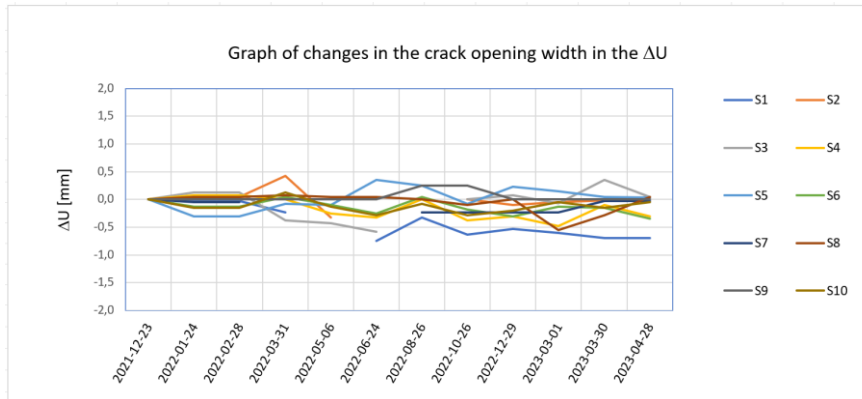
Fig. 19. Changes in the crack opening width in the ΔU direction for crackmeters S1-S10

max $\Delta V = +2.40$ mm – crackmeter no. S10.

It was found that changes in the width of monitored cracks located on the walls of the building's facade are caused by changes in atmospheric conditions: ambient temperature, humidity, and sunlight. Significant changes in the readings of the S10 crack gauge means that the crack above the lintel is active, and therefore it is recommended to check the lintel's stress and propose ways to strengthen it.

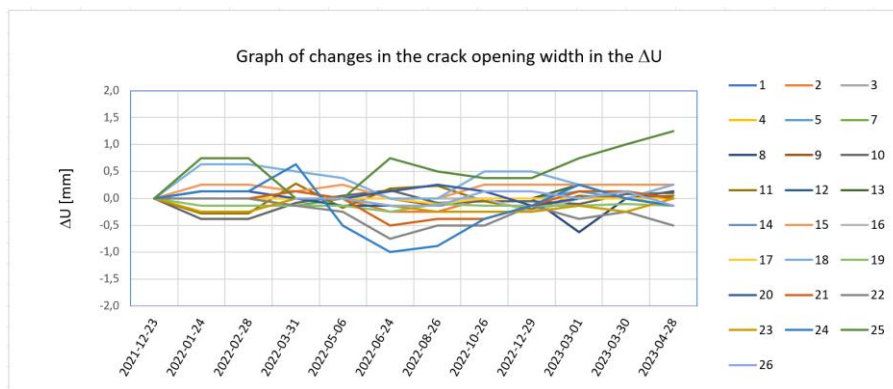
Fig. 21. Changes in the crack opening width in the ΔU direction for crackmeters 1-26

min $\Delta U = -1.00$ mm - crackmeter no. 24,

max $\Delta U = +1.25$ mm – crackmeter no. 25,

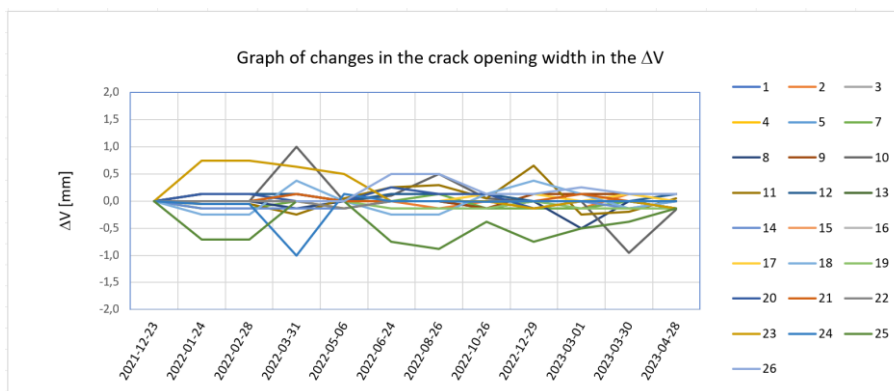
Fig. 22. Changes in the crack opening width in the ΔV for crackmeters 1-26

min $\Delta V = -1.63$ mm – crackmeter no. 25,

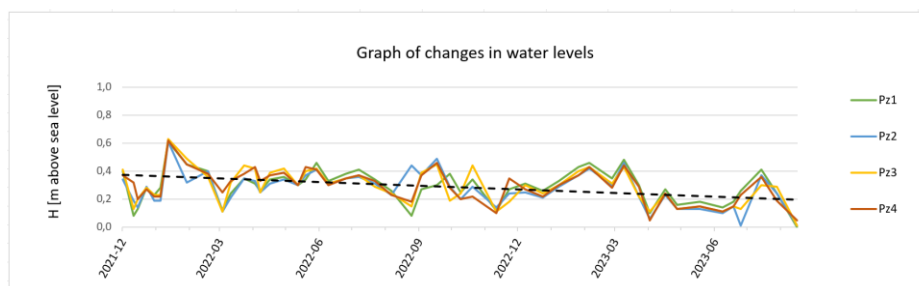
Fig. 23. Graph of changes in water levels in monitored piezometers

Fig. 23 shows the linear regression of changes in the height of the groundwater table in the monitored piezometers as a dashed line. A decreasing trend in the groundwater level near the building was observed in all monitored piezometers.
