Corrosion of evaporator tubes in low emission steam boilers

S. Topolska ^{a,*}, J. Łabanowski ^b

Purpose: of this paper is to reveal the mechanisms of corrosion processes of outer surfaces of low-emission steam boiler evaporator tubes. Examinations were performed to find the reasons of different corrosion susceptibility of tubes situated at combustion chamber on various levels.

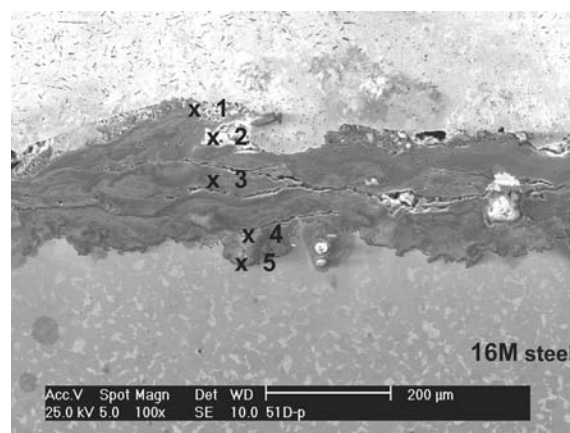
Scales consist mainly of iron oxides with considerable amount of sulfides. Detected elements were not uniformly spaced at the scale. The bands rich in sulfur were detected as well as zones enriched in chlorine. More alkaline metals were observed at scales covered samples taken from the level of 18m. Maximum sulfur contents were 32% and chlorine about 6%.

Fig. 7. Cross section of the fire side face of water wall tube. Sample 51D taken from the level of 10 m, "X" indicate points of spot analysis

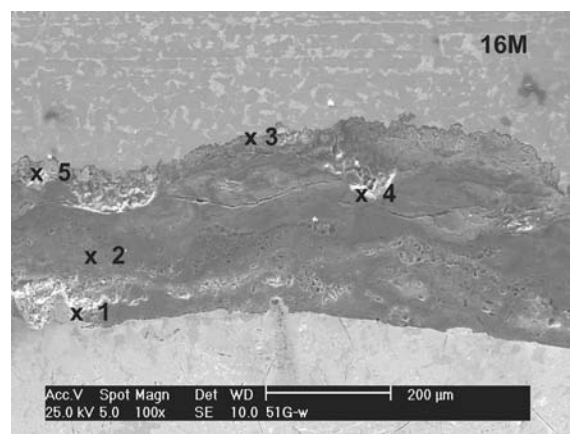
Fig. 8. Cross section of the fire side face of water wall tube. Sample 51G taken from the level of 18 m, "X" indicate points of spot analysis

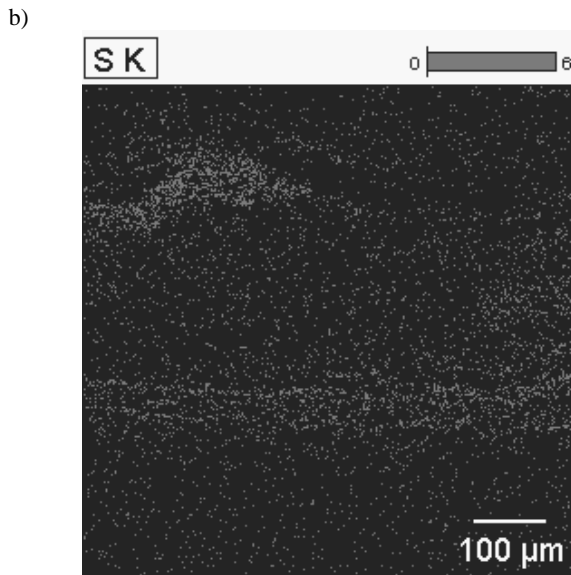
Fig. 11. Cross section of fire-side face of water wall tube subjected to reducing combustion conditions a) optical micrograph b) x-ray elemental dot map for sulphur

Dot maps confirmed observation on inhomogeneous of scale composition. Fig. 11 shows bands enriched in sulfur situated at external layer of the scale and second band close to the interface of base material and scale.

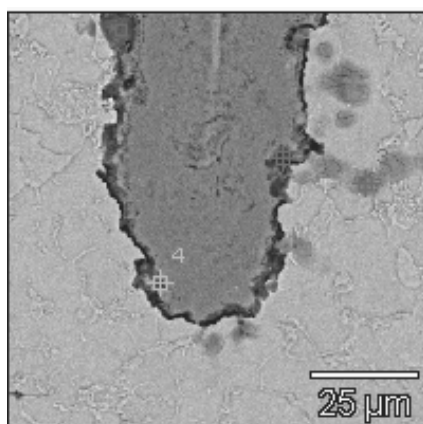
Fig. 14. Chemical analysis of the scale at the tip of corrosion pit (wt. %). Level - 18m, measure points indicated in micrograph
