# Corrosion of evaporator tubes in low emission steam boilers

**Purpose:** of this paper is to reveal the mechanisms of corrosion processes of outer surfaces of low-emission steam boiler evaporator tubes. Examinations were performed to find the reasons of different corrosion susceptibility of tubes situated at combustion chamber on various levels.

Examinations were conducted on four segments of  $\varnothing 57 \times 5.0$  mm evaporator tubes made of 16M (16Mo3) steel grade. Segments were taken from two tubes at levels 10 and 18 meters from the chamber bottom. The highest row of burners was situated on the level 14 meters. Tubes were in operation for two years.

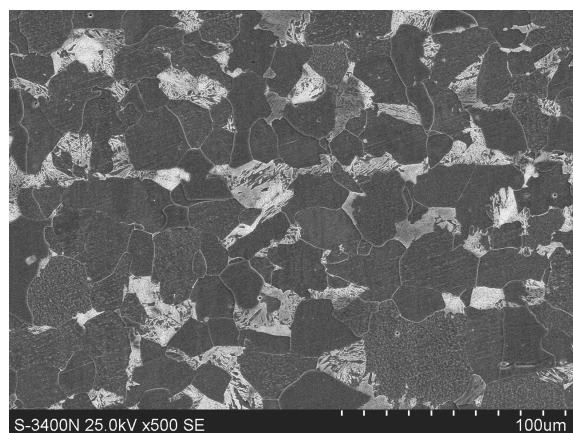
Microstructure of tube wall material (16M steel) is shown at Fig. 3 and 4. Microstructure of both tube segments taken from the level 10 and 18 m from the bottom of combustion chamber show non degraded structure consisted of ferrite and bainite grains. The grain growth due to the high temperature operation was not detected.

Fig. 3. Microstructure of 16M steel. Tube segment taken from the level of 10 m at combustion chamber, SEM image

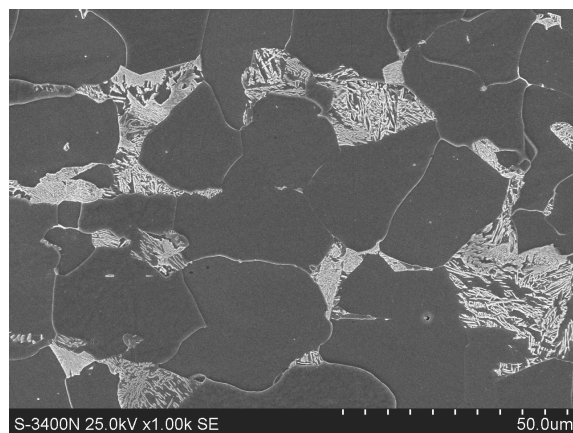
Fig. 4. Microstructure of 16M steel. Tube segment taken from the level of 18 m at combustion chamber, SEM image

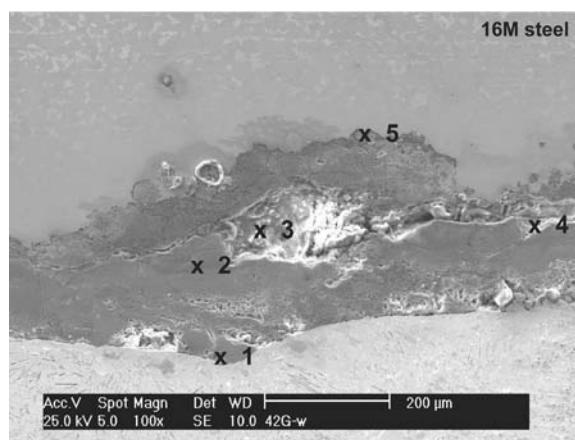
Scales consist mainly of iron oxides with considerable amount of sulfides. Detected elements were not uniformly spaced at the scale. The bands rich in sulfur were detected as well as zones enriched in chlorine. More alkaline metals were observed at scales covered samples taken from the level of 18m. Maximum sulfur contents were 32% and chlorine about 6%.

Fig. 6. Cross section of the fire side face of water wall tube. Sample 42G taken from the level of 18 m, "X" indicate points of spot analysis

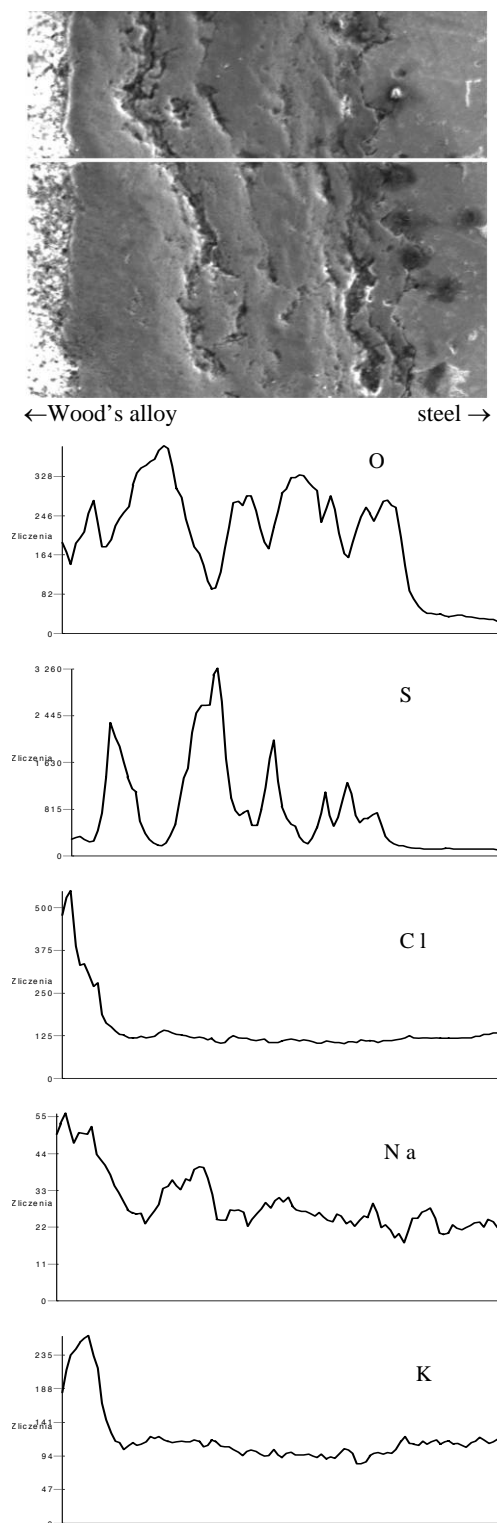
Linear distribution of elements (Figs. 9 and 10) has shown the increased concentration of chlorine and alkaline metals in the areas adjacent to the interface of base material and scale. Such shape of element distribution is dominant for samples taken from the level of 18 m.

Fig. 9. Linear distribution of elements on cross section of deposit layer on  $\varnothing 57 \times 5.0$  mm evaporator tube, level of 10 m

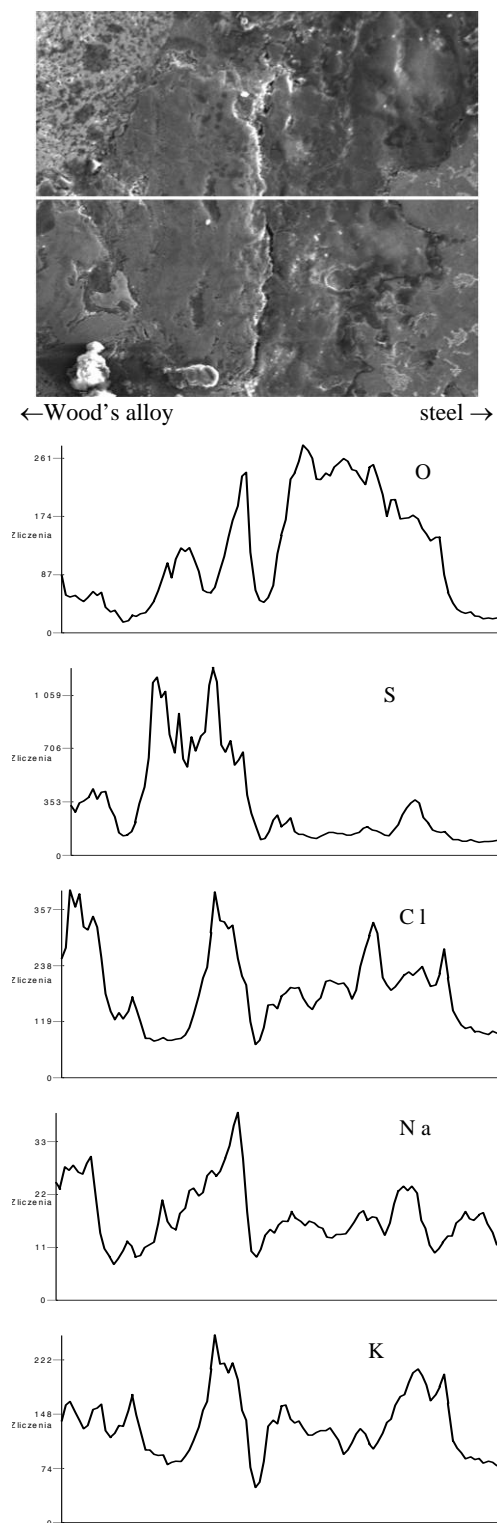
Fig. 10. Linear distribution of elements on cross section of deposit layer on  $\varnothing 57 \times 5.0$  mm evaporator tube, level of 18 m
