Demolition of the cereal elevator building located in the conservation protection zone in the aspect of technical, functional-utility and economic conditions

Maciej NIEDOSTATKIEWICZ^{*1}, Tomasz MAJEWSKI²

¹ Department of Engineering Structures, Faculty of Civil and Environmental Engineering, Gdańsk University of Technology, Gdańsk, Poland

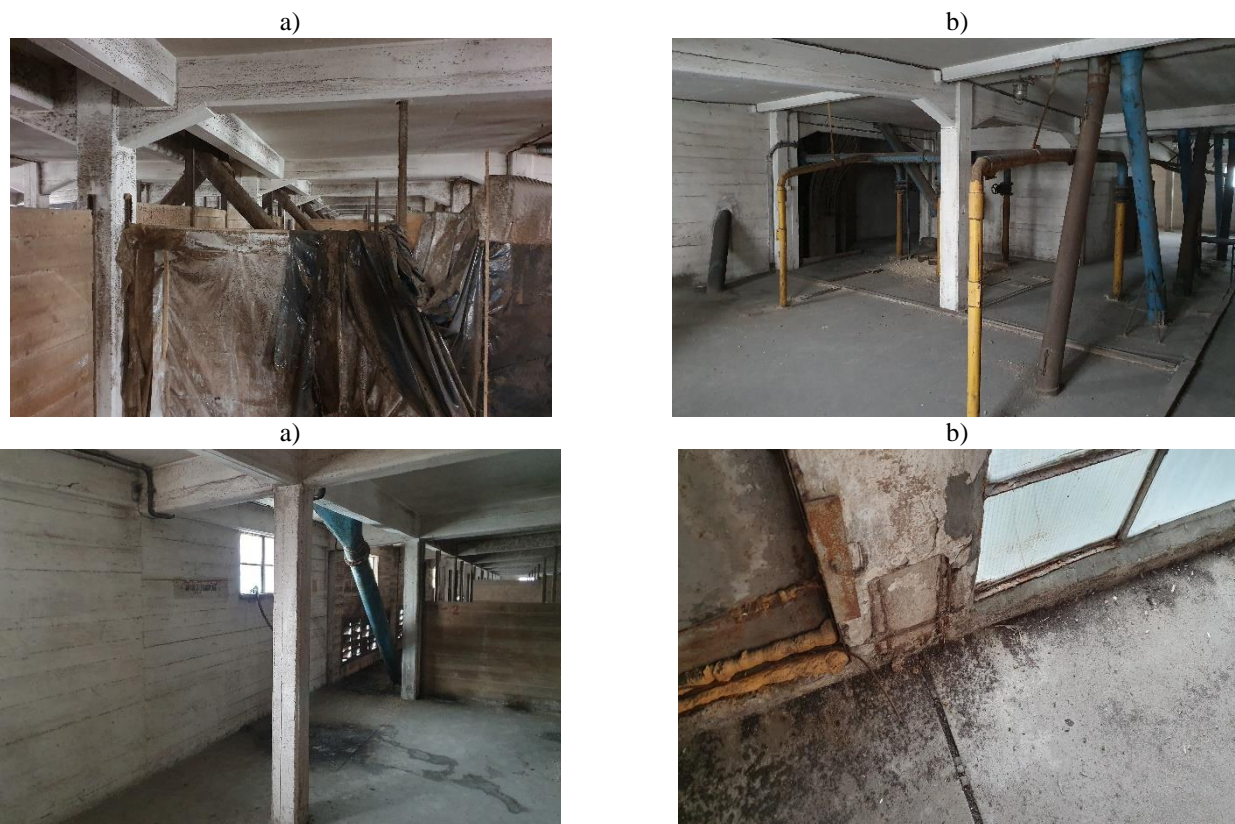
The rooms on the +7 level, as well as the higher rooms: +8, +9, and the lower ones: +6, +5, +4, +3, +2 and +1 floors had sections for storing materials separated by wooden partitions loose. In the rooms, inoperative devices for transporting the stored materials were visible. Traces of freezing of external walls were visible in the floor zone. Loss of concrete cover was visible on some of the pillars between the windows (reinforced concrete columns) (Photo 4).

Photo 4: Grain Elevator building - level +7: a), b), c) division of the usable area with wooden partitions, d) falling off the concrete cover in the floor zone

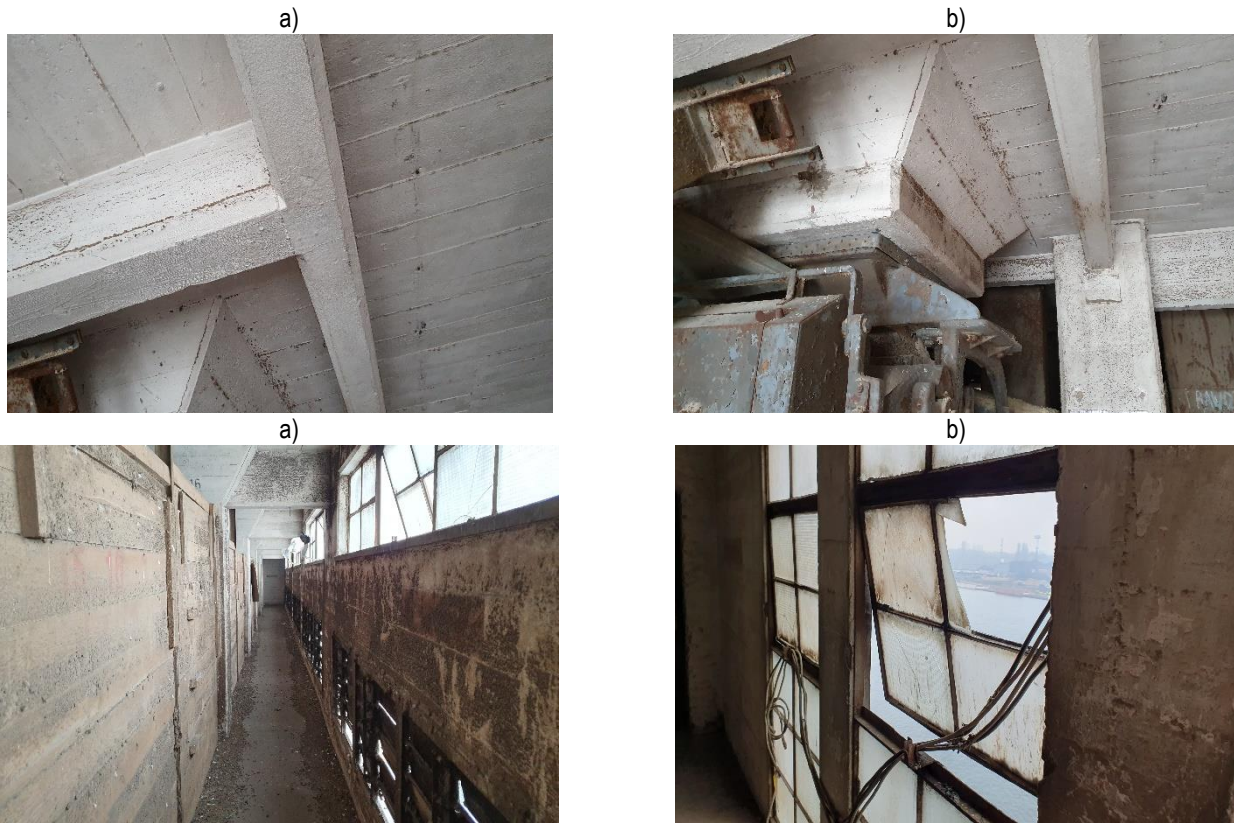
Reinforced concrete elements, in practice at the level of all above-ground storeys, especially at the level of +5, had local mechanical damage visible on the ceiling, walls and columns. As in the case of other storeys, in the rooms there were visible inoperative devices for transporting loose materials. Loss of concrete cover was visible on some of the pillars between the windows (reinforced concrete columns) (Photo 5).

Photo 5: Grain Elevator building - level +5: a) mechanical damage to structural elements, b) equipment for transporting loose materials left inoperative and incomplete, decapitalization of: c) ventilation shutters, d) window joinery
