Diagnostics and protection methods a residential building in connection with the reconstruction of a road located in its immediate neighborhood - case study

Maciej NIEDOSTATKIEWICZ ^{1*}

¹ *Department of Engineering Structures, Faculty of Civil and Environmental Engineering,
Gdansk University of Technology, Gdansk, Poland*

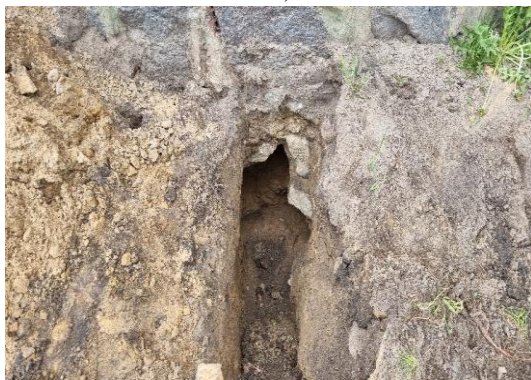
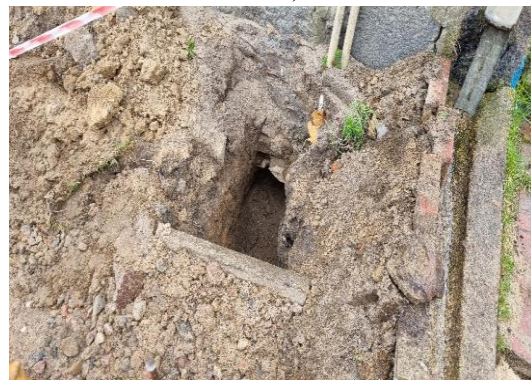
Fig. 3: Location of the outcrops in the residential building: a) view of the building from the street (front elevation), b) internal outcrop (in the basement): O1, external outcrops: c) O2 and d) O3

Based on the excavations made, it was determined that the building is founded on stone walls that do not have any offsets.

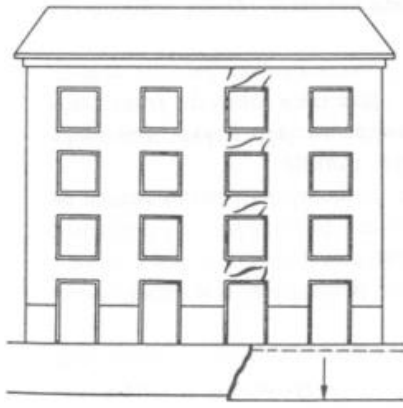
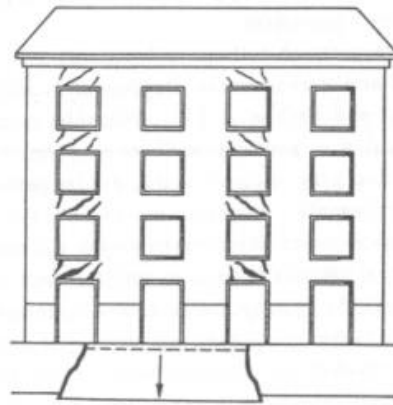
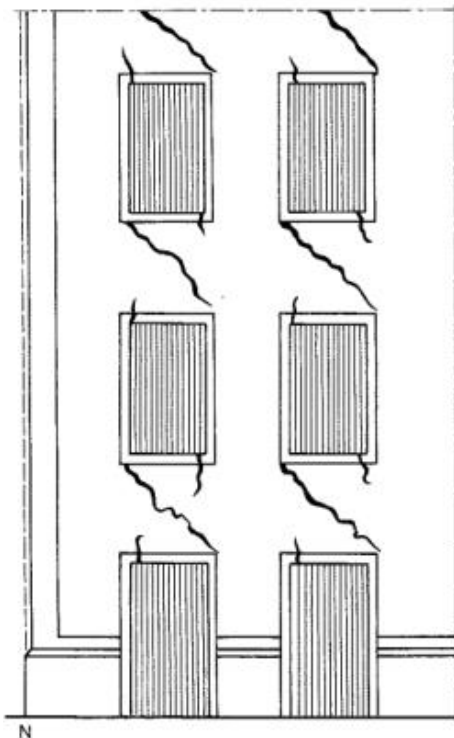
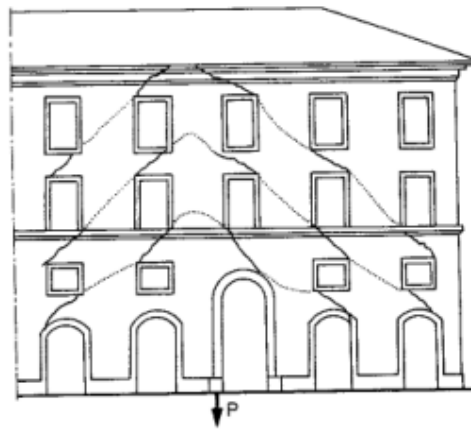
Fig. 5: The mechanism of damage to external walls caused by uneven settlement according to: a) Mitzel A., Stachurski W., Suwalski J.: Failures of concrete and masonry structures, *Arkady Publishing House*, Warsaw 1973, b) Masłowski E., Spiżewska D.: Strengthening of building structures, *Arkady Publishing House*, Warsaw 2000
