DYNAMIC STATE ASSESSMENT OF THE WATER TURBINE WITH THE POWER OF 600 kW

Grzegorz ŻYWICA, Paweł BAGIŃSKI, Łukasz BREŃKACZ

Institute of Fluid-Flow Machinery, Polish Academy of Sciences
80-231 Gdansk, Fiszerka 14 str., gzywica@imp.gda.pl

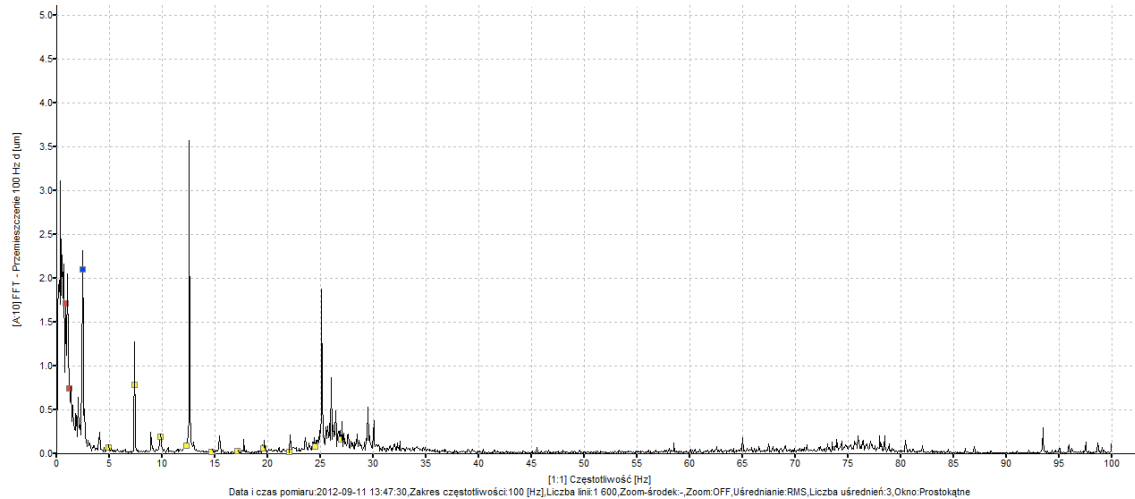
Analyzing the vibration spectrum shown in Figure 4 we can see the dominance of the following components of vibration. At very low frequencies (up to 2 Hz), components were associated with the resonance frequency of the system, which results in the vibration of the whole machine and the foundation. At a frequency of 2.5 Hz the rotational speed component was observed (for the water turbine shaft). At 7.5 Hz we can distinguish the component associated with the shaft misalignment or bend, but its amplitude was lower than the synchronous component. At a frequency of 12.5 Hz synchronous component of generator shaft appeared, and at 25 Hz the increased amplitude of vibration testified about a misalignment or deflection of the shaft. Other components of vibrations in Figure 4 was characterized by a much smaller amplitude. Since in the case of measuring the amplitude $A_{p,p}$ vibration limits for new machines are not exceeded even once, it can be concluded that the observed symptoms of various defects were at an acceptable level. Synchronous vibrations of both shafts were relatively low, and the successive harmonics were reduced almost twice, which meant a slight bend or misalignment.

Fig. 4. Frequency spectrum of the vibration amplitudes measured at node III in the direction Y with the selected synchronous frequency of water turbine's shaft at 2.5 Hz (blue dot) and its harmonics (red and yellow dots)

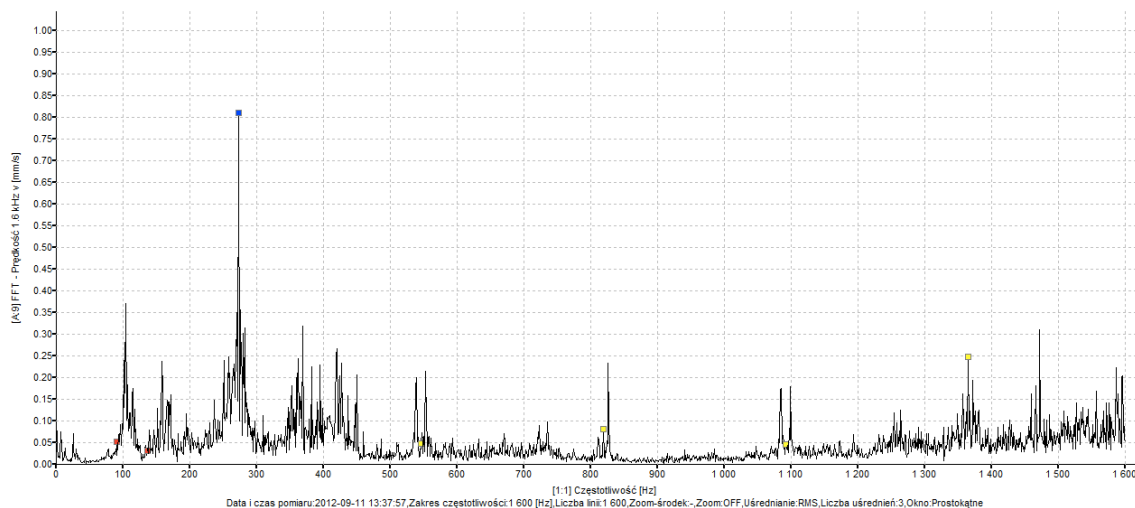
At higher frequencies, for all the measuring nodes similar vibration spectra were recorded. Characteristics shown in Figure 5 was determined for the measured signal at node II in the direction of the Y axis (on the flange connecting the generator with the transmission gear). The recorded vibration signal allowed to draw the following conclusions. The dominant component (272 Hz frequency) of the resulting characteristics relates to the toothed ring's meshing frequency (it was marked by a blue point and its harmonics by yellow and red points). The origin of the vibrations of toothed gear also testified clear sidebands. Elevated levels of vibration can also be observed in successive harmonic frequencies of toothed ring's meshing: 544, 816, 1088, 1360 Hz. At the frequency of 103 Hz a component occurred resulting from the frequency of meshing the satellite wheels with the toothed ring. Under the frequencies within the range of 170 Hz appeared increased vibration levels that could be associated with the co-operation of the satellite wheels with the central wheel of the planetary gear. Other areas of high vibration levels were difficult to clearly interpret.

Fig. 5. Frequency spectrum of the vibration velocity measured at measuring node II in the Y direction with the marked frequency of toothed ring meshing with the planetary cage at 272 Hz (blue dot) and its harmonics (red and yellow dots)

The study clearly showed that the cause of elevated levels of rms values of vibration velocity was the operation of planetary gear, and more specifically the lack of smooth cooperation of gears. Since the vibration of the machine was measured on the housing, the registered signal was dominated by vibrations coming from the toothed ring cooperation with the planetary gear. This ring was permanently connected to the gear's body, resulting in the direct transfer of vibrations to the housing.

The analysis conducted of vibrations therefore clearly indicated the source of high level of vibrations, which impacted directly on the acceptable level of vibration (for new objects which are ready for use). The cause of the elevated vibration level was due to the planetary toothed gear. Since this was a new gear, it was unlikely that such quick wearing or damage could have occurred, so this evidenced by low accuracy performance of toothed wheels.

- In the test machine at each of the five tested states the level of RMS value of vibration velocity was exceeded (according to the standard ISO10816-5:2000 for newly commissioned machines),
- The results of measurements allowed to qualify the turbine set for zone B, which according to [3] is the possibility of long-term operation without restrictions,
- The frequency analysis showed that the cause of high levels of vibration was due to the toothed gear operation, and other incompatibilities (e.g. rotors unbalance, bend or misalignment) were at an acceptable level,
- Because studies have shown that the vibration levels were exceeded for the new objects placed in operation, the next inspection of the machine is recommended in the future to detect possible rapid wearing of components (mainly the parts of toothed gear).
