Emergency condition of the ceramic facade of a residential building

Maciej NIEDOSTATKIEWICZ *¹

¹Civil and Environmental Engineering, Gdańsk University of Technology, Gdańsk, Poland

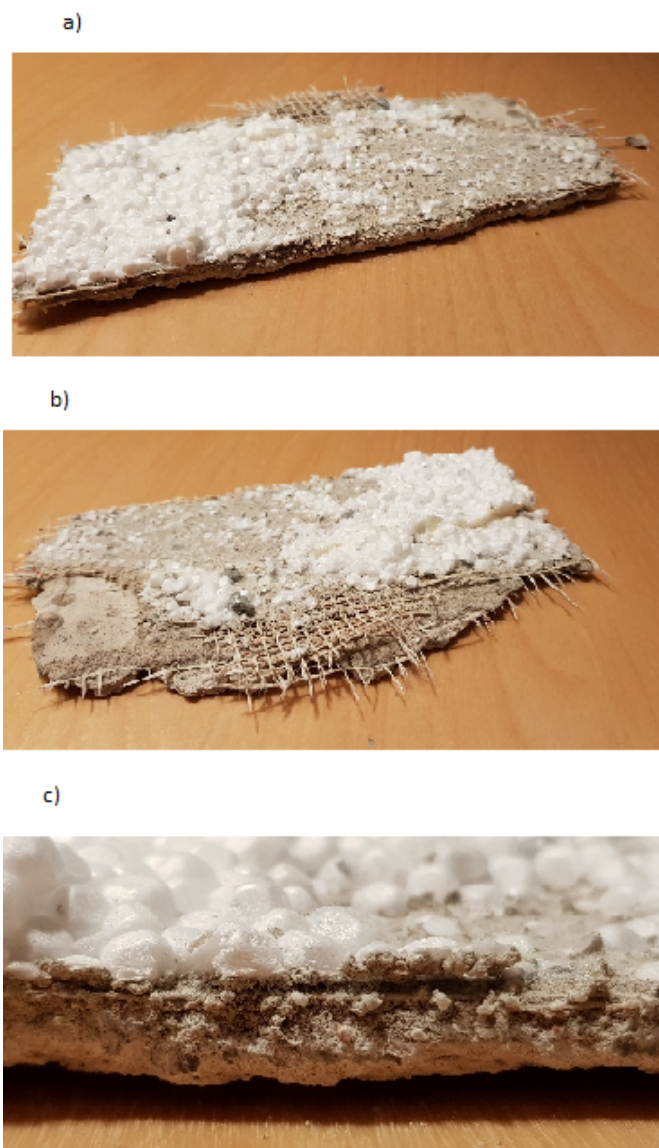
Figure 2. Details of thermal insulation (substrate) a), b) and c) for the ceramic cladding of the building facade

- the pins should be fixed in the first layer of the facade mesh and then covered with the second (top) layer of the mesh with glue - in the outcrops, the use of a double facade mesh and fixing the pins according to the technological requirements (+) was found. The thickness of the glue allows the facade mesh to be fully covered (Fig. 2),

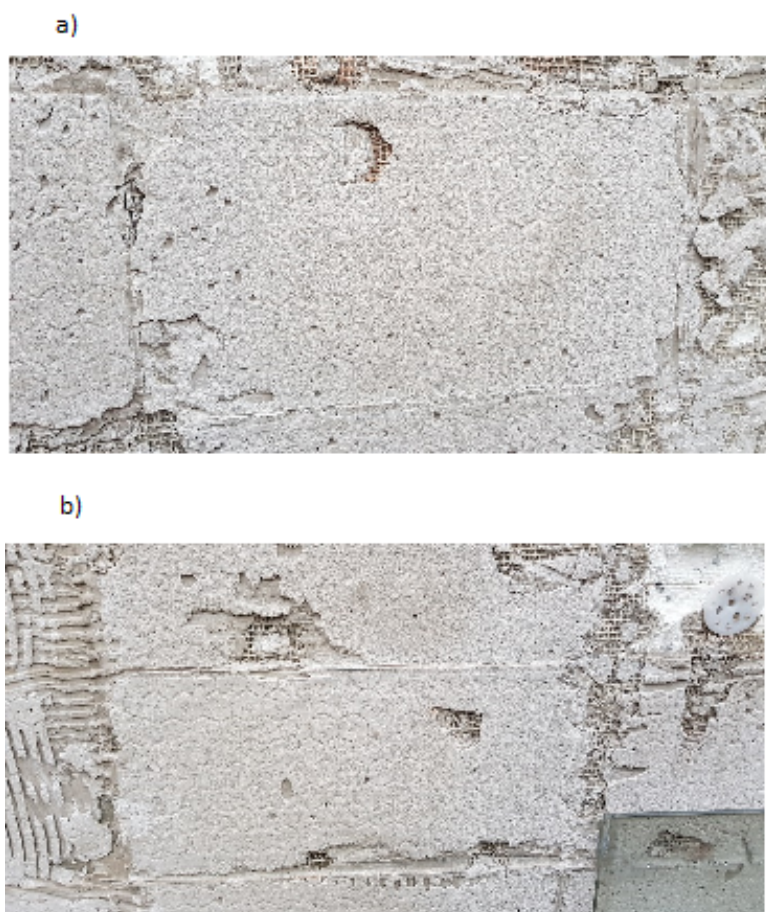
Figure 3. Mechanism a), b) (method of detaching) the ceramic cladding of the building facade
