Emergency condition of the ceramic facade of a residential building

Maciej NIEDOSTATKIEWICZ*¹

¹Faculty of Civil and Environmental Engineering, Gdańsk University of Technology, Gdańsk, Poland

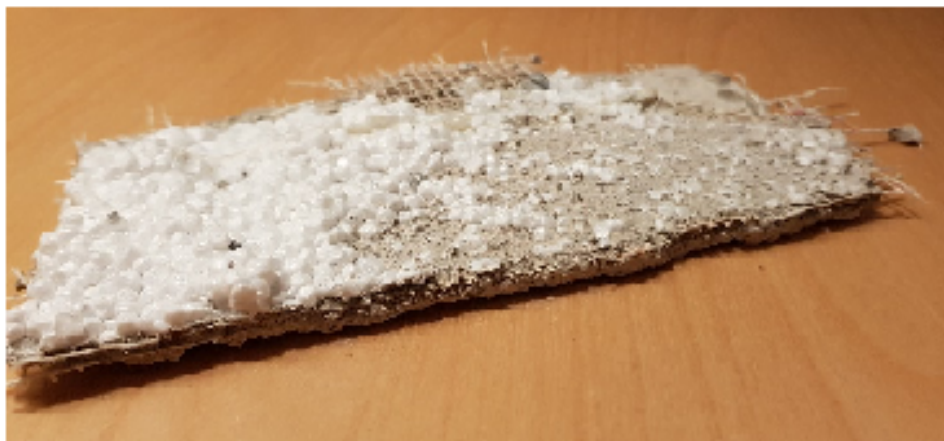
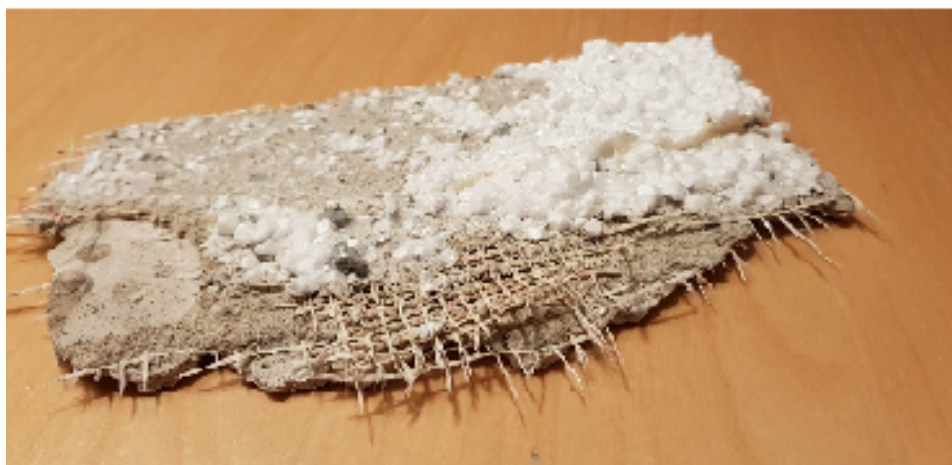
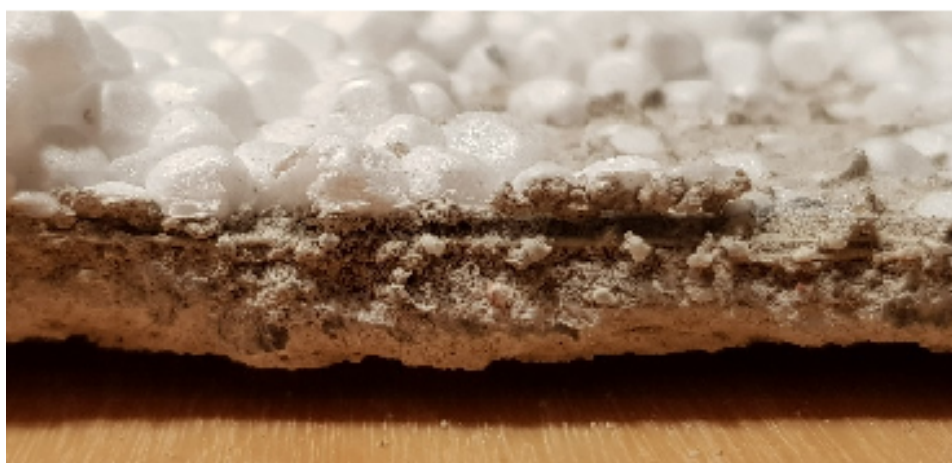
- the pins should be fixed in the first layer of the facade mesh and then covered with the second (top) layer of the mesh with glue - in the outcrops, the use of a double facade mesh and fixing the pins according to the technological requirements (+) was found. The thickness of the glue allows the facade mesh to be fully covered (Fig. 2),

Figure 2. Details of thermal insulation (substrate) a), b) and c) for the ceramic cladding of the building facade

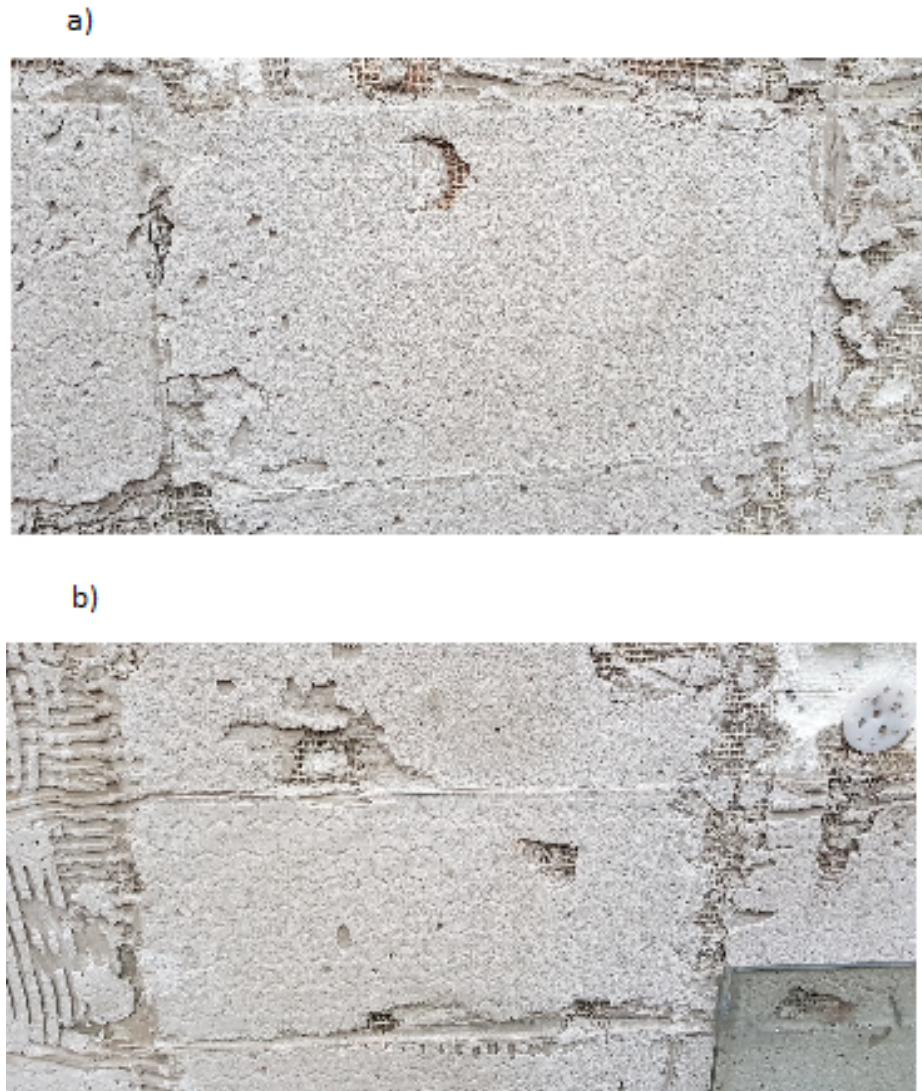
In the case of damage to the ceramic cladding of the building façade, it was most likely a consequence of using too little water added to the adhesive, which resulted in its drying too quickly instead of the spread of bonding over time. Carrying out cladding works in the period when the wind was probably periodically blowing, which resulted in exceeding the so-called open time and resulted in the glue drying out, and consequently accelerated setting start contributed to the tiles being scorched by the glue layer. Likewise, the probable performance of works in the period of periodic increased insolation had a negative effect on the adhesion of the adhesive to the substrate and to the tiles. In addition, the implementation of the cladding fragments on the thickened adhesive layer led to excessive shrinkage and loss of adhesion. Leaks in the attic's plinth also contributed to the degradation of the cladding.

Figure 3. Mechanism a), b) (method of detaching) the ceramic cladding of the building facade
