# Excavation induced cast iron pipeline failure – a numerical study

Dr inż. Krzysztof Szarf, dr inż. Rafał Ossowski

Gdańsk University of Technology, Faculty of Civil and Environmental Engineering

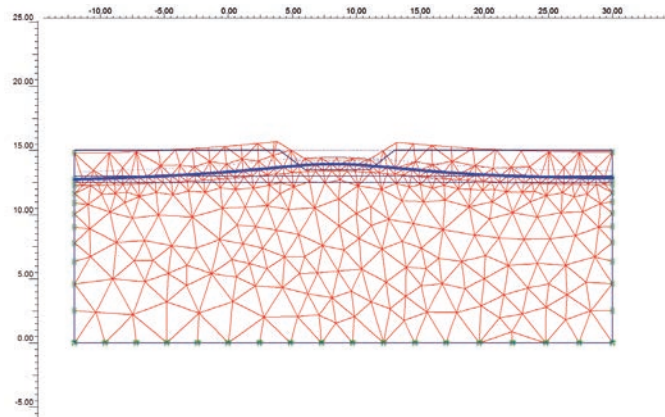
tion, but without traffic loading. Figure 6 depicts a deformed mesh with indicated uplift caused by unloading the trench. Figure 7 and Figure 8 show detailed displacement fields divided into horizontal and vertical components.

Figure 6. Deformed mesh after excavation (scaled up 10 times)  
Subsoil type: Or – Compacted mud ( $M_0 = 2$  MPa)

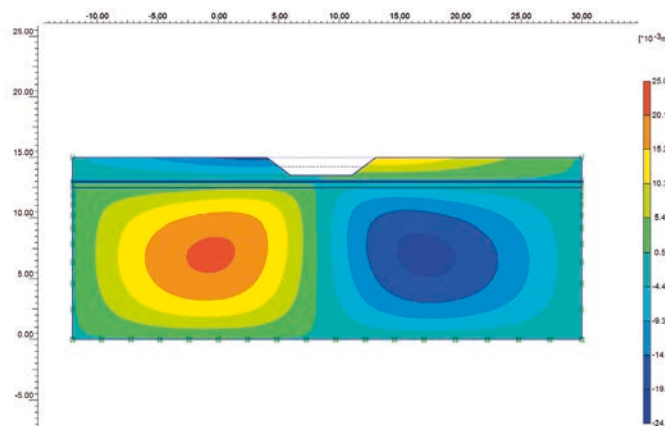
Figure 7. Horizontal soil displacements map (excavation unloading)  
Subsoil type: Or – Compacted mud ( $M_0 = 2$  MPa)

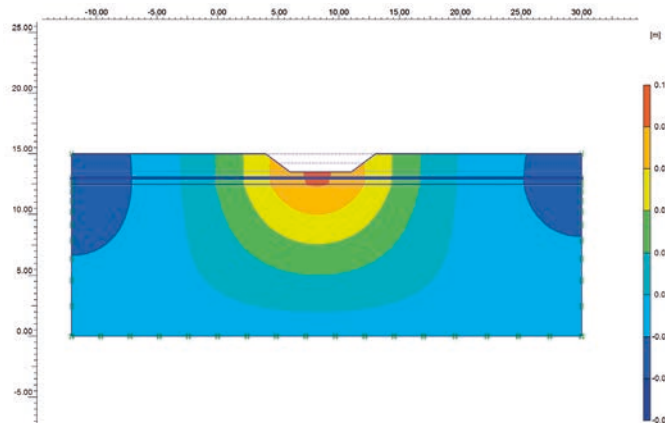
Figure 8. Vertical soil displacements map (excavation unloading)  
Subsoil type: Or – Compacted mud ( $M_0 = 2$  MPa).

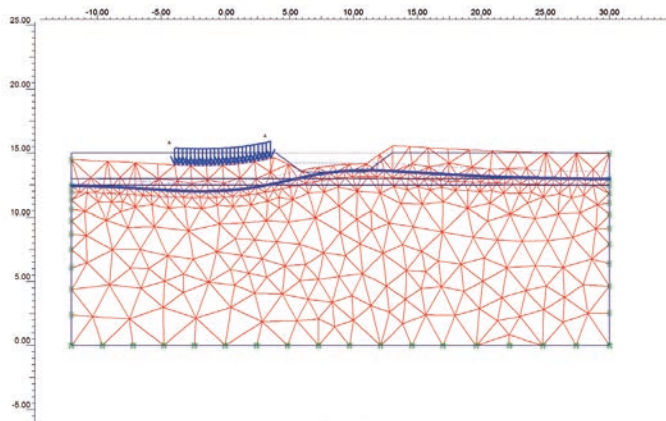
The second failure phase – after applying the loading acting on the road, are presented in Figures 9 ÷ 11. Figure 9 presents a deformed mesh with clearly visible pipe deformation as a result of traffic load. Figure 10 and Figure 11 show detailed displacement fields divided into horizontal and vertical components.

Figure 9. Deformed mesh after traffic loading (scaled up 10 times)  
Subsoil type: Or – Compacted mud ( $M_0 = 2$  MPa)

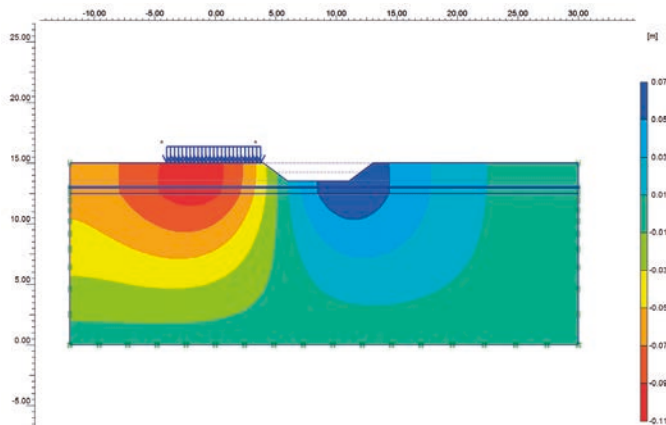
As stated previously, there is a difference in the direction of vertical displacements below the road and below the excavation, see Figure 11. Soil settlements exceed 90 mm below the road centreline, are close to 0 mm at the edge of the excavation near to the road and finally reach 60 mm of uplift on the other side of the excavation. Such differences occurring around points placed less than 15 m from each other could lead either to stress increase in the pipe joint material and possibly fracturing of the bell, or to disjoining of the pipe elements through rotation. Conversely, in Figure 10 we observe smaller horizontal displacements of the soil, in the range of 10 mm. Horizontal soil

Figure 11: Vertical soil displacements map (after traffic loading)  
Subsoil type: Or – Compacted mud ( $M_0 = 2$  MPa)

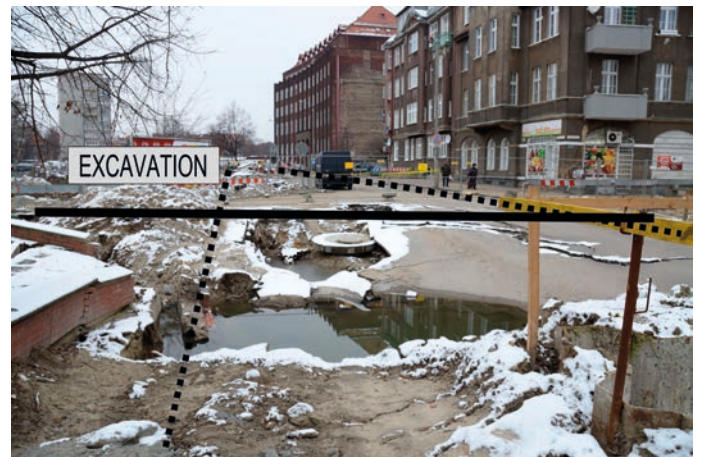
Engineers performing works in dense urban areas with long history often face unexpected complications. The existing infrastructure can pose problems due to imprecise localisation, especially when the archival data are incomplete, uncertainty of its actual technical condition, or due to being subjected to situations not accounted for during its design (e.g. additional constructions in the area or much higher loads). In such environment engineering works should be performed with great care and attention to safety. In the Figure 12 and Figure 13 one can see effects of such unexpected circumstances acting together.

Figure 12. General view of Gdańsk 2013 real-life case of a pipe failure in the vicinity of an unsecured excavation that inspired this study  
Dotted lines indicate road edges while solid line indicates the axis of the pipeline

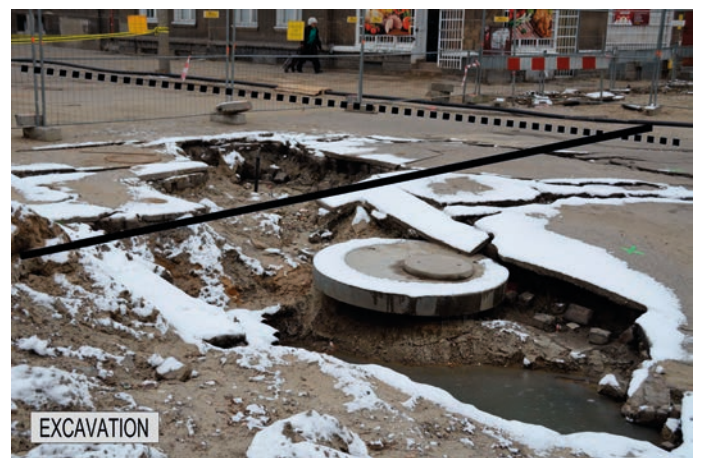
Figure 13. Close-up of the Gdańsk 2013 pipe failure area  
Dotted lines indicate road edges while solid line indicates the axis of the pipeline
