Monitoring of a historic sacral building on an example Basilica St. Nicholas in Gdańsk

Abstract

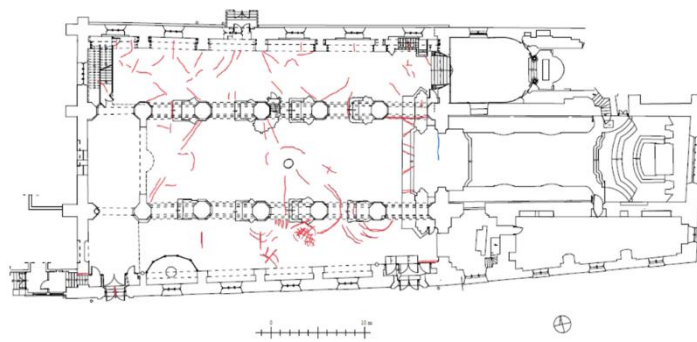
Fig. 1. Basilica of St. St. Mikołaja in Gdańsk: morphology of the features - as of January 19, 2019. [24]

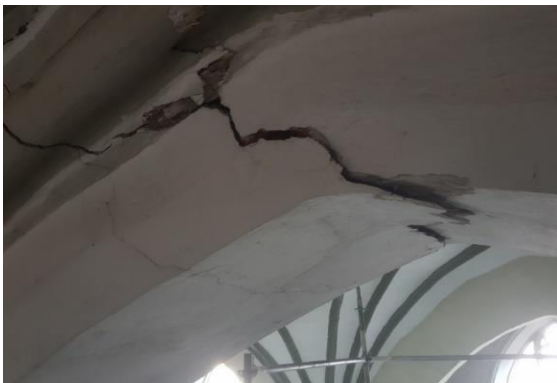
In the initial stage of the recognition, a visual inspection of the condition of the Basilica's structural elements was made (Photo 1 and Fig. 1), photographic and drawing documentation of the faults and damages was prepared [24]. Photo 2 and Photo 3 show the photos of the cracked arch between the pillars of the southern aisle and representative damage to the vault rib for the southern aisle. Based on the information collected, it was decided to immediately temporarily support the damaged vaults of the south aisle with temporary supporting scaffolding. The scaffolding was to be placed on the historic floor of the church, which was deformed and locally collapsed. For this reason, local covers were made to check the condition of the subfloor under the floor, in which voids and cavities were found. Preliminary tests of the entire floor in the Basilica were carried out using the GPR ground-penetrating radar [25]. Based on the results obtained, a decision was made to temporarily dismantle the floor within the southern aisle for the duration of the scaffolding operation. Before dismantling the floor, a detailed conservation inventory was made. After dismantling the floor, scaffolding was erected to protect the vaults of the southern aisle (Photo 4).

Photo 2. Damage to the arch between pillars 2 and 3 of the southern aisle of the Basilica of St. Nicholas in Gdańsk (*photo by T. Majewski*)

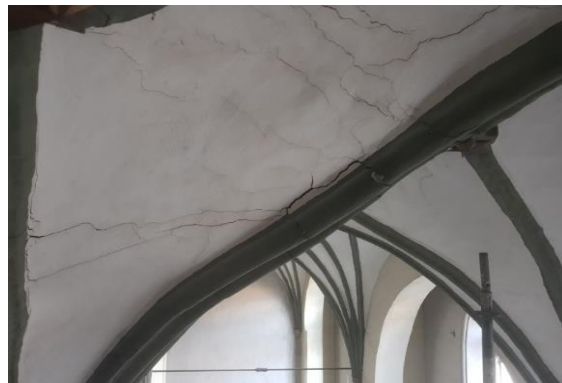
Photo 3. Damage to the diagonal ribs (deformations, scratches and cracks) of the southern aisle of the Basilica of St. Nicholas in Gdańsk (*photo by T. Majewski*)

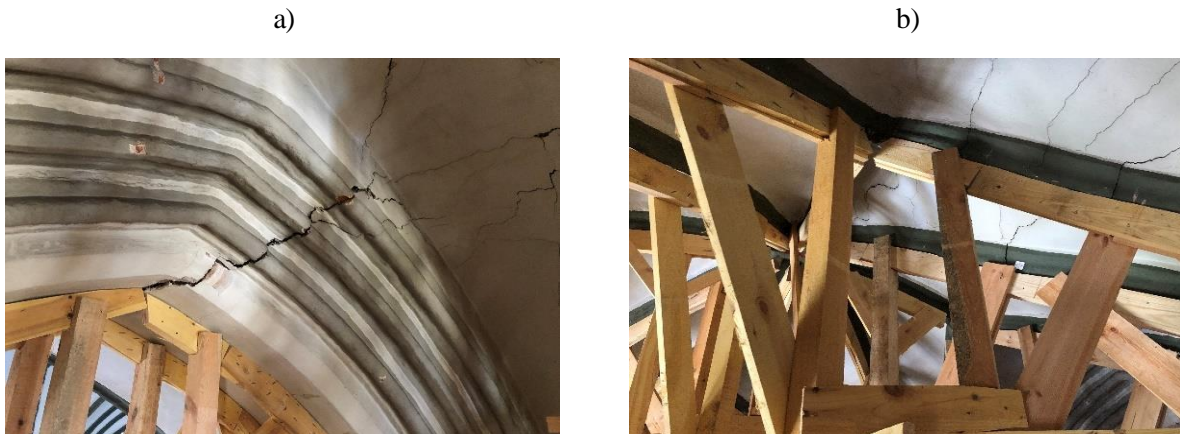
Photo 4. Scaffolding stabilizing the vaults of the southern aisle of the Basilica of St. St. Mikołaja in Gdańsk: a) an arch between pillars no. 2 and no. 3, b) supported ribs of the vaults (*photo by T. Majewski*)

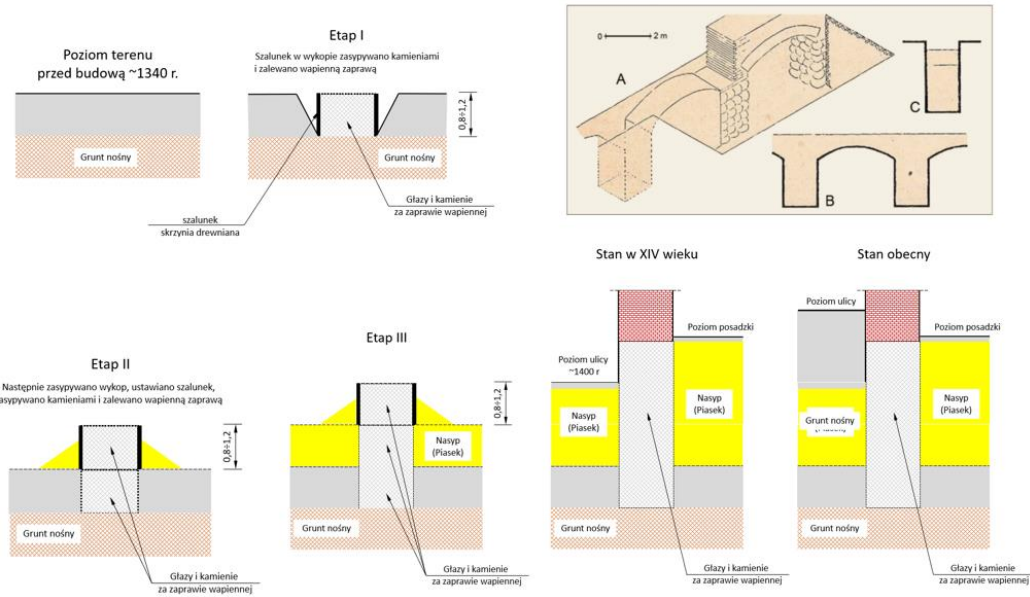
In order to recognize the type and condition of the foundations of the Basilica, classic narrow-spatial excavations were made. The excavations revealed that the foundations of the building were made in the form of stone pillars, on which brick arches are based, above which ceramic walls and pillars of the building were built [31]÷[32]. The condition of the foundations of the building was different in individual excavations. Based on the inspection, it was found that the stone foundations were placed directly on the layers of load-bearing soils (sands and gravels), under which no wooden piles and fascines were found. The layered structure of the pillars at their height was determined. The foundations were made in three stages, approximately 1.0 m high for each layer of stones (Fig. 3). Boulders and stones are laid on lime mortar, and the external surfaces are clad with clay.

Fig. 3. Foundations of the building of the Basilica of St. St. Nicholas in Gdańsk Basilica [31]-[32]

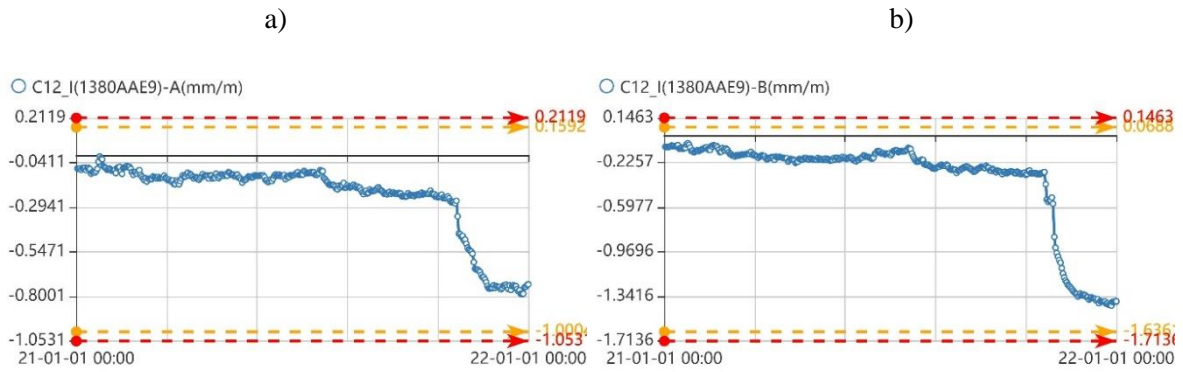
A cracked inter-column arch is based on the F2 and F3 pillars, Fig. 9, Fig. 10 and Fig. 11 show the results of inclination measurements of three selected pillars, F1, F2 and F3, respectively. Fig. 12 shows changes in vertical displacements (settlements) of piers F1 (a) and F2 (b) recorded in 2021. by distance sensors D17_I and D18_I. The charts show changes in the trend of recorded values caused by an increase in the load from the weight of the concrete ribs and the shell reinforcing the arches.

Fig. 9. Inclination of the pillar F1 of the southern aisle in the direction of axis A (a) and axis B (b): readings of the C12_I sensor in the period 01.01÷31.12.2021

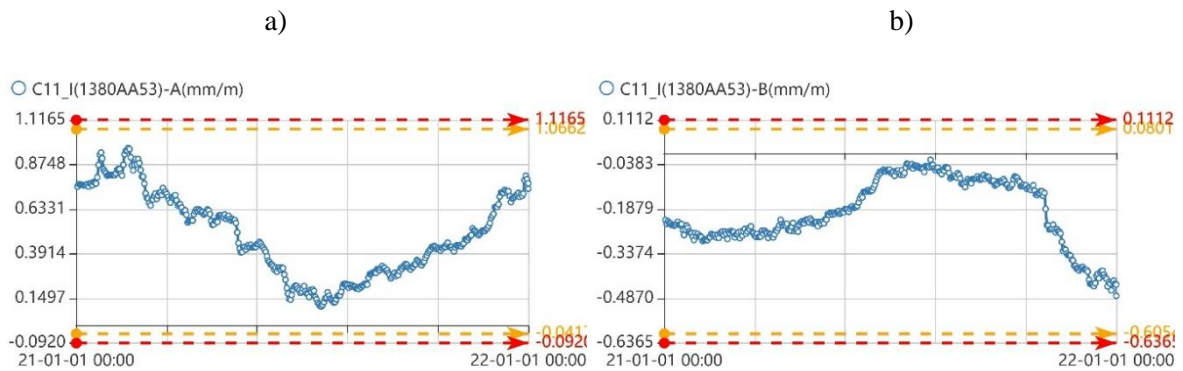
Fig. 10. Inclination of the pillar F2 of the southern aisle in the direction of axis A (a) and axis B (b): readings of the C11_I sensor in the period 01.01÷31.12.2021

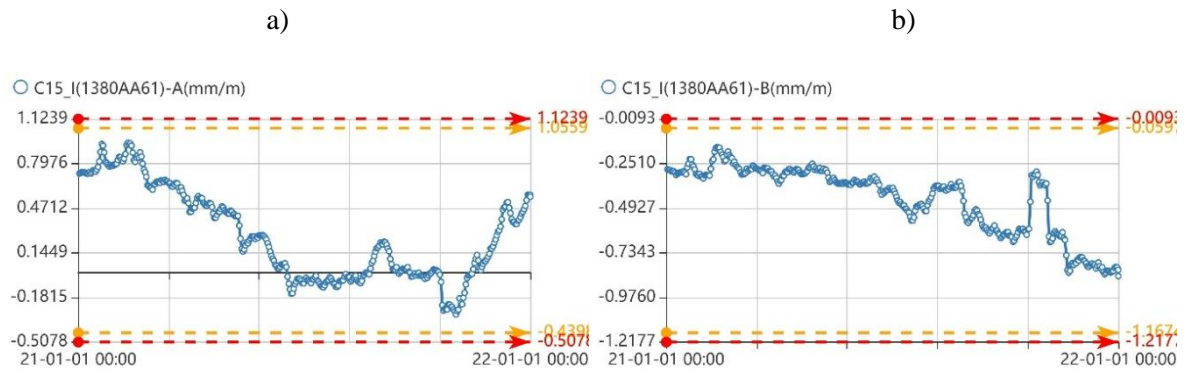
Fig. 11. Inclination of the pillar F3 of the southern aisle in the direction of axis A (a) and axis B (b): readings of the C15_I sensor in the period 01.01÷31.12.2021

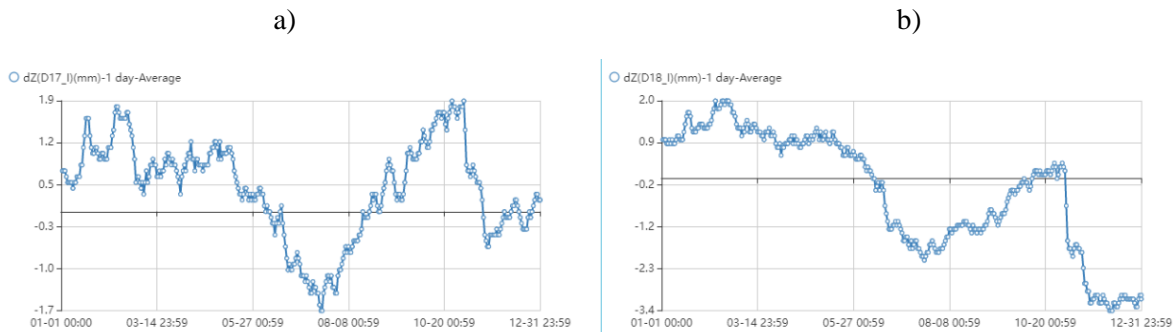
Fig. 12. Vertical displacement of the pillars of the southern aisle based on readings from distance sensors: a) C17_I (F1) and b) C18_I (F2) in the period 01.01÷31.12.2021
