## **On the current state of dovetail wall-corner joints in wooden Greek Catholic churches in Polish Subcarpathia with structural and sensitivity analyses**

# On the current state of dovetail wall-corner joints in wooden Greek Catholic Churches in Polish Subcarpathia with structural and sensitivity analyses

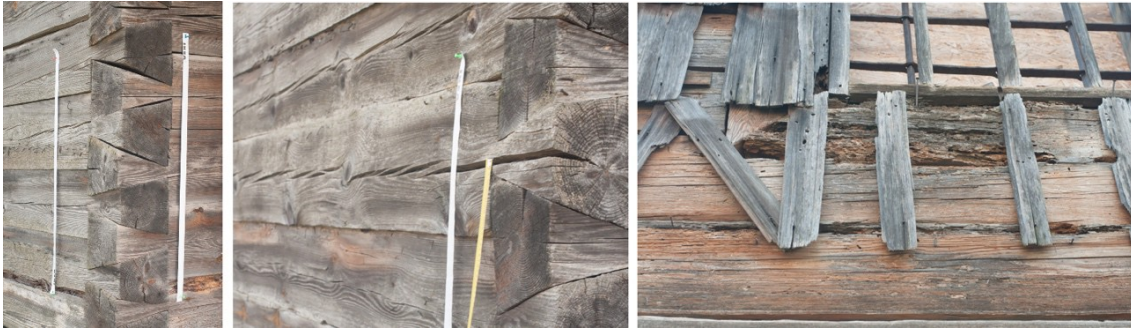
The current condition of the walls is good. The church has log walls with dovetail notches (Figure 6). The walls are made of wood beams with a rectangular cross-section of 21 x 30 cm. No significant moisture was found and the humidity of the corners remains at 12.2% on the south side and at 16.2% on the north side (Figure 7). The horizontal damp proof course in the foundations is not broken and the roof covering is rain-tight. There are some visible longitudinal cracks and a few transverse cracks in the beams. There also exist some signs of damage caused by insects and some minor local cavities in the wall structure (Figure 6). The vertical out-of-plane deviations of the walls are relatively small – from 0.46 cm to 0.53 cm. The internal angles have not changed since the church assembly - deformations inside and outside the building amount range from 88.6° to 91.5°. The same is true for the whole construction which has never been rebuilt and hence there are no additional loads on the walls. Moreover, the gravity ventilation of the facility is intact. At present the church is not in use but local authorities have designated a person responsible for taking care of it. Due to this the building is closed and protected against vandalism and the area around it is well kept.

Figure 6. The church in Cewków: wall corner, longitudinal cracks in the wall, visible cavities in the wall.
