On the current state of dovetail wall-corner joints in wooden Greek Catholic churches in Polish Subcarpathia with structural and sensitivity analyses

On the current state of dovetail wall-corner joints in wooden Greek Catholic Churches in Polish Subcarpathia with structural and sensitivity analyses

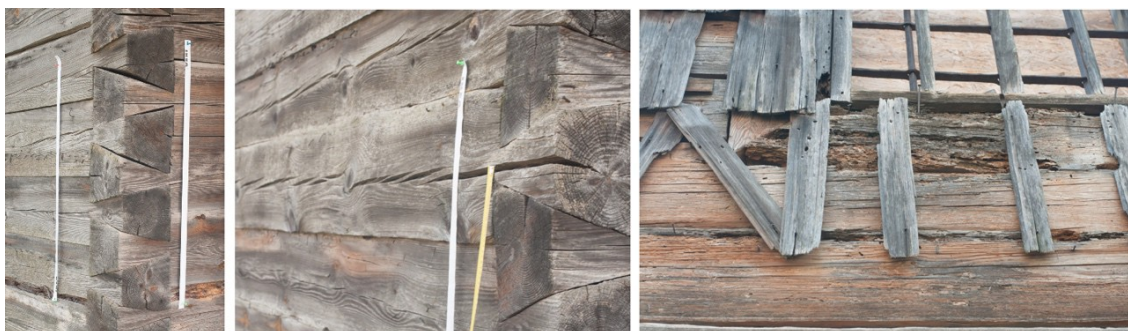
The current condition of the walls is good. The church has log walls with dovetail notches (Figure 6). The walls are made of wood beams with a rectangular cross-section of 21 x 30 cm. No significant moisture was found and the humidity of the corners remains at 12.2% on the south side and at 16.2% on the north side (Figure 7). The horizontal damp proof course in the foundations is not broken and the roof covering is rain-tight. There are some visible longitudinal cracks and a few transverse cracks in the beams. There also exist some signs of damage caused by insects and some minor local cavities in the wall structure (Figure 6). The vertical out-of-plane deviations of the walls are relatively small – from 0.46 cm to 0.53 cm. The internal angles have not changed since the church assembly - deformations inside and outside the building amount range from 88.6° to 91.5°. The same is true for the whole construction which has never been rebuilt and hence there are no additional loads on the walls. Moreover, the gravity ventilation of the facility is intact. At present the church is not in use but local authorities have designated a person responsible for taking care of it. Due to this the building is closed and protected against vandalism and the area around it is well kept.

Figure 6. The church in Cewków: wall corner, longitudinal cracks in the wall, visible cavities in the wall.

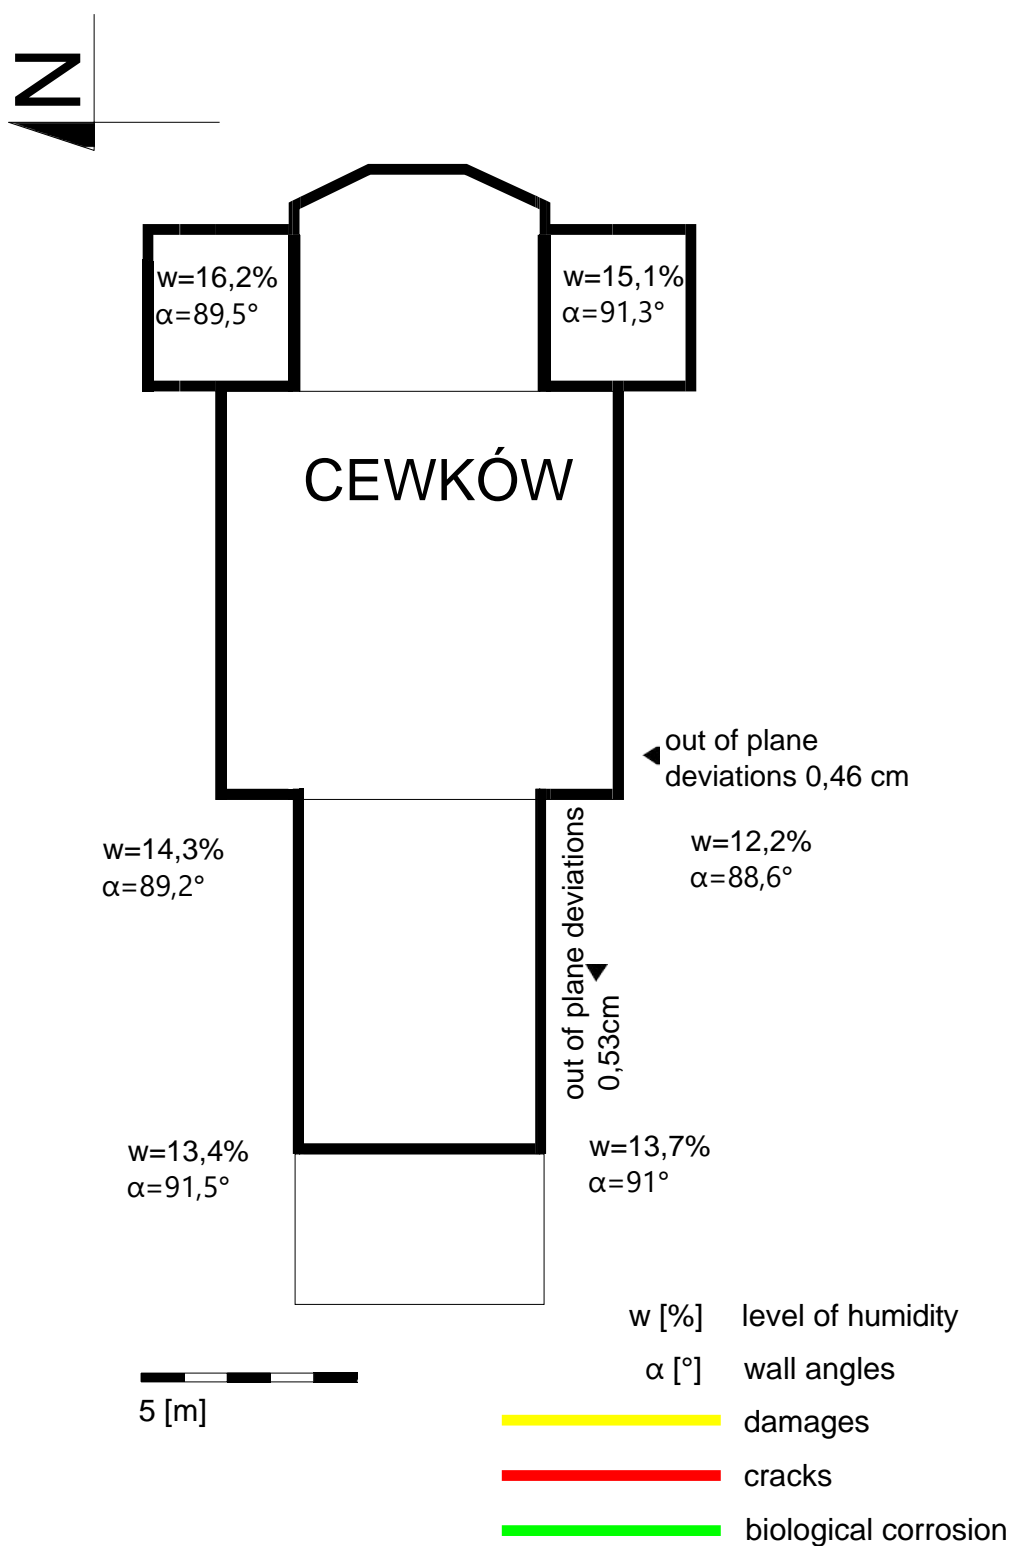
Figure 7. Results of measurements in the church in Cewków. The plan shows the level of humidity, angles, the scale and direction of deviations. Colors denote places where damage, cracks and biological corrosion occur.

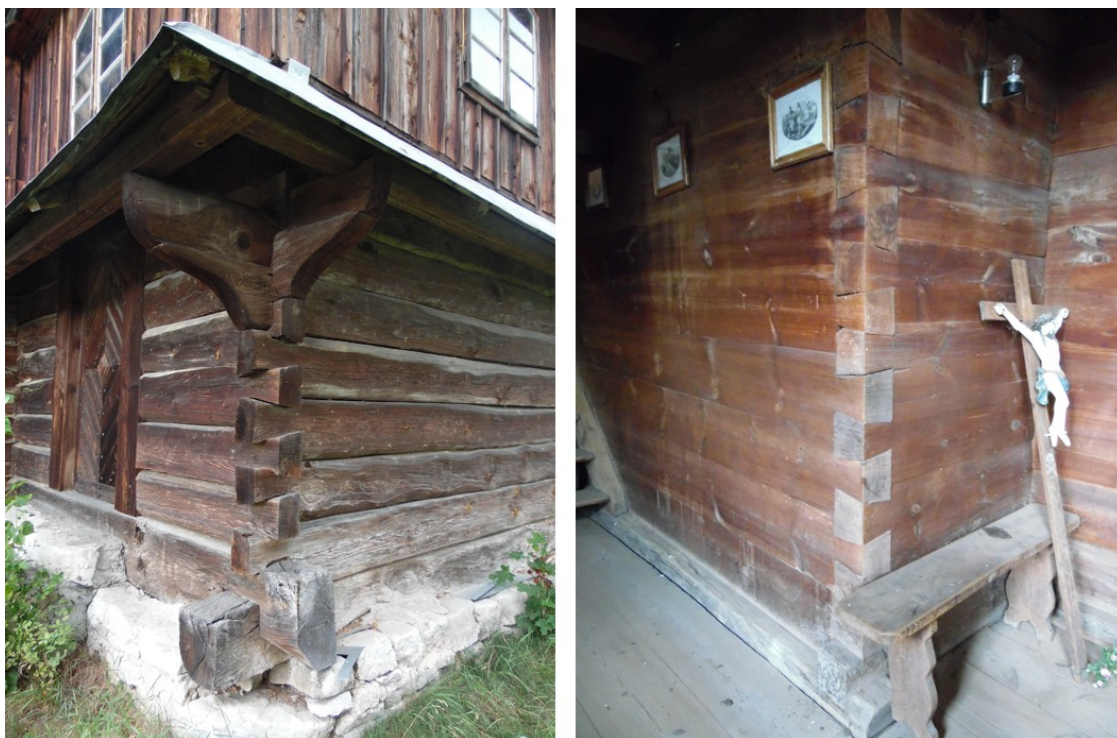
The current condition of the walls is good. The church has log walls with dovetail notches (Figure 9, 10). The walls are made of wood beams with a rectangular cross-section of 15 x 21 cm. No significant moisture has been found and the humidity level of the corners remains at 12.5% on the south side and 17.8% on the north side (Figure 11). The horizontal damp proof course in the foundations is not broken and the roof covering is rain-tight. There are some visible longitudinal cracks (Figure 10) and a few transverse cracks in the beams. There are also some signs of damage caused by insects and some

minor local cavities of the structure. The out-of- plane vertical deviations of the walls are relatively small - from 0.15 cm to 1.2 cm. The internal angles have not changed since the church assembly - deformations inside and outside the building range from 88.9° to 90.5°. The same is true for the construction as a whole which has never been rebuilt and hence there are no additional loads on the walls. Moreover, the gravity ventilation of the object is intact. At present the church is not in use but local authorities have designated a person responsible for taking care of it. Owing to this the building is closed and protected against vandalism and the area around it is well kept.

Figure 9. Current condition of log walls with dovetail notches in Chotylub outside and inside.

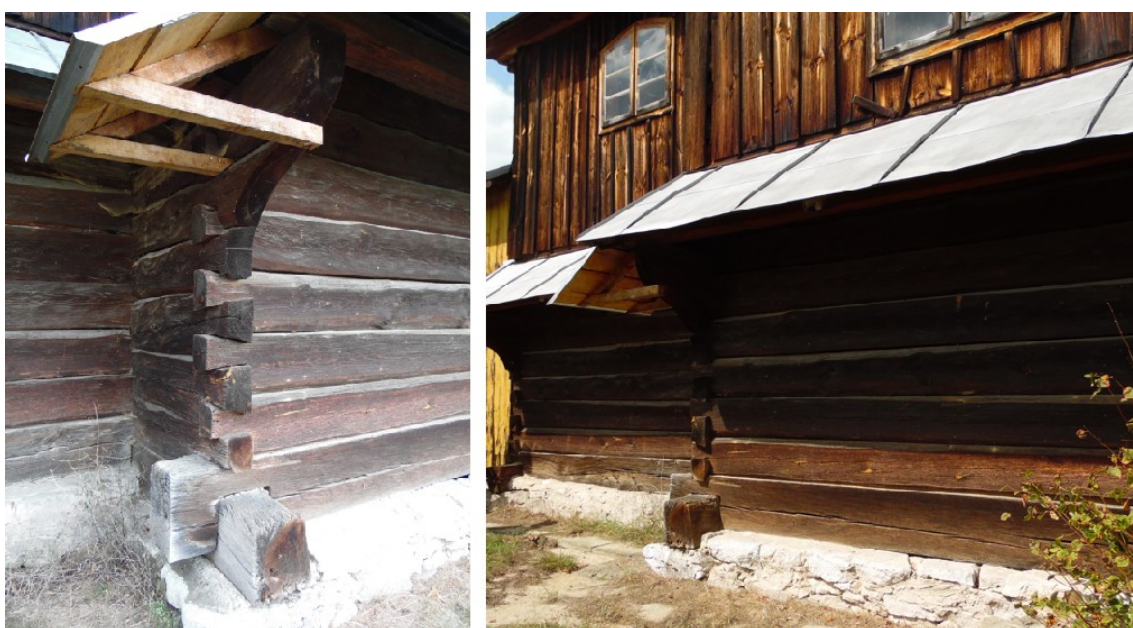
Figure 10. Current condition of log walls with dovetail notches in Chotylub: cracks in log walls in and contemporary repairs of the eaves roof.

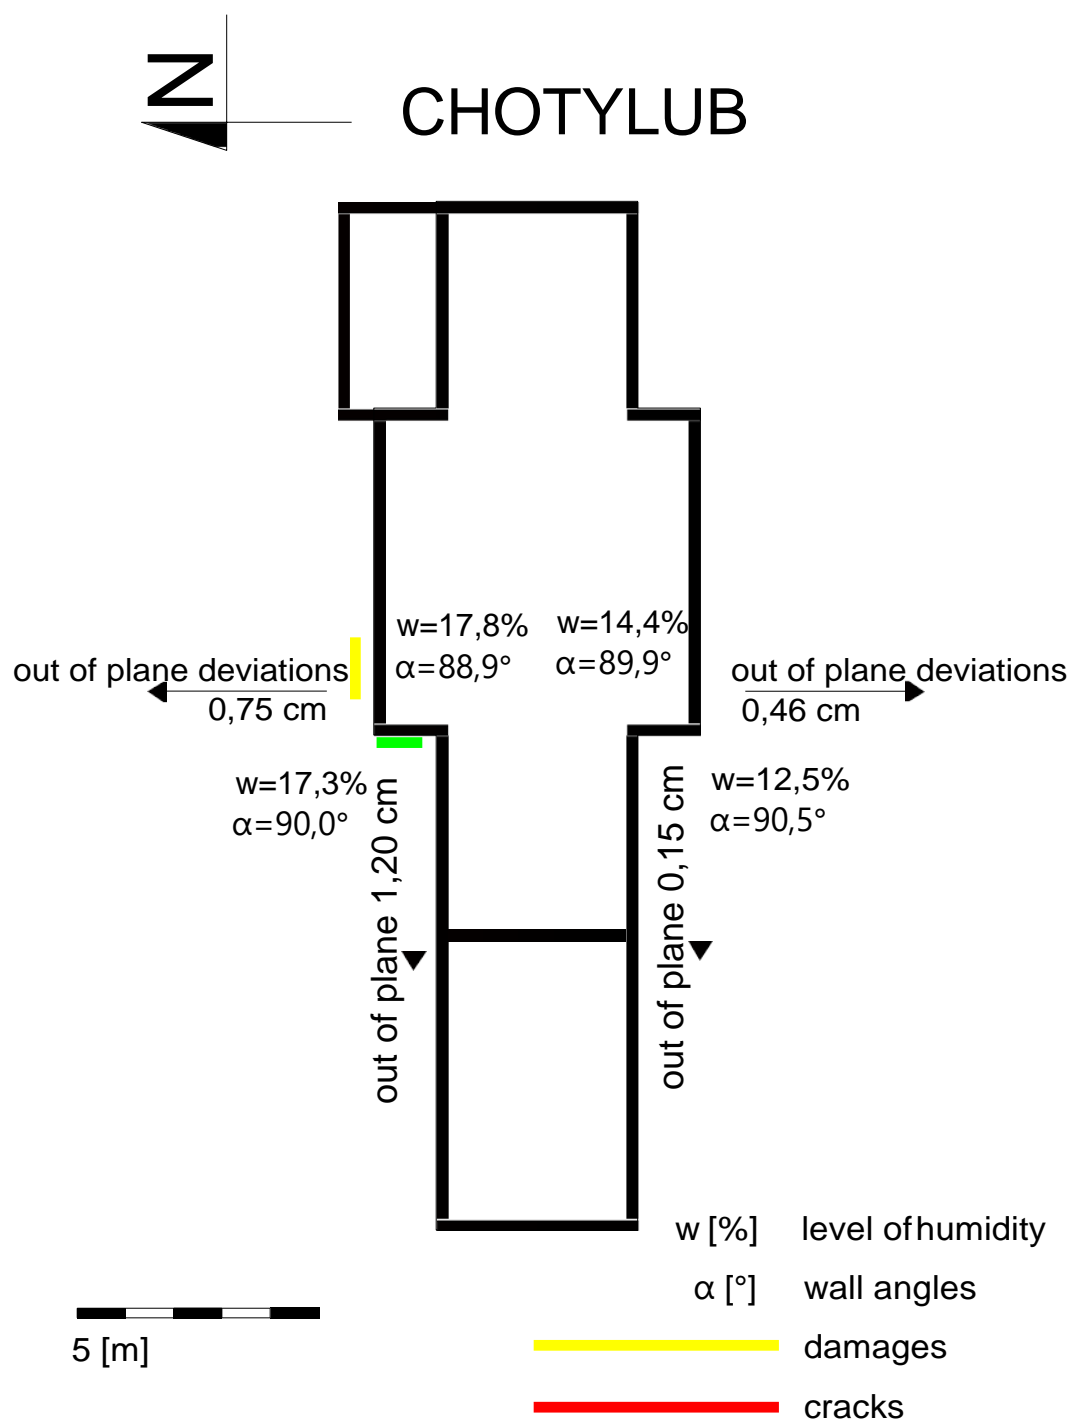
Figure 11. Results of measurements in the church in Chotylub. The picture shows: the level of humidity, the angles and the scale and direction of deviations. Colours indicate places where damage, cracks and biological corrosion occur.

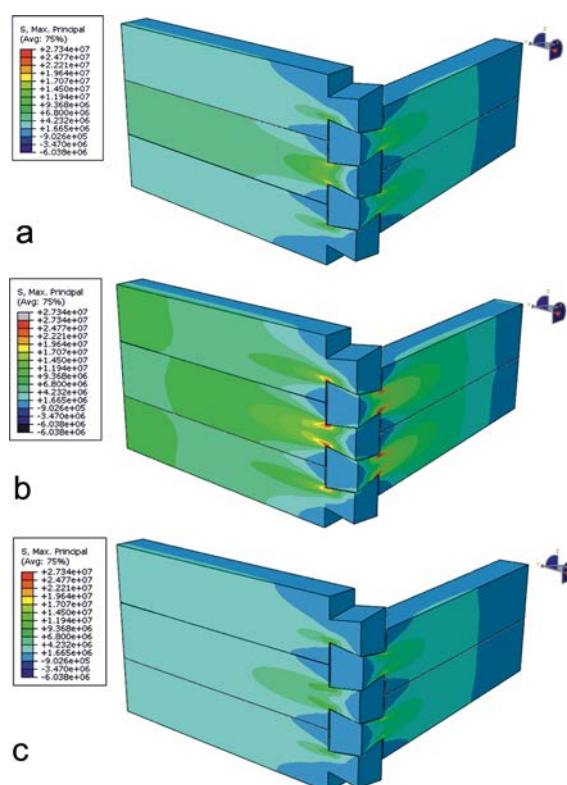
Significant deformations of the logs cause high stress on some contact surfaces. Large displacements can also expose the inside surfaces of the timber joints to environmental and biological degradation. The area of stress concentration area was therefore analysed and compared in the models considered. The principal stress and resultant force R_y were the significant quantities in the analysis. The maximum and minimum principal stress maps covering the three studied cases are shown in Figures (13-14). The comparison of the calculated values of the stress S and force R_y corresponding to the maximum lateral displacement u_y of each joint in each case studied is summarised in Table 2. The maximum principal stress is almost doubled when one member of an old joint ($S_{max} = 12.31$ MPa) is replaced with one made of dry new wood ($S_{max} = 22.82$ MPa).

Figure 13. Maximum principal stress in the joint where a) one log has been exchanged into a new wood; b) all logs are made of the same new wood; c) all logs are made of the same old wood.

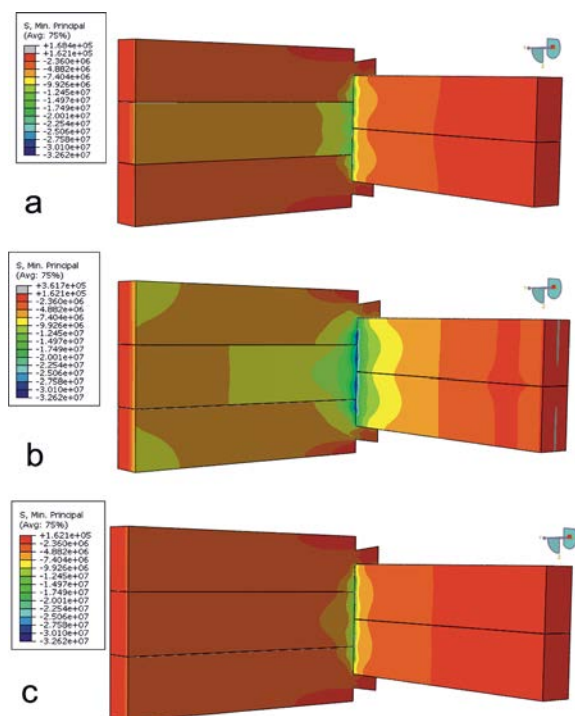
The minimum principal stress differs less and it is equal to $S_{min} = 14.66$ MPa in the case of old wood and $S_{min} = 15.87$ MPa with one new log in the joint. Under the applied displacement the stress concentration does not exceed the ultimate stress identified and described by (Pestka et al. 2018) as 71.9 MPa for dry wood. Moreover it appears is concentrated in the new log where the ultimate stress is higher than in the case of the old wood, which according to (Pestka et al. 2018) is 39.6 MPa. However, it indicates how such a replacement may affect the stress concentration in the joint. The force necessary to move the logs by 0.05 m, along their longitudinal axis is $R_y = 1.99$ kN in the case of the old joint, $R_y = 4.42$ kN in the new joint and $R_y = 2.20$ kN in the old joint with one log exchanged for new wood.

Figure 14. Minimum principal stress in the joint where a) one log has been exchanged into a new wood; b) all logs are made of the same new wood; c) all logs are made of the same old wood.
