# Operational causes of fatigue failures within passages of gas turbine engines

Zbigniew Korczewski, Assoc. Prof.  
Gdansk University of Technology

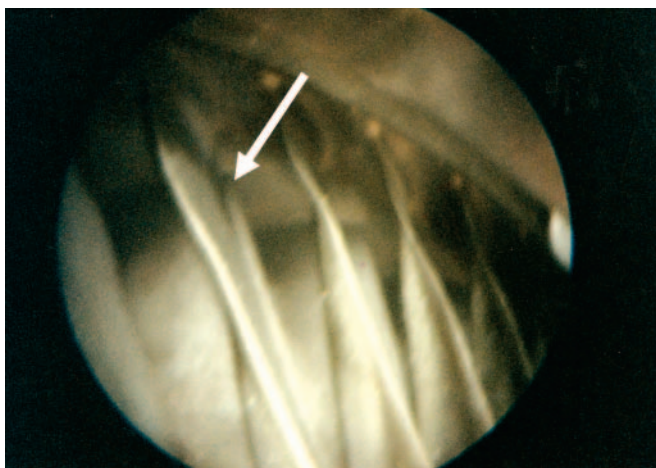
For instance, during engine's starting-up, within a few seconds structural elements of combustion chamber are exposed to dynamic thermal loads characterized by instantaneous exhaust gas temperature increments reaching about 80÷90 K/s [16]. In the case of exceeding the allowable temperature gradients, pumping phenomenon and even that of structural material creeping and deformation of turbine blades can occur Fig. 1.

Fig. 1. Deformations of LP turbine rotor blades, resulting from structural material creeping (acc. endoscopic examination)

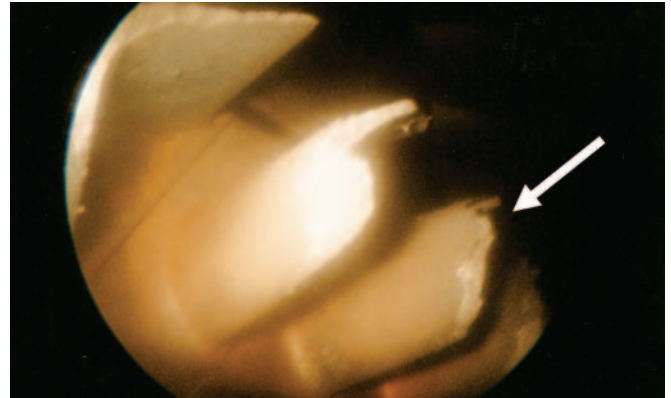
In extreme cases, local burning-of f edges and tips of HP turbine blades can happen, Fig. 2 and 3. Such failures of ship engine flow part usually result from sudden and unforeseeable operational events such as:

- choking the exhaust gas outflow due to fire in outlet channel,
- choking the engine air inlet (frozen air inflow shutters, sucking-in random things such as protective covers of shipboard devices etc).

Fig. 2. Burnt-off tips of HP turbine rotor blades (acc. endoscopic examination)

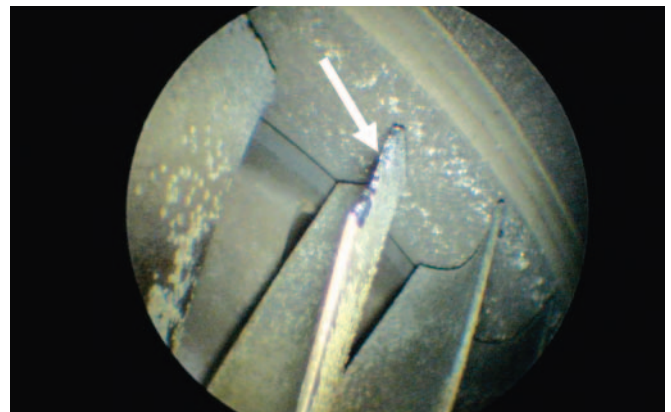
Fig. 3. Burnt-off tips of HP turbine rotor blades (acc. endoscopic examination)

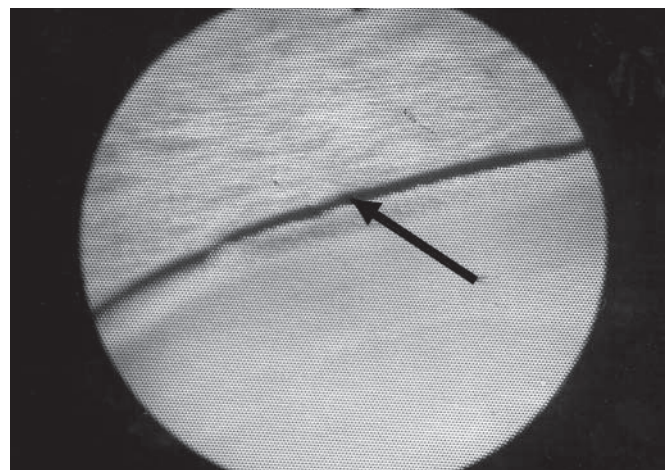
And, in the case of immediate stopping the engine during its operation in nominal (or near nominal) conditions, associated with eliminating idle running cooling phase, rotor seizure in turbine body may happen, Fig. 4 and 5.

Fig. 4. Increased tip clearance of HP turbine blade with visible traces of seizing in engine body (acc. endoscopic examination)

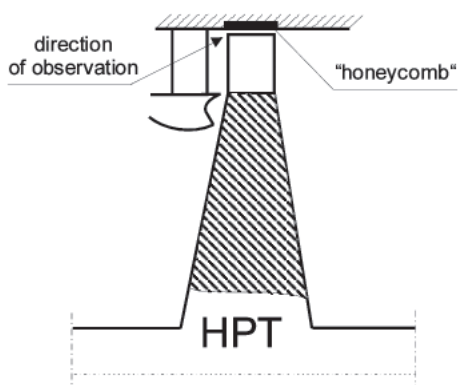
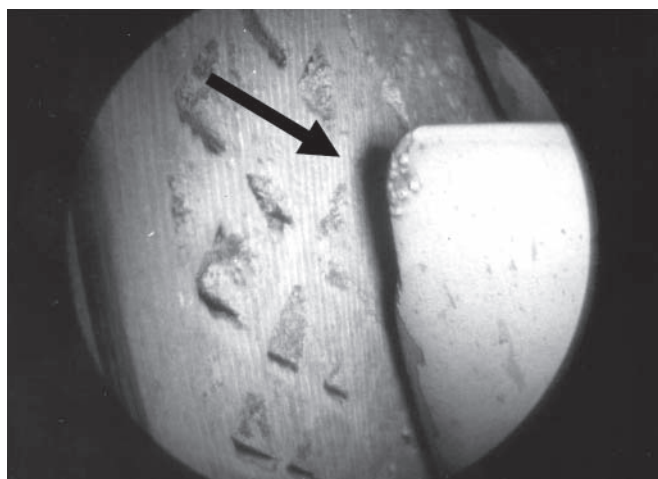
**Fig. 5.** Wear of sealing of HP turbine (HPT) rotor blades due to their seizing in engine body (acc. endoscopic examination)

It usually results in an intensive wear of body sealing of „honeycomb” type (Fig. 5), that in consequence leads to significant increasing the clearance of rotor blades of turbine and dropping its efficiency even by 10% [13]. It impairs efficient performance of entire engine because, as a result of increased radial clearance of HP turbine, character of distribution, to successive turbine stages, of disposed enthalpy drop becomes changed. The largest power drop occurs at the last turbine stages, i.e. engine propulsion turbine [12,13].

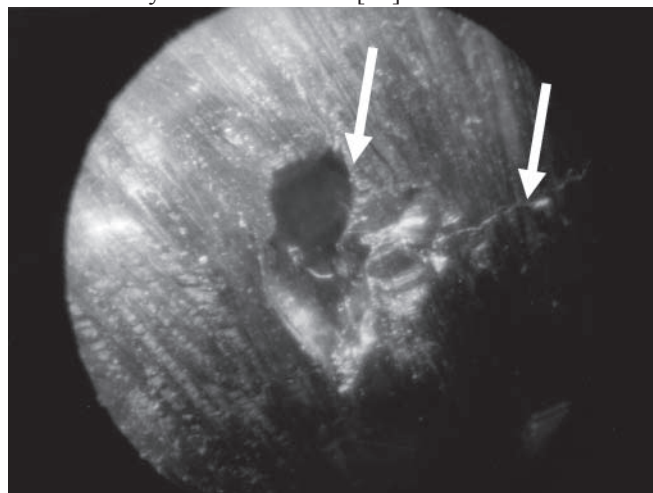
Another hazard to engine reliability, which results from rotor seizing in engine body, consists in possible cracking of the compressor body, Fig. 6. The presented failure has been identified during endoscopic examination of a GTU6a single-shaft engine (of block structure) driving ship electric generating set. Compressor's body was made of 40HNMACr-Ni low-alloy steel of a higher metallurgical purity. The situation occurred as a result of immediate switching-off the engine from operation under nominal load and passing over the cooling phase under idle running. Such decision of operators resulted from a fire observed in exhaust gas channel and entering the engine into unsteady operation range. After that the engine was dismantled and sent to its producer. Repair of the body consisted in vacuum electron-beam welding the crack.

On the basis of the character of the appeared failure of the compressor body it can be concluded that the initial cause of the crack was a material defect, e.g. presence of sulfides at place of fracture. In effect of action of dynamic loads the fatigue fracture propagating just from the edge of the material defect, was initiated. As a result of rotor seizing in the compressor body in the temperature of about 700-800 K, further propagation of the gap took place in the form of cleavage fracture. As the body was cooled more fast than the rotor the gap became separated mainly due to tensile forces (axial ones) with an influence of shear forces.

Designers of gas turbine engines take into account possible stopping the engine working under high load with passing over the cooling phase under idle-running. It is covered by manufacturer's testing program. Therefore the seizing of rotor units in engine body should not happen at all. However in the described case the engine immediate stopping was preceded by its unsteady work when a flash-back towards engine intake took place causing an inadmissible, very intensive rise of compressor material temperature much over its permissible value of 520K, determined by the manufacturer [15].

**Fig. 6.** Internal surface of GTU6a turbine engine compressor body, showing a fatigue fracture (acc. endoscopic examination)

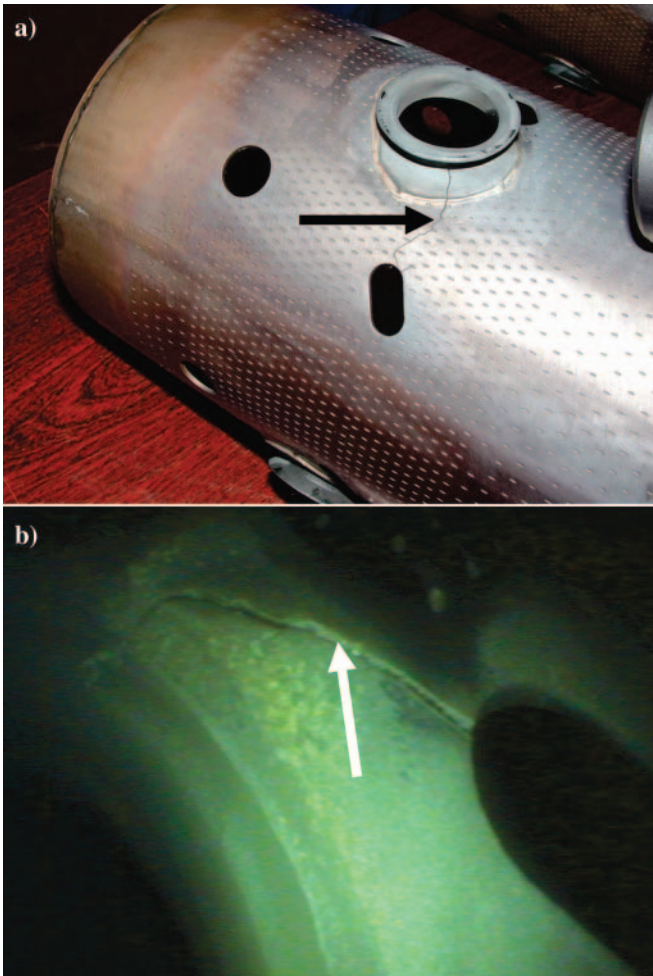
**Fig. 7.** Low-cycle fatigue fracture of flame tube of turbine engine combustion chamber: **a)** picture recorded just after the engine's dismantling; **b)** picture obtained by endoscopic examination

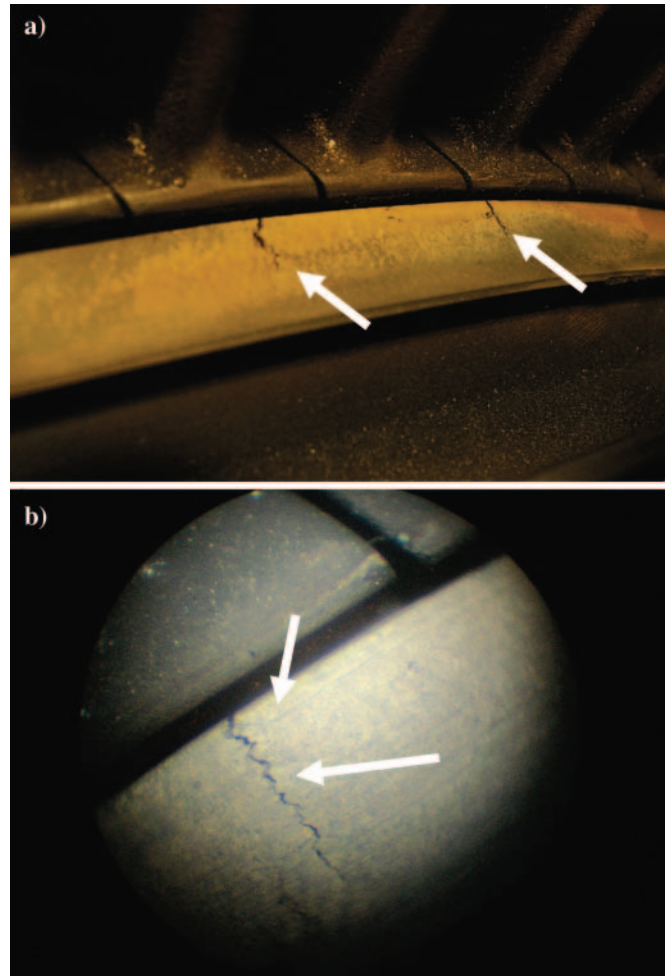
**Fig. 9.** Low-cycle fatigue fracture on internal body surface, under HP turbine guide vanes of a Zorya UGT3000 engine: **a)** picture recorded just after the engine's dismantling; **b)** picture obtained by endoscopic examination.

disks of rotors, in places of the greatest diameter changes, close to openings and gaps of combustion chamber flame tubes as well as in neighborhood of significant changes of profiled cross-sections of internal shell bodies, Fig. 9.
