Problem of Clogging in Drainage Systems in the Examples of the Żur and Podgaje Dams

Witold Sterpejkowicz-Wersocki

Gdańsk University of Technology, Faculty of Civil and Environmental Engineering,
ul. G. Narutowicza 11/12, 80-233 Gdańsk, Poland, e-mail: wste@pg.gda.pl

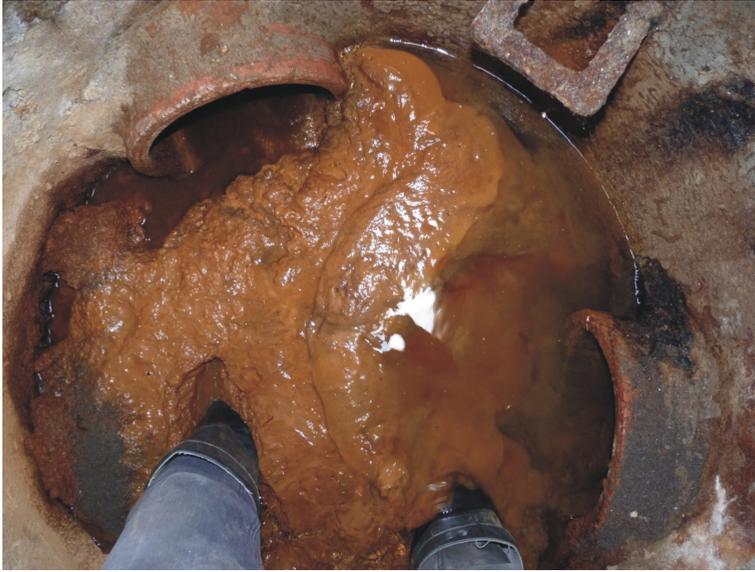
During operation, a slow but steady increase in pressure filtration can be observed. Inside wells and drainage pipes, clogging is caused by iron oxide in the form of fer-

Fig. 3. Ferruginous substance in a well

ruginous deposits, which reappear within a few months after being removed (Fig. 3 and Fig. 4).

The technical condition of the drain and the observed upward trend of the phreatic curve clearly demonstrate the need to restore the drainage system. Under the existing conditions, it is impossible to protect the drain effectively against the precipitation of iron oxide, but measures should be taken to delay the consequences of progressive clogging.

These measures include the replacement of the geotextile as a drainage layer with classic mineral inverted filters. The author's experiences (Bolt, Sterpejkowicz-Wersocki 2006; Sterpejkowicz-Wersocki Szudek 2011, 2013; Sterpejkowicz-Wersocki 2013) regarding the effectiveness of geotextiles in filtration and drainage solutions indicate that the presence of ferruginous groundwater results in the formation of an impermeable film on the surface of geosynthetics. In other cases, geotextiles retain their function, acting effectively as filters.

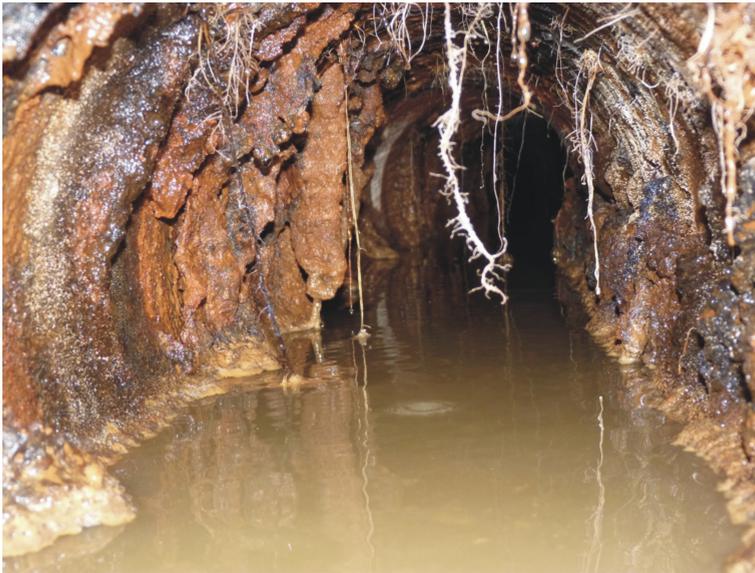
Fig. 4. Ferruginous substance in a pipe

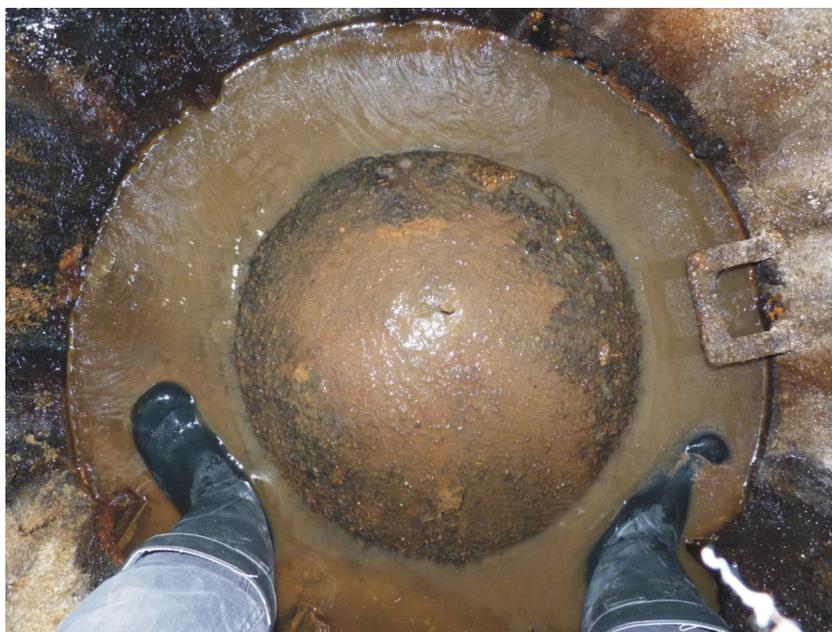
Some of the drainage wells have been mounted only on a geotextile (without a concrete plug). Inside the wells, a severe clogging of the geotextile can be observed, which

results in a bulge of the material (Fig. 5) caused by groundwater pressure, which is stabilized at a height of about 2 m above the bottom of the well.

Fig. 5. A bulge caused by groundwater pressure in geotextile at the bottom of a well
