# Renovation works in buildings in the area of former defensive fortifications

Maciej NIEDOSTATKIEWICZ<sup>\*1</sup>, Tomasz MAJEWSKI<sup>2</sup>, Adam BARYŁKA

<sup>1</sup> Department of Engineering Structures, Faculty of Civil and Environmental Engineering, Gdańsk University of Technology, Gdańsk, Poland

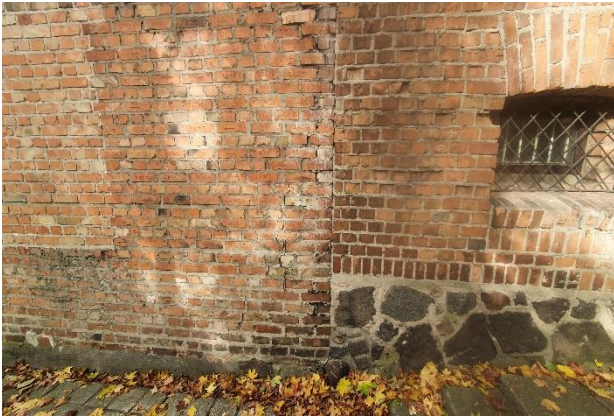
**Photo. 2:** No masonry bond at the junction of the former office spaces (A) with the former staff apartment (B), part of which are the rooms of the Southern Guardhouse

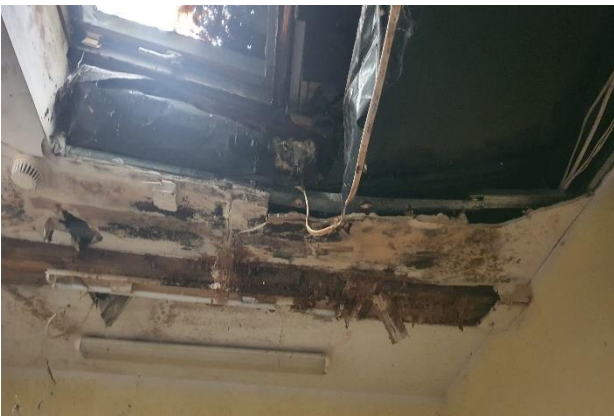
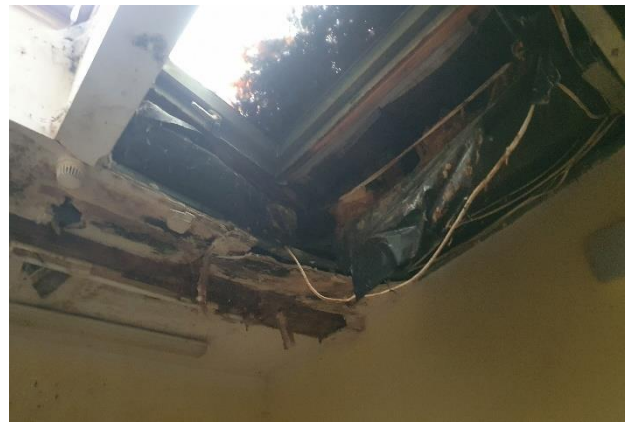
In the summer, in the room of the former office premises (A) adjacent to the defensive embankment, a random event occurred involving the collapse of a fragment of the roof structure (Photo 5). The roof, made as a ceiling on wooden beams with mineral wool insulation, has collapsed. Damage to the roof caused the ingress of rainwater into the interior of the rooms, contributing to the dampness of the walls and floor.

During the inspection, a local collapse of the flat roof structure (roof collapse) was found, made as a ceiling on wooden beams with mineral wool insulation. The direct cause of the damage to the roof structure was the breaking of the beams caused by biological corrosion of the wood, its rotting, probably the result of long-term dampness of the wood and the fungus and mold. It is worth noting that the roof damage occurred in the place where snow bags formed in winter, i.e. the wet wooden beams, weakened by biological corrosion, were subjected to an increased load from the weight of the snow. With the passage of time and the progress of corrosion, the wooden beams weakened so much that during the next winter, after snowfall, their bearing capacity was exhausted and the roof collapsed.

A visual assessment of the wood in the area of the damaged flat roof, in the zone of rooms adjacent to the top of the defensive rampart, clearly allowed to classify the wood as wet.

It was also very important that the roof surface had undulations, i.e. on fragments of the slope there were depressions in which the roofing could be felt. This is a characteristic symptom for wooden roof trusses with wooden elements damaged by biological corrosion. Depressions (sinks) were particularly perceptible in the zones in front of the skylights, where there were no fenders (baskets), i.e. in places where there were water pools. In the case of leaks in the roofing felt, these places are particularly exposed to moisture, and the depressions of the pavement indicated that such damage occurred in these places.

**Photo. 5:** Zapadnięty dach w części nad dawnymi pomieszczeniami biurowymi (A) Collapsed roof in part above former office spaces (A)

- perform temporary protection of the damaged flat roof as a matter of urgency:
  - ❖ in the space of the collapsed ceiling, place wooden square timber vertically, which will ultimately serve as a supporting structure for the roof over the damaged fragment of the roof,

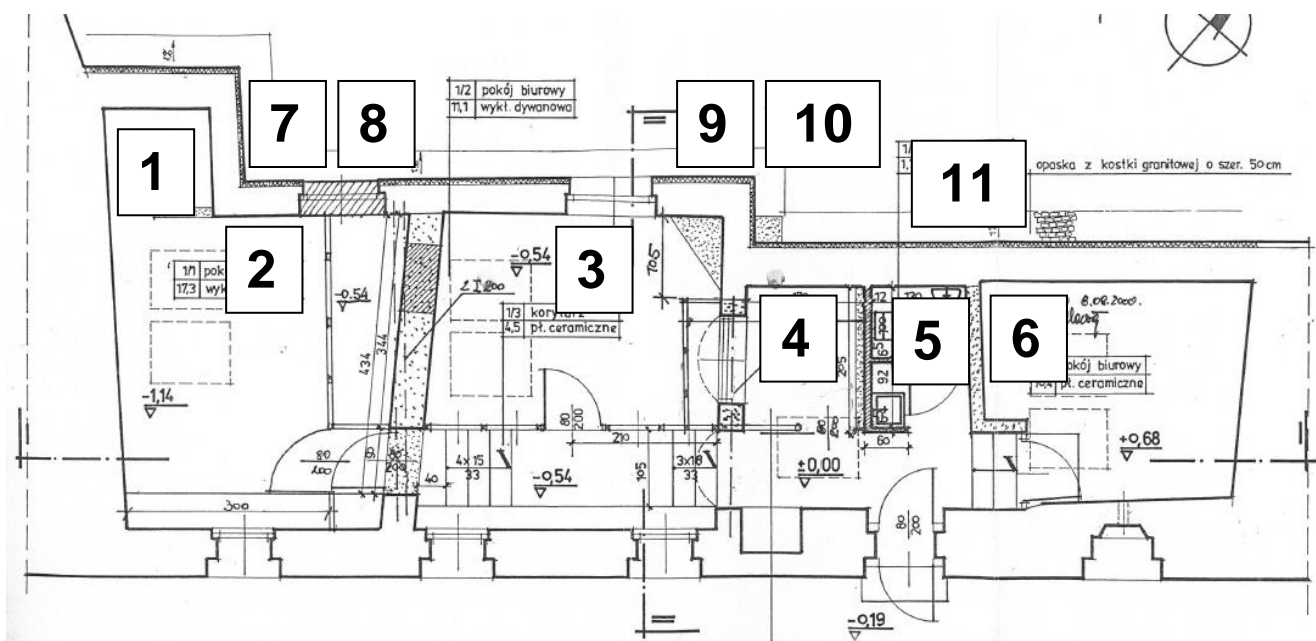
In order to estimate the method of constructing the wall from the side of the slope in the area of the former office premises (A), excavations were made, both from the outside and the inside of the building (Fig. 2). Thanks to the excavations made, it was checked whether the historical, brick reinforcements of the escarpment were used during the construction of the rear wall. Based on the excavations made, it was found:

Fig. 2: Location of opencasts in the external wall (on the slope side) of the former office rooms (A): 1, 2, 3 ... - number of the opencast

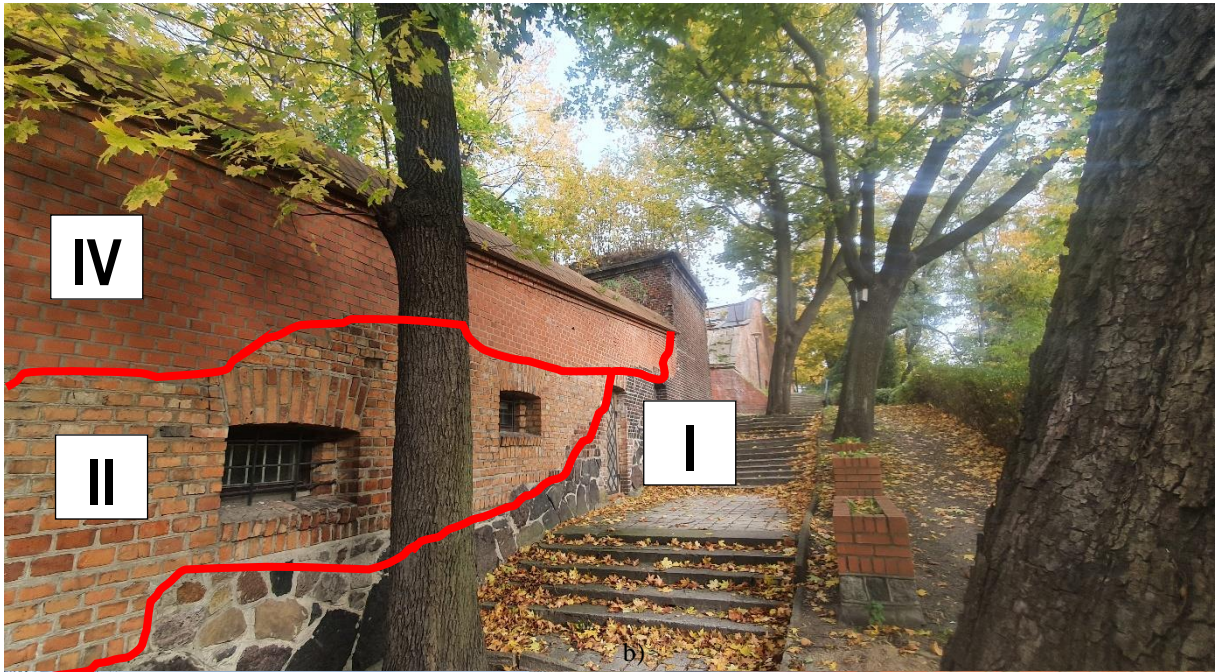
- stage I: in the second half of the 19th century, the construction of the defensive rampart was completed, fragmentary brick reinforcements of the escarpment were made and the Southern Guardhouse was built, which is now part of the former service apartment (B),
- stage II: probably at the turn of the 70's and 80's of the 20th century, a building was constructed which is currently referred to as former office space (A). It is highly probable that in the period between stage I and stage II, utility rooms (C) were added to the front wall of the South Guardhouse,

- stage III: a fragment of the area between the Southern Guardhouse and the former office premises (A) was developed, thanks to which a building was created that was later used as a former business apartment (B),
- stage IV: at the beginning of the 21st century, probably at the turn of 2000-2001, the former office premises were renovated (A)

**Photo. 10:** Probable stages (I, II, III and IV) of the construction of the walls of the buildings from the south-eastern (front) elevation (fragment) of the Complex of Buildings located at the South Guardhouse of Napoleńska Redita in Gdańsk:  
a) former office rooms (A), b) former apartment service (B) + former office space (A)
