# Revitalizing the Sacral Complex of the Parish of the Sacred Heart of Jesus in Gdynia: A Comprehensive Restoration Project in Alignment with Monument Conservator's Guidelines and Technical Prerequisites

Maciej NIEDOSTATKIEWICZ<sup>\*1</sup>, Jacek BRAMORSKI<sup>2,3</sup>

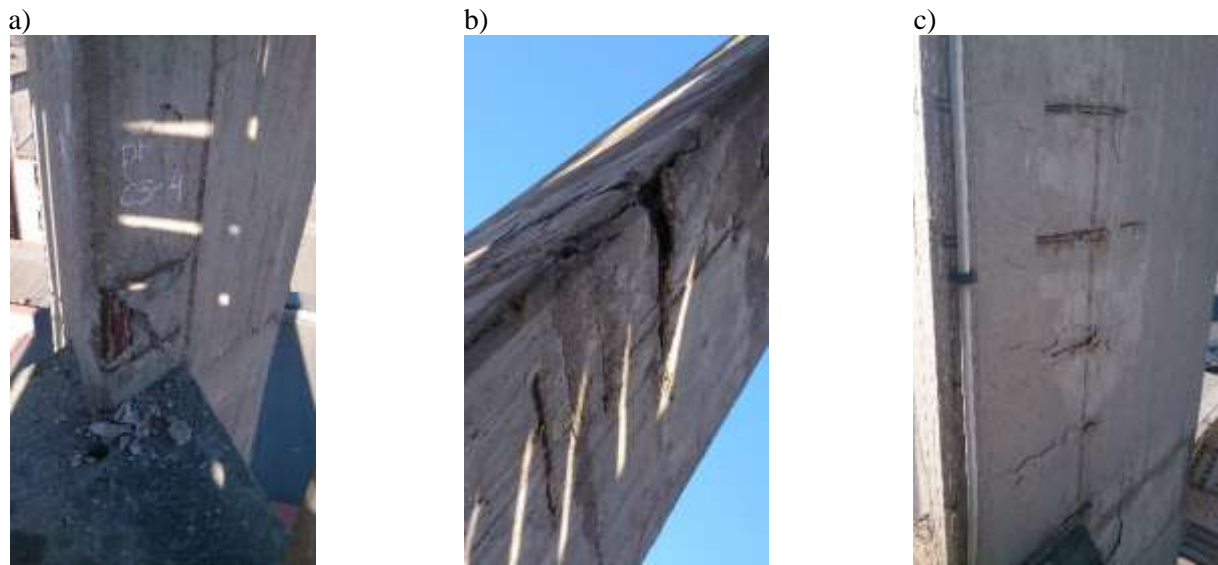
transoms were found. On the other hand, there was massive loosening of the cover of the main reinforcement and stirrups as a result of corrosion of the bars and stirrups (Photo 2, Photo 3 and Photo 4).

**Photo 2.** Examples of damage to reinforced concrete, monolithic columns of the belfry tower: a), b), c) detachments and losses of the concrete cover and corrosion of the reinforcement bars (photo by Maciej Niedostatkiwicz)

Corrosion damage at levels 4-5 and 5-6 was more intense than at levels 2-3 and 3-4. Occurring damage to the tower made it necessary to shut down the carillon, which had been operating continuously for almost 35 years, due to the danger of moving around the internal staircase in order to activate the bell. Vertical cracks were visible on the column formed from the assembly of prefabricated stairs, in the section between levels 2-3 (Photo 5).

- structural elements (main columns in the axes A, B, C, prefabricated auxiliary posts, as well as transoms and beams at the level of technical platforms from 1 to 6) were reprofiled with the use of PCC and PCC II repair compounds,
- scratches on the column of the spiral stairs between levels 2-3 were secured by the use of adhesive injection. It was assumed that if the cracking of the column reappeared, it would be necessary to strengthen it and protect it by gluing carbon mats, creating the form of closed rings around the column between the prefabricated steps of the stairs,
- after the reprofiling, the surfaces of the reinforced concrete elements were covered with hydrophobing agents that minimize the migration of moisture and compounds contained in the air into the concrete, at the same time minimizing the progress of concrete carbonation.

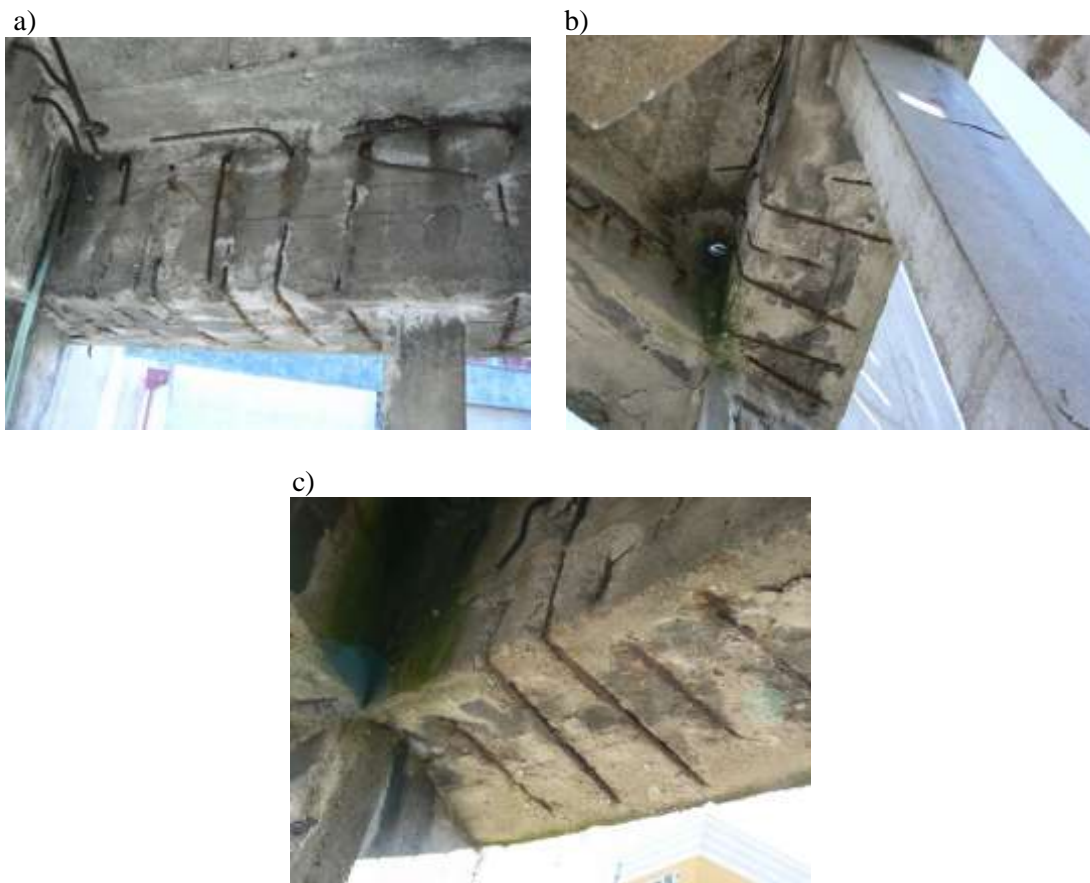
**Photo 3.** Examples of damage to the monolithic reinforced concrete bolts of the belfry tower: a), b), c) losses of the concrete cover and corrosion of the reinforcement bars (photo by Maciej Niedostatkiwicz)

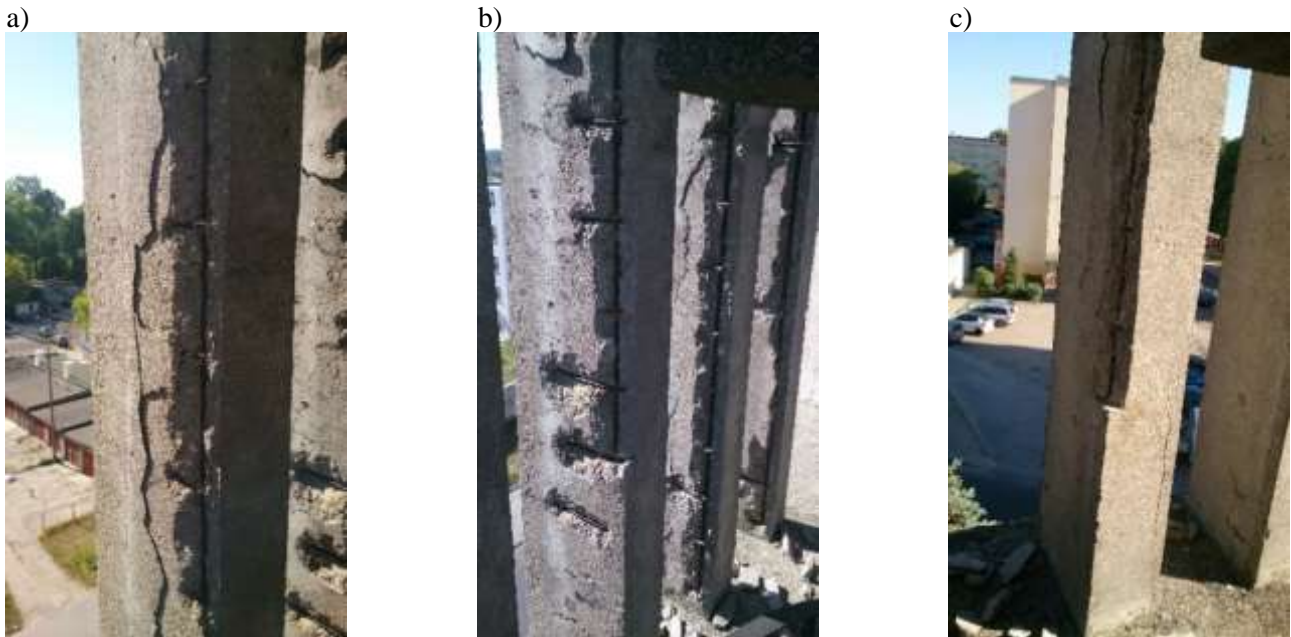
**Photo 4.** Examples of damage to the reinforced concrete prefabricated pillars of the belfry tower: a), b), c) losses of the concrete cover and corrosion of the reinforcement bars (photo by Maciej Niedostatkiewicz)

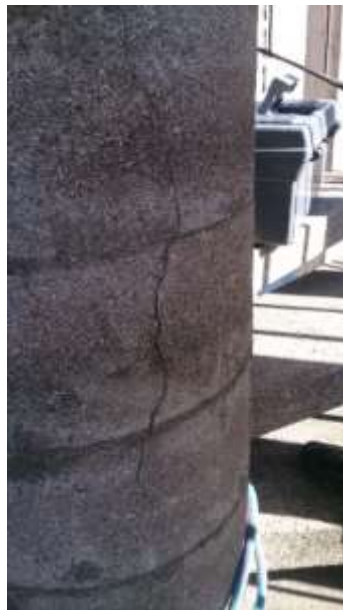
**Photo 5.** Outlined, in the line of the axial anchorage, prefabricated steps of the spiral stairs leading to the top of the belfry tower (photo by Maciej Niedostatkiewicz)

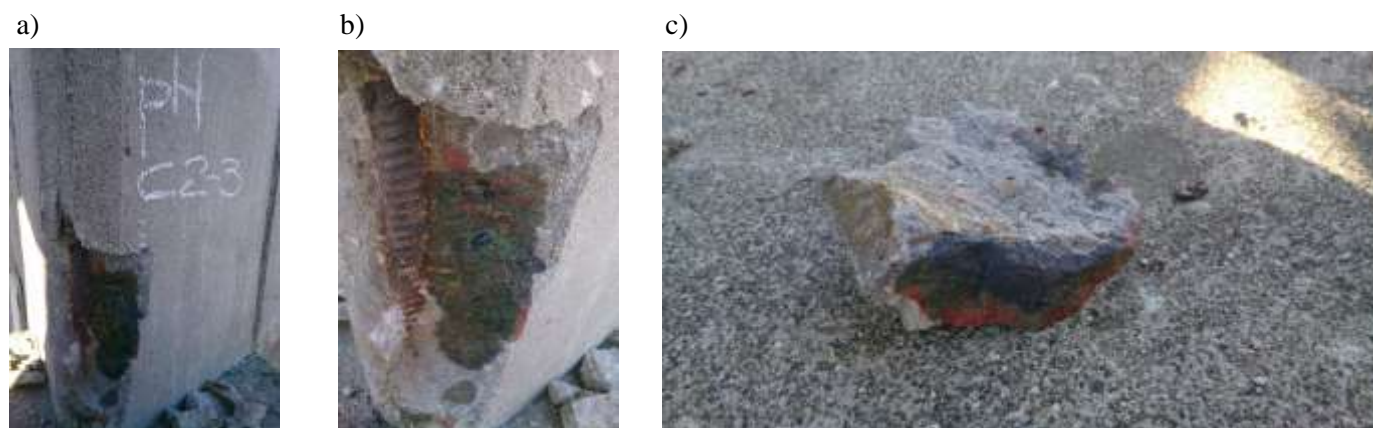
**Photo 6.** Exemplary results of measurements of the degree of concrete carbonation in the performed open pits: a) and b) discoloration of concrete on the main pillars of the bell tower from  $pH=5$  to  $pH=11$  and c) discoloration of the forged fragment of the concrete cover of the transom reinforcement bars from  $pH=5$  to  $pH=13$  (photo by Maciej Niedostatkiewicz)

- pole A3-4 (level 4)  $pH = 7$ ,
- column C3-4 (level 4)  $pH = 7$ ,
- column C2-3 (level 3)  $pH = 9$ ,
- column A1-2 (level 2)  $pH = 11$ .

The obtained test results allowed to conclude that the concrete in the near-surface zone (cover) lost its ability to protect the reinforcement bars against corrosion [N7]. In the excavations, corrosion of the reinforcement bars was found: the measured corrosion losses of the bars were up to 2 mm in diameter of the main reinforcement bars and up to 1.50 mm in diameter of the transverse reinforcement bars (stirrups).

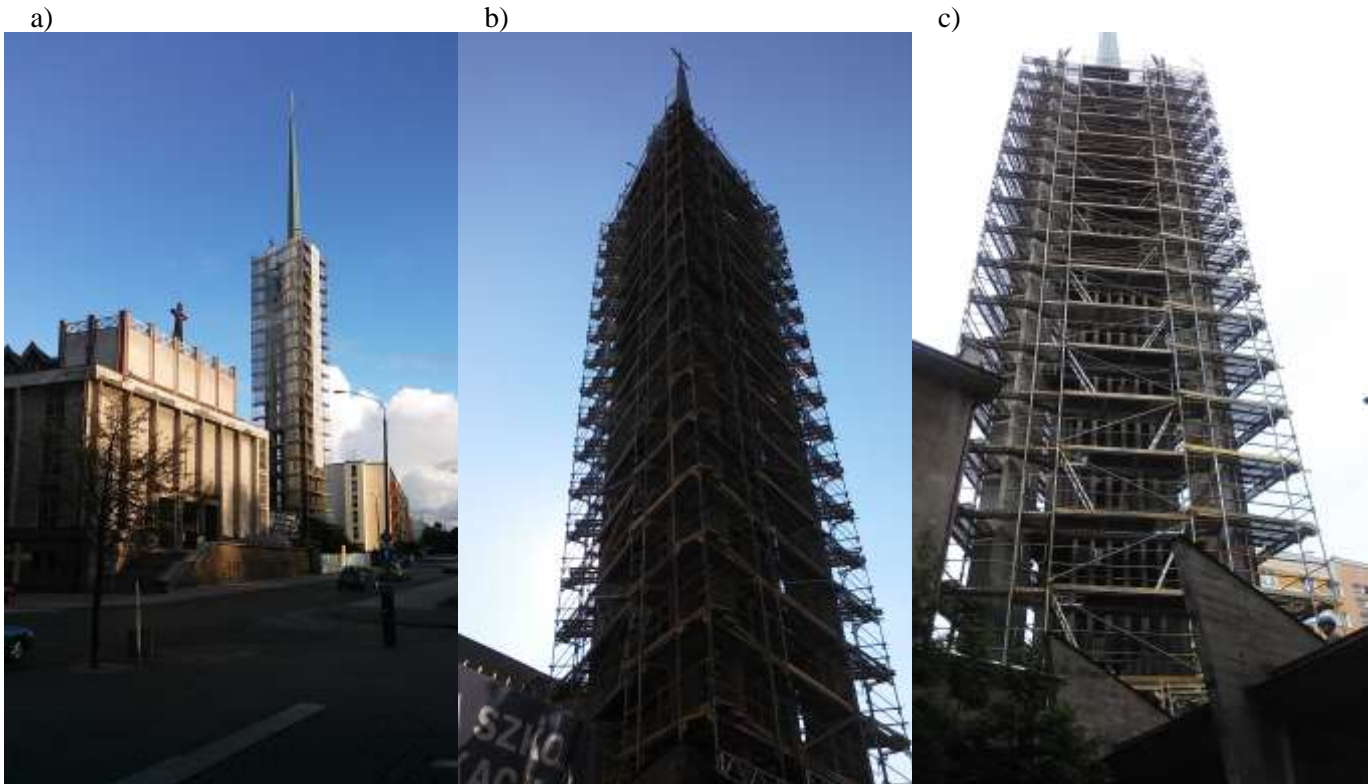
**Photo 7.** Reinforced concrete belfry tower during renovation works: a) general view, b), c) close-up details of the scaffolding (photo by Jacek Bramorski)

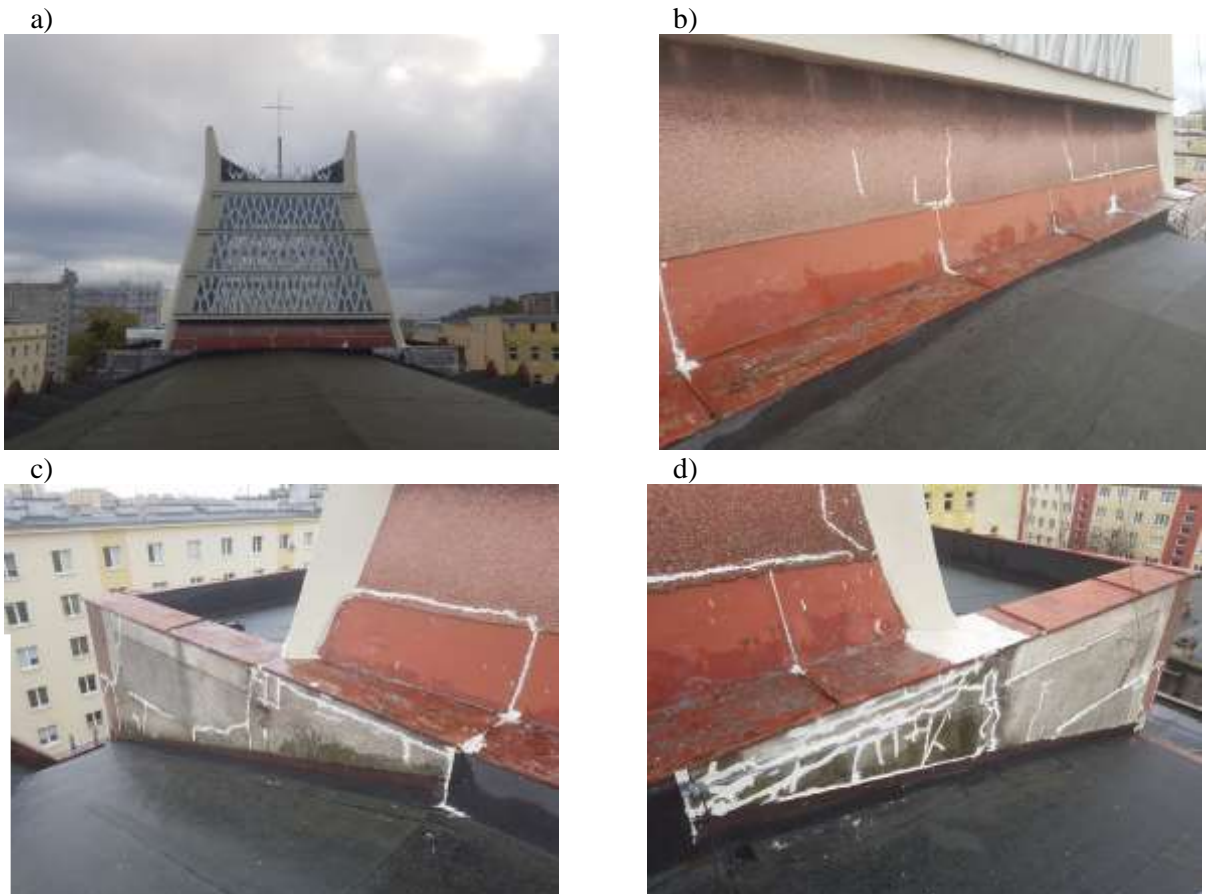
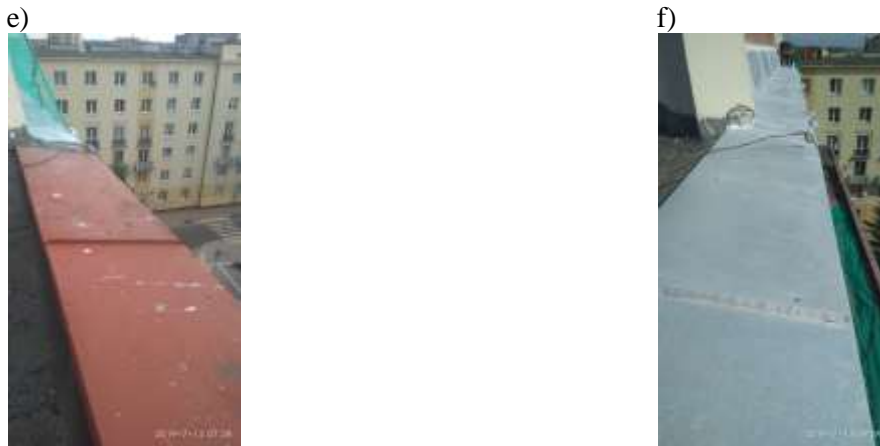
**Photo 9.** Roof of the Church of the SHoJ in Gdynia: a) general view towards the so-called lantern over the presbytery, b) cracks in the plaster of the lantern plinth, c), d) cracks in the plaster of the attic along the lantern, flashings of the attic along the lantern: e) before and f) after the replacement (photo by Maciej Niedostatkiwicz and Jacek Bramorski)

The renovation works also included the replacement of the existing, intensively depreciated flashings. The main scope of renovation works on the roof over the central nave included reprofiling the reinforced concrete gable beams of the roof slopes - the beams had numerous corrosion damages, the concrete cover of the reinforcement bars was falling off and extensive moisture damage was visible (Photo 10). The repair works included the reprofiling of reinforced concrete elements with the use of PCCI and PCC II repair compounds, taking into account the use of passivating materials for corroded reinforcing bars. The scope of renovation works also included the replacement of flashings and flashings of the roof slopes and the replacement of existing downpipes.

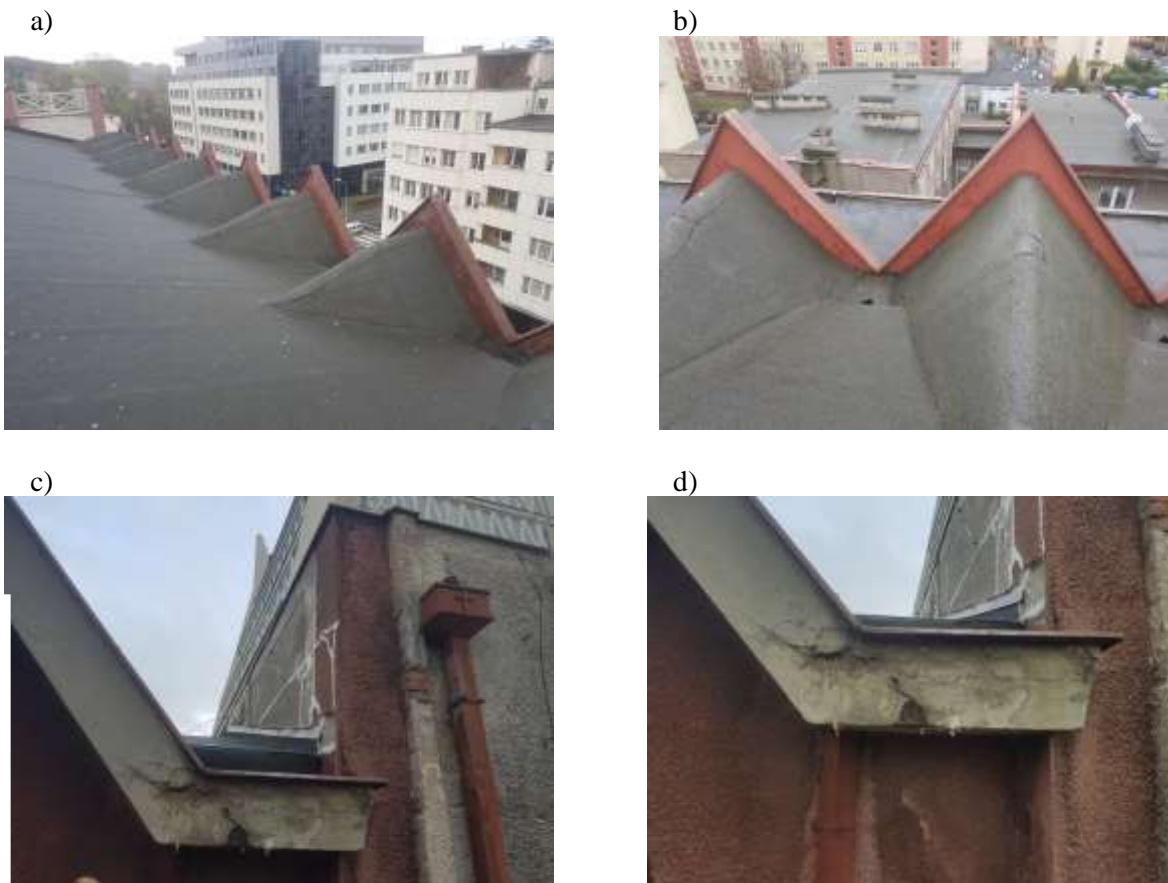
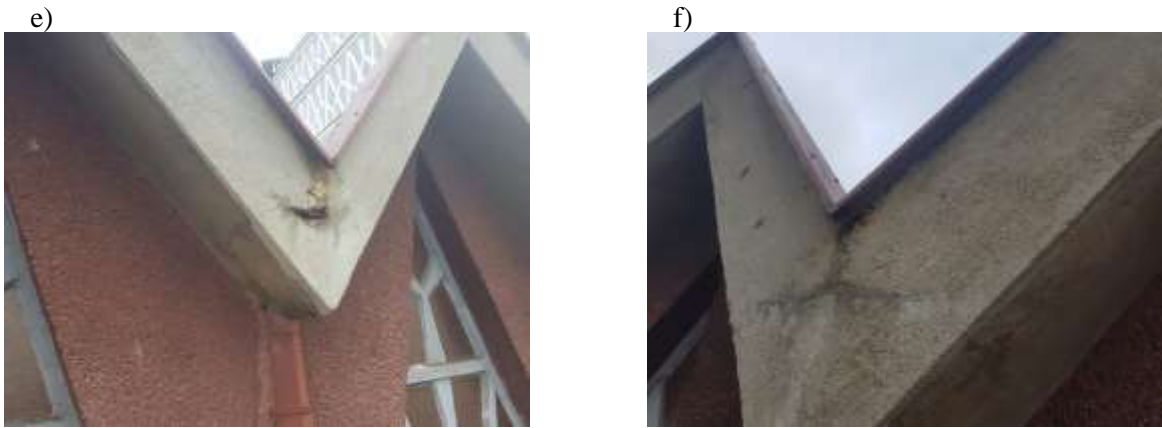
**Photo 10.** Shed roof over the nave of the Church of the SHoJ in Gdynia: view: a) general, b) close-up, c), d), e), f) examples of damage to the roof cornice (photo by Maciej Niedostatkiwicz)

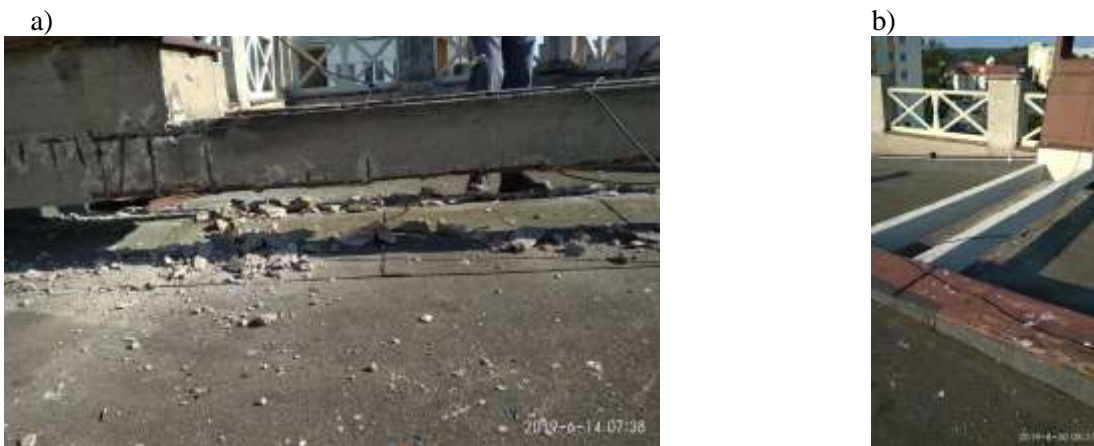
**Photo 11.** Reinforced concrete, monolithic beams of the grate supporting the cross from the west elevation (along 3 Maja Street) - condition: a) before, b) after renovation (street names as of 2023) (photo by Maciej Niedostatkiwicz)

As part of the repair work on the reinforced concrete elements of the roof slope above the central nave, the reinforced concrete beams supporting the cross placed on the roof, visible from the side of the front façade, were also reprofiled (Photo 11).

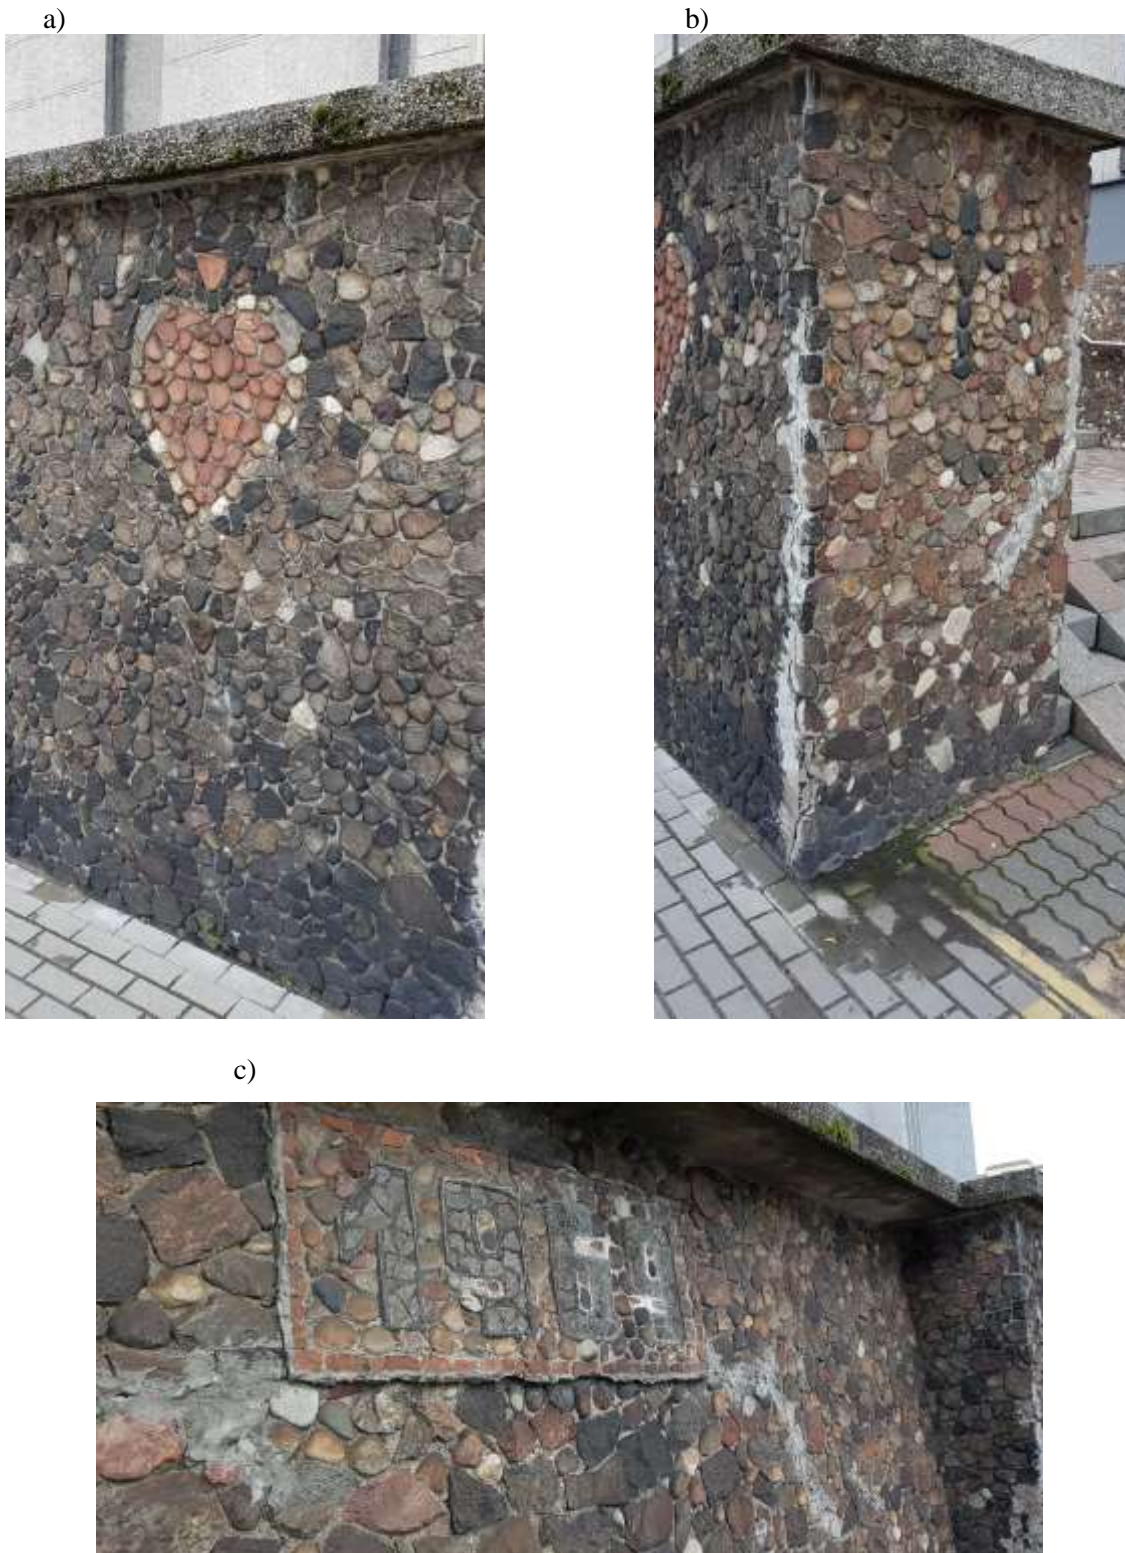
Decorative elements made on the cladding - religious symbols in the form of a heart and a cross and the date (year of completion of the construction of the Church) have not stratified over the years of operation (Photo 13), but it was noted that the date is detached from the structural wall.

**Photo 13.** Characteristic symbols made in the stone cladding of the wall from the west elevation (along 3 Maja Street): a) heart, b) cross, c) 1969 (year of completion of the construction of the church) (street names as of 2023) (photo by Maciej Niedostatkiwicz)

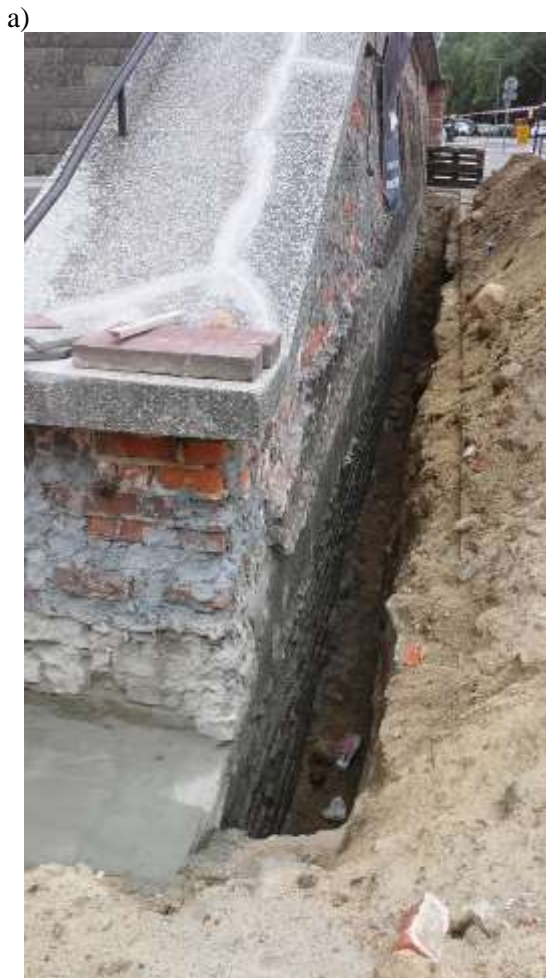
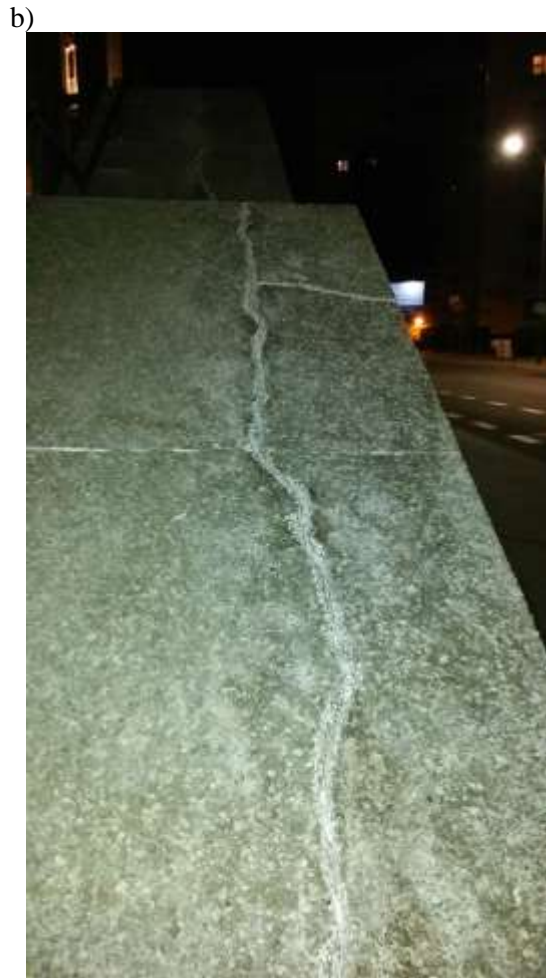
**Photo 14.** The wall at the entrance from the west elevation (along 3 Maja Street) during renovation works: a) dismantled cracked stone cladding and implementation of vertical damp-proof insulation, b) repaired cracks in the terrazzo cladding of the wall cap (names of the street as of 2023)  
(photo by Jacek Bramorski)

As part of the renovation works, the cladding was dismantled, locally down to the foundation level (Photo 14a), its stable fragments were left along part of the length of the wall. The cladding was rebuilt with recovered stones, after their prior mechanical cleaning and bathing in a paste solution with the addition of ammonium fluoride. A vapor-permeable, low-shrinkage packaged mortar with a reduced amount of lime was used to build the stone cladding. The laying of the cladding was preceded by the implementation of anti-moisture insulation on the footing and on the outer wall in the ground zone (Photo 14b). The insulation was made of a mineral mortar based on polymer-modified microsilica. As part of the work related to the execution of insulation, a facet was profiled at the junction of the continuous footing and the structural wall.

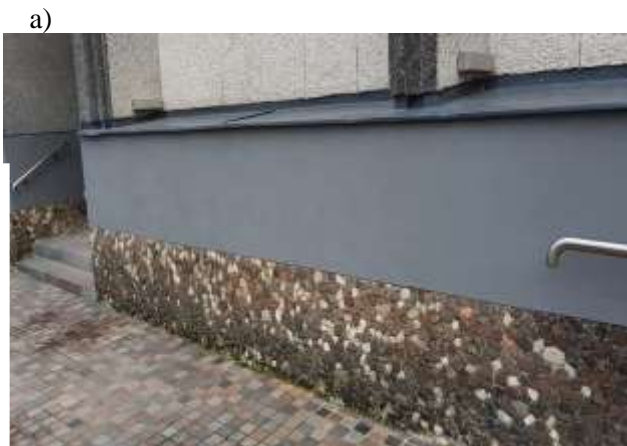
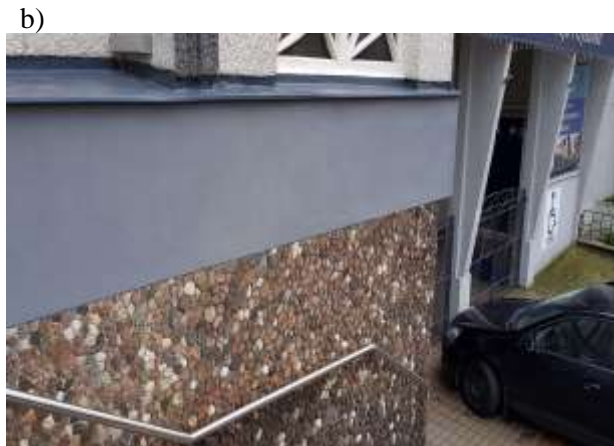
**Photo 15.** Base cornice after completion of renovation works: a), b) along the western elevation (from the side of 3 Maja Street), c) from the southern elevation (along Armii Krajowej Street), d) along the eastern elevation (from the side of Monsignore Hilarego Jastaka Street), e), f) from the northern elevation (along Stefana Batorego Street) (street names as of 2023) (photo by Maciej Niedostatkiwicz)

The lower part had damage similar to damage to the stone cladding of the wall at the main entrance. The stones were dirty, covered with a coating. Single stones were loosened, some of the joints were chipped. As part of the renovation works, the entire surface of the lower part of the plinth was first wetted with water at a temperature of  $\sim 30^{\circ}\text{C}$ , and then a thin layer of ammonium fluoride-based cleaning paste was applied to the surface of the plinth using a bench brush and the plinth was again washed with warm water. After cleaning, loose stones were glued in, and then the jointed stone cladding was supplemented with the materials used to repair the stone cladding of the wall at the main entrance.

The upper part of the plinth had damages in the form of plaster burns from the concrete base, the entire surface of the plaster was discolored and faded. As part of the renovation work, the scalded plaster was chipped off and restored. The new plaster was made as a layered plaster, with a primer layer and a top layer, after prior priming of the substrate and making a bond bridge. The top layer of the plaster was made as colored in the mass, with the use of fine quartz aggregate, with the use of a trass mortar dyed in the mass. The newly made external plaster on the plinth was made as rubbed plaster, with a structure matched to the structure of the plaster fragments left. After the local plaster repairs were completed, its entire surface was secured with an additional protective paint coating, in accordance with the conservation guidelines - a silicone facade paint was used, characterized by high water vapor diffusivity. As part of

the repair work, the flashings on the upper surface of the plinth were also replaced. The original flashings were made of zinc sheet, joined with the use of reflected and smooth coils, they were replaced with flashings made of steel-titanium sheet joined with standing seams.

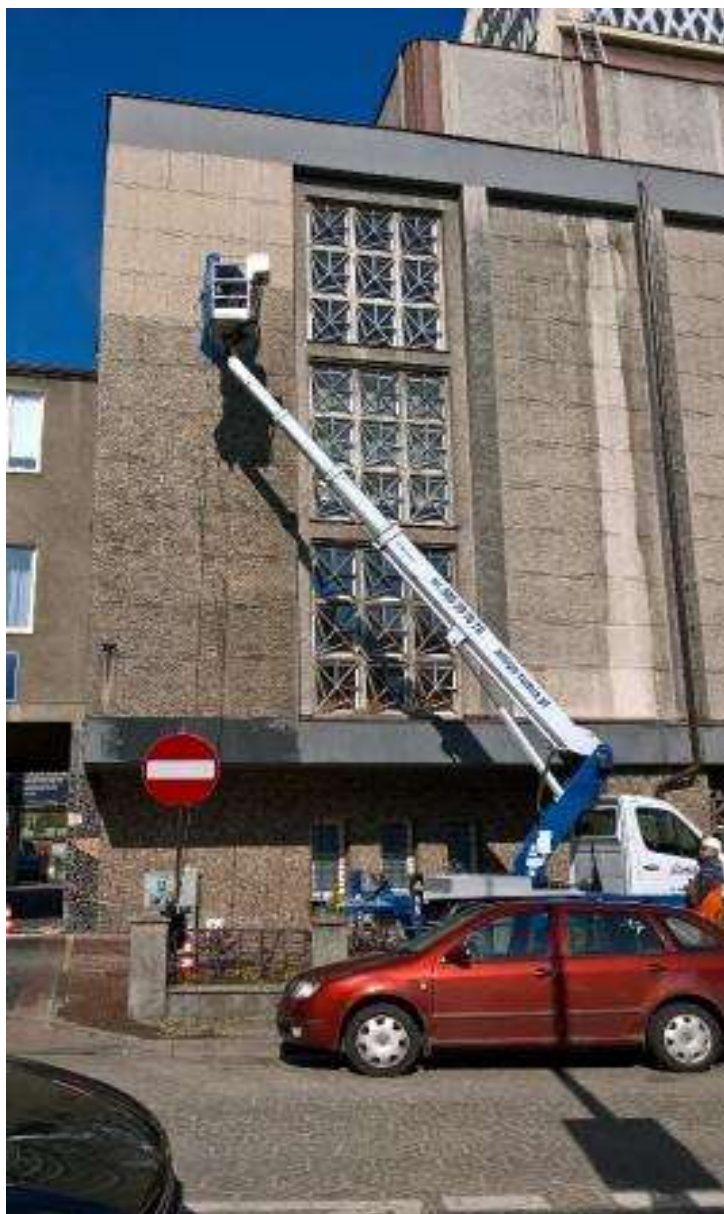
**Photo 17.** Comparison of the structure and color of the facade a) before and b) after its cleaning - on the example of the eastern facade (from the side of Monsignore Hilarego Jastaka Street) (street names as of 2023) (photo by Jacek Bramorski)

The next stage of the renovation works of the Church building was the cleaning of the elevation (Photo 16). All facades of the building were subjected to restoration works, which were cleaned using the hydromonitoring method (Photo 17), using hot water at a temperature of 30°C. As an addition to the purification, an agent with a neutral  $pH$  was used, containing surfactants, i.e. surfactants that lower the surface tension of water. Thanks to the emulsifying properties of the agent used, the washed dirt and impurities were bound, especially the layer of grease and dust accumulated over the years of operation on the surface of the plaster made as the so-called. scraper. After cleaning, the facades were not additionally secured with a protective paint coating with the addition of anti-algae and anti-fungal agents, it was assumed that the protection would be provided by preservatives used in the production of the detergent in order to obtain its durability.
